Profile/Photo Observation Report

Date:	09/12/2021	Weather:		Coding:	PACP 7.0
Pipe Length (ft):	167.2	Owner:	City of Hobart	Pre Clean:	Heavy Cleaning
P.O.#:	YES502259	Surveyor:	S. Bucklin	PSR:	P-504-088-130
Customer:	City of Hobart	Clean Date:	08/29/2021	Shape:	C

Street:	West 42nd Avenue	Flow Control:	Not Controlled
City:	Hobart, IN	Year Renewed:	
Location:	Alley	Tape/Media #:	
Purpose:	Routine Assessment	Dia/Height:	12"
Use:	Sanitary Sewage Pipe	Material:	VCP
Drain Area:		Lining:	None
Category:	NA		
Comment:			
Location Details:		Direction of Survey:	Downstream
US MH:	M-504-130	DS MH:	M-504-088
		Total Length Surveyed (ft):	167.2

O&M Index:	1.96	O&M Quick:	4137	O&M Rating:	112.00
Structural Index:	3.68	Structural Quick:	4E32	Structural Rating:	136.00
Overall Index:	2.64	Overall Quick:	4E39	Overall Rating:	248.00

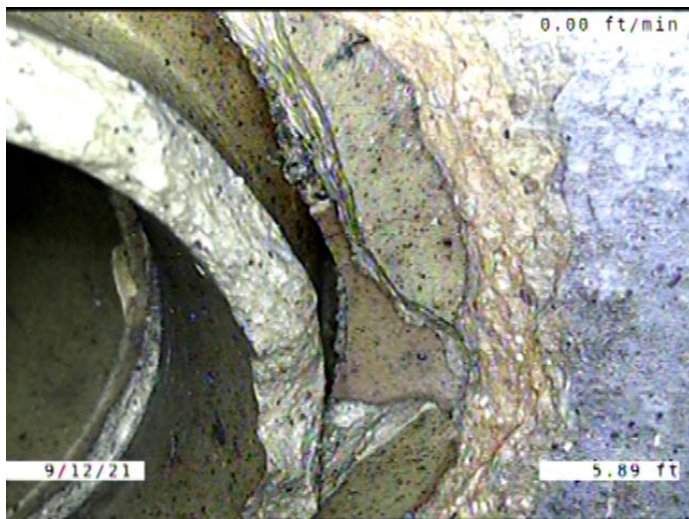
Code: **B**
 Description: **Broken**

Distance (ft): **5.9**
 Structural Grade: **4**
 O&M Grade: **0**
 Clock Start/From: **12**
 Clock To:
 1st Value:
 2nd Value:
 Value Percent:
 Continuous Index:
 Within 8" of Joint: **YES**
 Remarks:

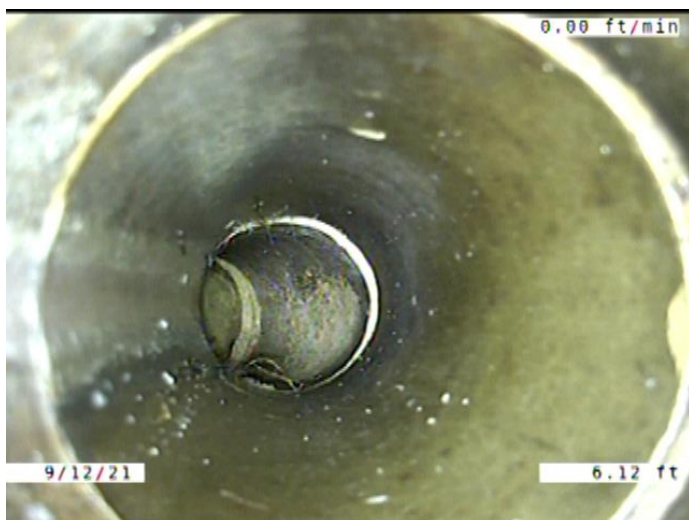
Code: **TB**
 Description: **Tap Break-in/Hammer**

Distance (ft): **6.1**
 Structural Grade: **0**
 O&M Grade: **0**
 Clock Start/From: **11**
 Clock To:
 1st Value: **4.000**
 2nd Value:
 Value Percent:
 Continuous Index:
 Within 8" of Joint: **YES**
 Remarks:

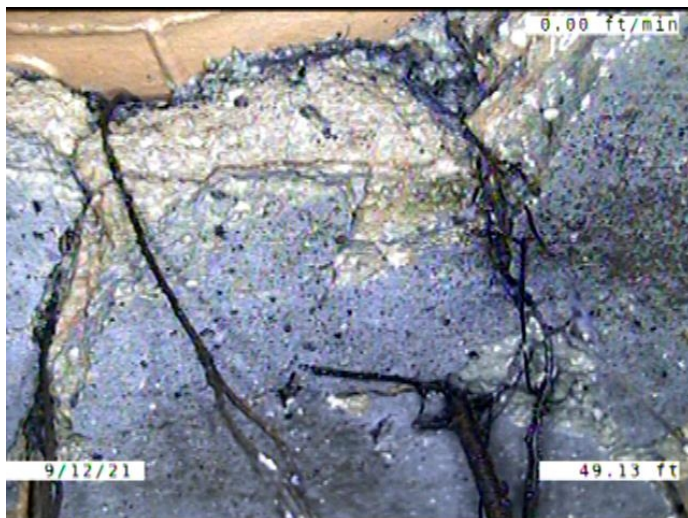
Code: **RFB**
 Description: **Roots Fine Barrel**

Distance (ft): **49.1**
 Structural Grade: **0**
 O&M Grade: **2**
 Clock Start/From: **11**
 Clock To: **1**
 1st Value:
 2nd Value:
 Value Percent:
 Continuous Index:
 Within 8" of Joint: **NO**
 Remarks:

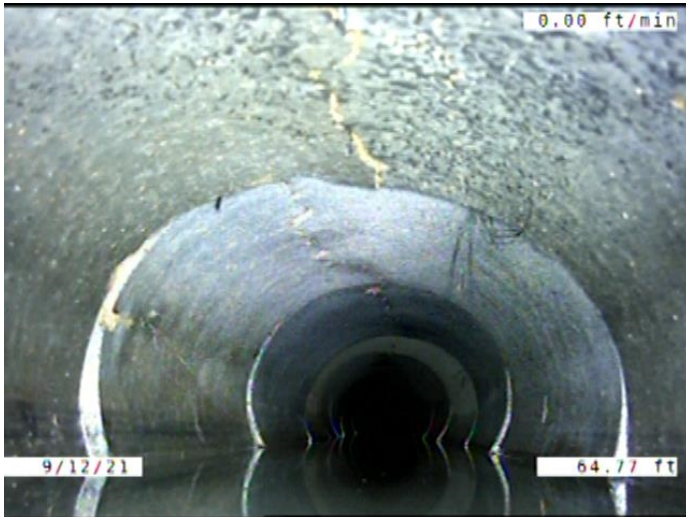
Code: **ISB**
 Description: **Infiltration Stain Barrel**

Distance (ft): **64.8**
 Structural Grade: **0**
 O&M Grade: **1**
 Clock Start/From: **9**
 Clock To: **3**
 1st Value:
 2nd Value:
 Value Percent:
 Continuous Index: **F03**
 Within 8" of Joint: **YES**
 Remarks:

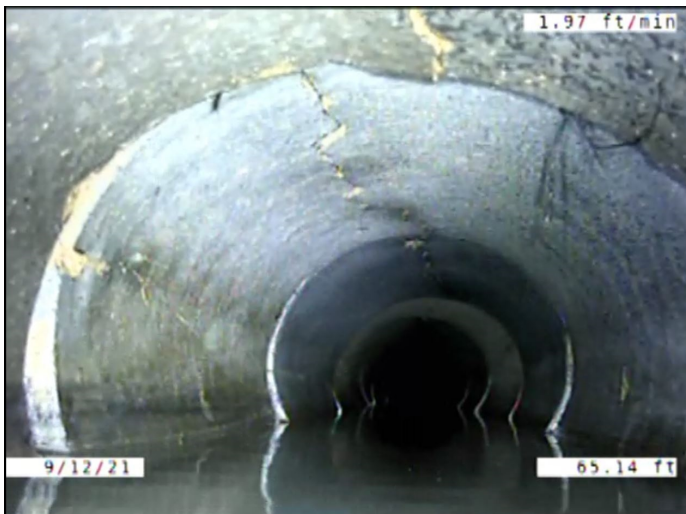
Code: **B**
 Description: **Broken**

Distance (ft): **65.1**
 Structural Grade: **4**
 O&M Grade: **0**
 Clock Start/From: **9**
 Clock To: **4**
 1st Value:
 2nd Value:
 Value Percent:
 Continuous Index:
 Within 8" of Joint: **YES**
 Remarks:

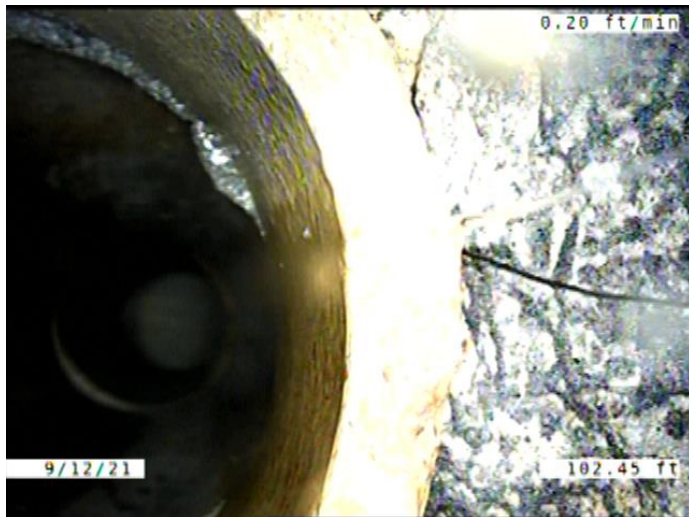
Code: **RFL**
 Description: **Roots Fine Lateral**

Distance (ft): **102.4**
 Structural Grade: **0**
 O&M Grade: **1**
 Clock Start/From: **1**
 Clock To:
 1st Value:
 2nd Value:
 Value Percent:
 Continuous Index:
 Within 8" of Joint: **NO**
 Remarks:

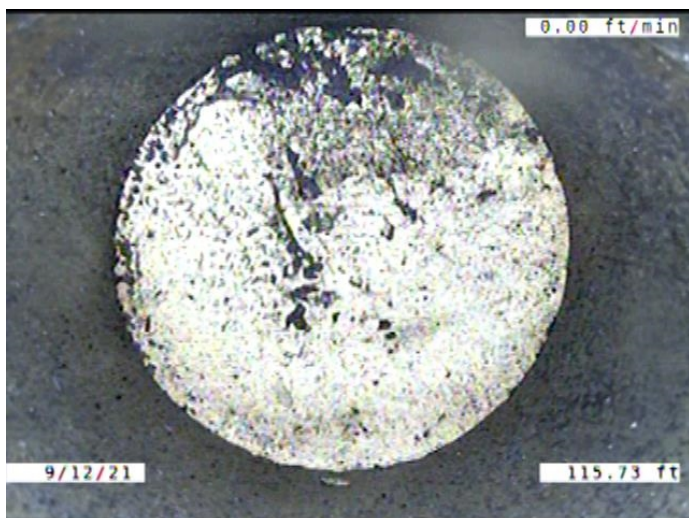
Code: **TFC**
 Description: **Tap Factory Capped**

Distance (ft): **115.7**
 Structural Grade: **0**
 O&M Grade: **0**
 Clock Start/From: **11**
 Clock To:
 1st Value: **4.000**
 2nd Value:
 Value Percent:
 Continuous Index:
 Within 8" of Joint: **YES**
 Remarks:

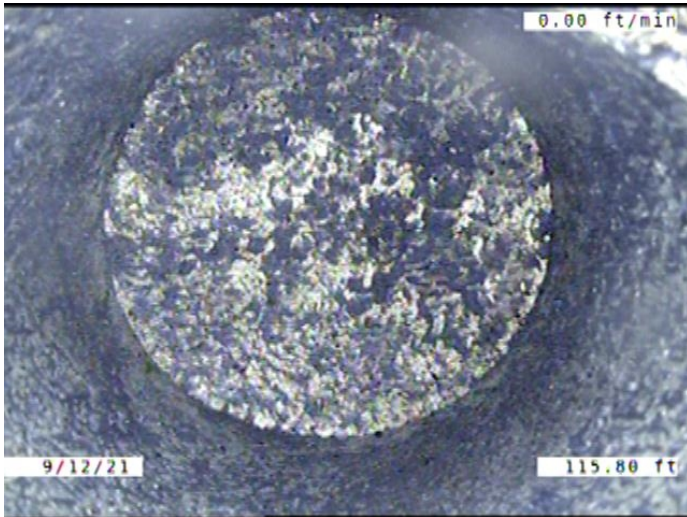
Code: **TFC**
 Description: **Tap Factory Capped**

Distance (ft): **115.8**
 Structural Grade: **0**
 O&M Grade: **0**
 Clock Start/From: **1**
 Clock To:
 1st Value: **4.000**
 2nd Value:
 Value Percent:
 Continuous Index:
 Within 8" of Joint: **YES**
 Remarks:

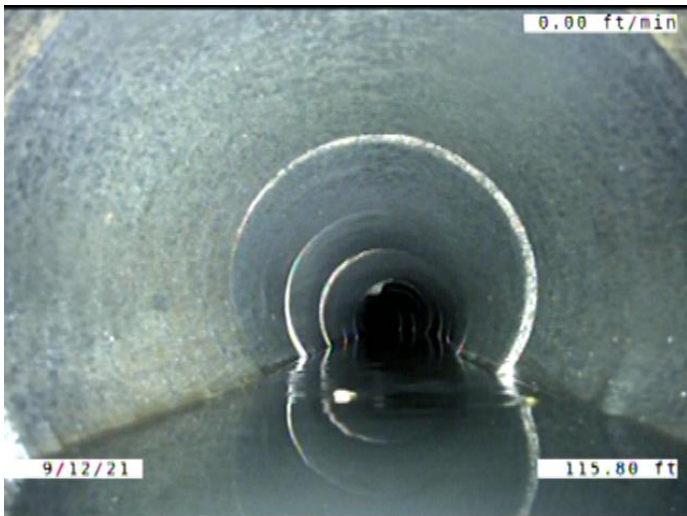
Code: **FM**
 Description: **Fracture Multiple**

Distance (ft): **115.8**
 Structural Grade: **4**
 O&M Grade: **0**
 Clock Start/From: **8**
 Clock To: **3**
 1st Value:
 2nd Value:
 Value Percent:
 Continuous Index: **F02**
 Within 8" of Joint: **YES**
 Remarks:

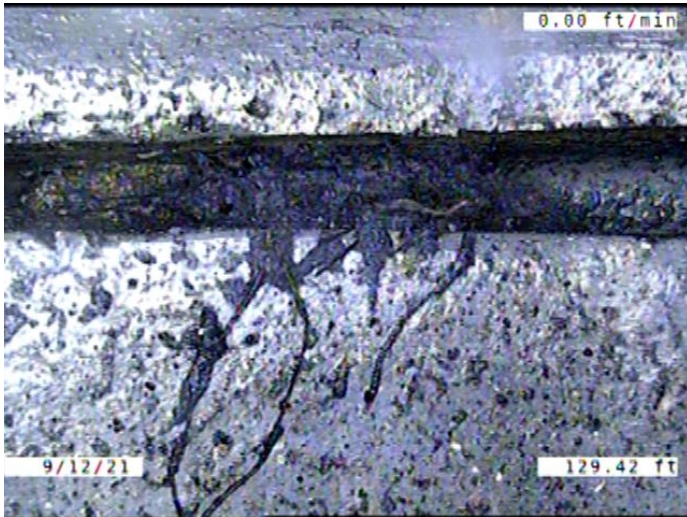
Code: **RFJ**
 Description: **Roots Fine Joint**

Distance (ft): **129.4**
 Structural Grade: **0**
 O&M Grade: **1**
 Clock Start/From: **3**
 Clock To:
 1st Value:
 2nd Value:
 Value Percent:
 Continuous Index:
 Within 8" of Joint: **YES**
 Remarks:

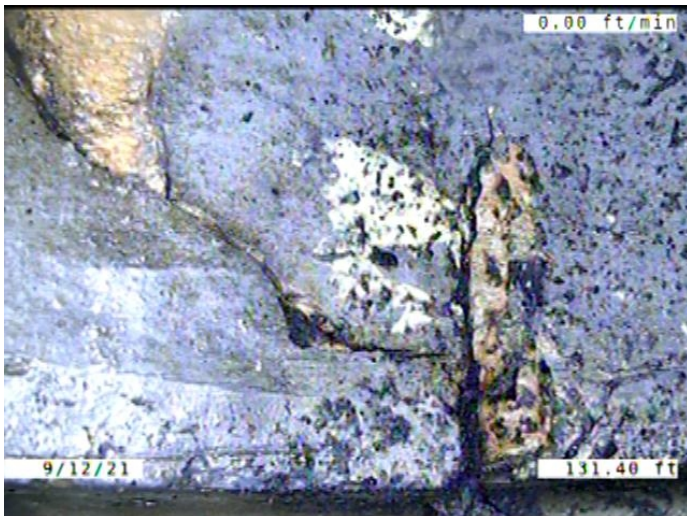
Code: **B**
 Description: **Broken**

Distance (ft): **131.4**
 Structural Grade: **4**
 O&M Grade: **0**
 Clock Start/From: **4**
 Clock To: **5**
 1st Value:
 2nd Value:
 Value Percent:
 Continuous Index:
 Within 8" of Joint: **YES**
 Remarks:

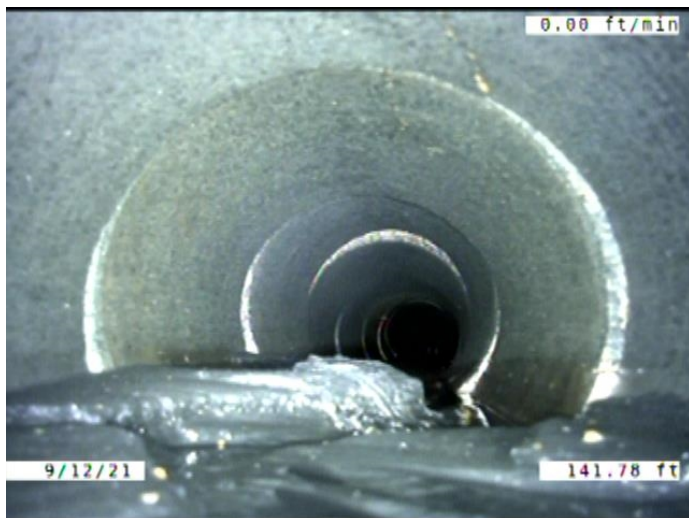
Code: **DSF**
 Description: **Deposits Settled Fine**

Distance (ft): **141.8**
 Structural Grade: **0**
 O&M Grade: **3**
 Clock Start/From: **4**
 Clock To: **8**
 1st Value:
 2nd Value:
 Value Percent: **15.000**
 Continuous Index:
 Within 8" of Joint: **YES**
 Remarks:

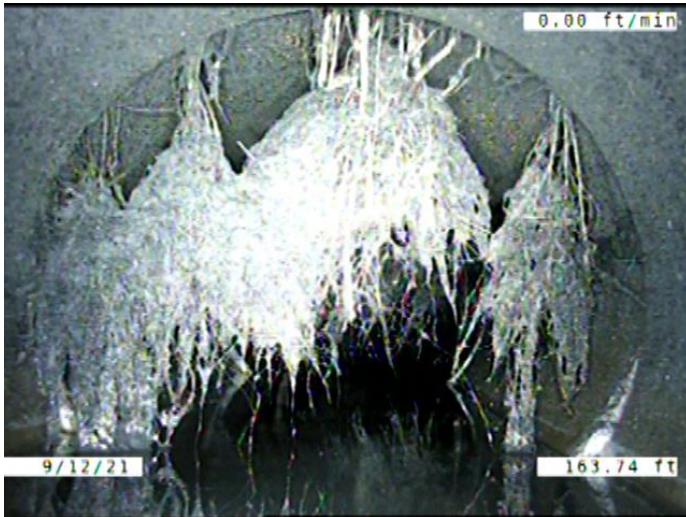
Code: **RMJ**
 Description: **Roots Medium Joint**

Distance (ft): **163.7**
 Structural Grade: **0**
 O&M Grade: **3**
 Clock Start/From: **9**
 Clock To: **3**
 1st Value:
 2nd Value:
 Value Percent: **35.000**
 Continuous Index:
 Within 8" of Joint: **YES**
 Remarks:

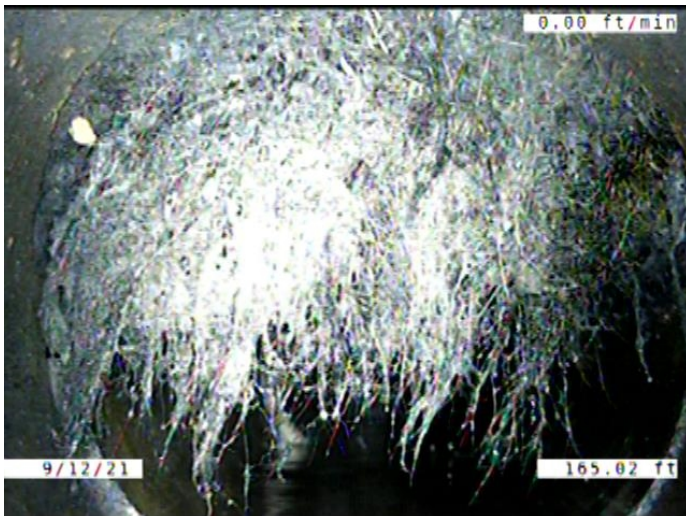
Code: **RBJ**
 Description: **Roots Ball Joint**

Distance (ft): **165.0**
 Structural Grade: **0**
 O&M Grade: **4**
 Clock Start/From: **9**
 Clock To: **3**
 1st Value:
 2nd Value:
 Value Percent: **60.000**
 Continuous Index:
 Within 8" of Joint: **YES**
 Remarks:
