Profile/Photo Observation Report

Date:	04/18/2018	Weather:		Coding:	PACP 6.0
Pipe Length (ft):	281.7	Owner:	NA	Pre Clean:	Not Known
P.O.#:		Surveyor:	Byrd Fitzgerald	PSR:	P-504-105-130
Customer:		Clean Date:	01/01/1900	Shape:	Z

Street:	W 42ND AVE & N VIRGINIA ST	Flow Control:	Not Controlled		
City:	Hobart, IN	Year Renewed:			
Location:	Light Highway	Tape/Media #:			
Purpose:	Not Known	Dia/Height:	10"		
Use:	Sanitary	Material:	CP		
Drain Area:	NA	Lining:			
Category:	NA				
Comment:					
Location Details:		Direction of Survey:	Downstream		
US MH:	M-504-130	DS MH:	M-504-105	Total Length Surveyed (ft):	3.5

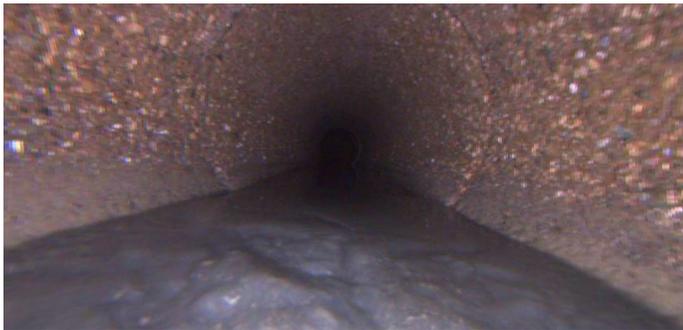
Code: **SAP**
Description: **Surface Aggregate Projecting**

Distance (ft): **.0**
Structural Grade: **3**
O&M Grade: **0**
Clock Start/From: **7**
Clock To: **5**
1st Value:
2nd Value:
Value Percent:
Continuous Index:
Within 8" of Joint:
Remarks:

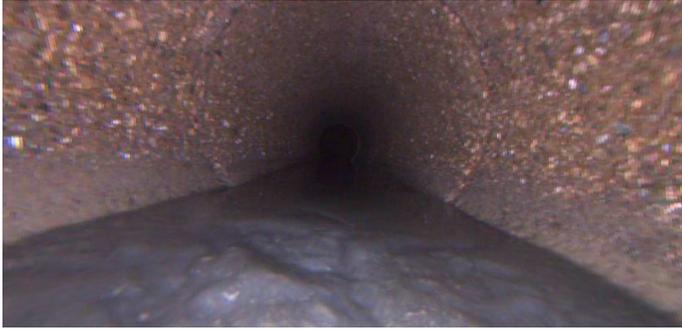
Code: **AMH**
Description: **Manhole**

Distance (ft): **.0**
Structural Grade: **0**
O&M Grade: **0**
Clock Start/From:
Clock To:
1st Value:
2nd Value:
Value Percent:
Continuous Index:
Within 8" of Joint: **NO**
Remarks: **M-504-130**

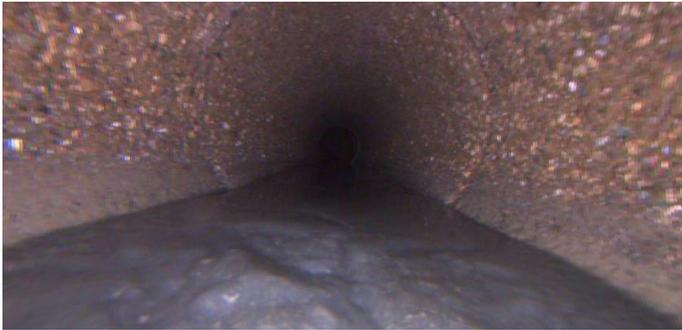
Code: **MWL**
Description: **Water Level**

Distance (ft): **.0**
Structural Grade: **0**
O&M Grade: **0**
Clock Start/From:
Clock To:
1st Value:
2nd Value:
Value Percent: **5.000**
Continuous Index:
Within 8" of Joint: **NO**
Remarks:

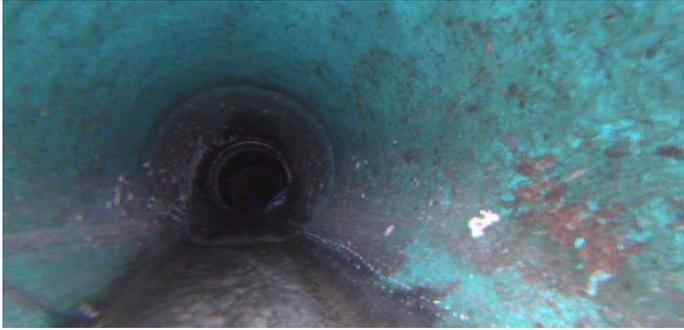
Code: **MMC**
Description: **Material Change**

Distance (ft): **3.5**
Structural Grade: **0**
O&M Grade: **0**
Clock Start/From:
Clock To:
1st Value:
2nd Value:
Value Percent:
Continuous Index:
Within 8" of Joint: **NO**
Remarks: **camera glitch material change to pvc exact footage of change unknown**

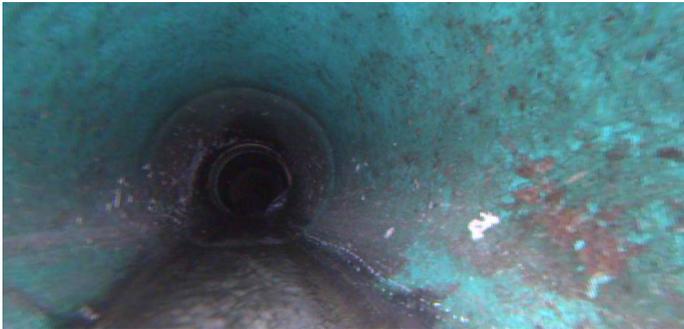
Code: **MSA**
Description: **Abandoned Survey**

Distance (ft): **3.5**
Structural Grade: **0**
O&M Grade: **0**
Clock Start/From:
Clock To:
1st Value:
2nd Value:
Value Percent:
Continuous Index:
Within 8" of Joint: **NO**
Remarks: **no blockage**
