Profile/Photo Observation Report

Date:	04/18/2018	Weather:		Coding:	PACP 6.0
Pipe Length (ft):	281.7	Owner:	NA	Pre Clean:	Not Known
P.O.#:		Surveyor:	Byrd Fitzgerald	PSR:	P-504-105-130
Customer:		Clean Date:	01/01/1900	Shape:	C

Street:	W 42ND AVE & N VIRGINIA ST	Flow Control:	Not Controlled
City:	Hobart, IN	Year Renewed:	
Location:	Light Highway	Tape/Media #:	
Purpose:	Not Known	Dia/Height:	12"
Use:	Sanitary	Material:	PVC
Drain Area:	NA	Lining:	
Category:	NA		
Comment:

Location Details:		Direction of Survey:	Downstream
US MH:	M-504-130	DS MH:	M-504-105
		Total Length Surveyed (ft):	182.0

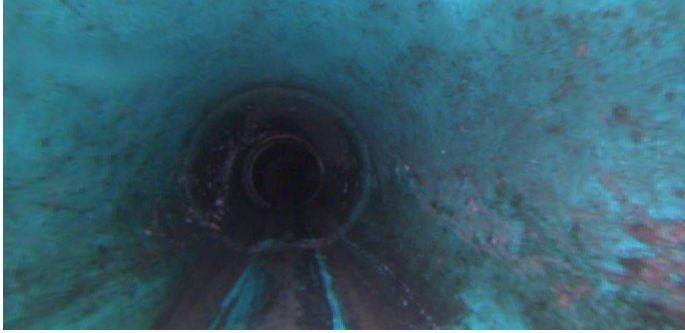
Code: **AMH**
Description: **Manhole**

Distance (ft): **.0**
Structural Grade: **0**
O&M Grade: **0**
Clock Start/From:
Clock To:
1st Value:
2nd Value:
Value Percent:
Continuous Index:
Within 8" of Joint: **NO**
Remarks: **M-504-130**

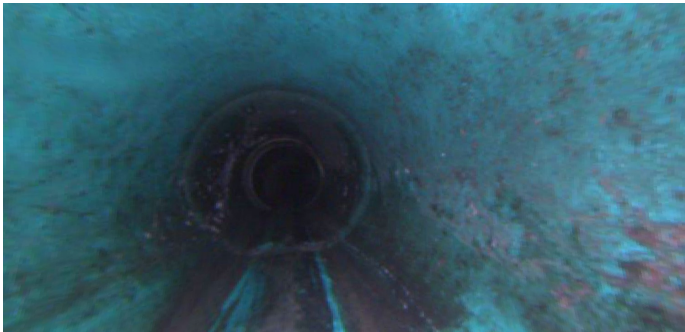
Code: **MWL**
Description: **Water Level**

Distance (ft): **.0**
Structural Grade: **0**
O&M Grade: **0**
Clock Start/From:
Clock To:
1st Value:
2nd Value:
Value Percent: **5.000**
Continuous Index:
Within 8" of Joint: **NO**
Remarks:

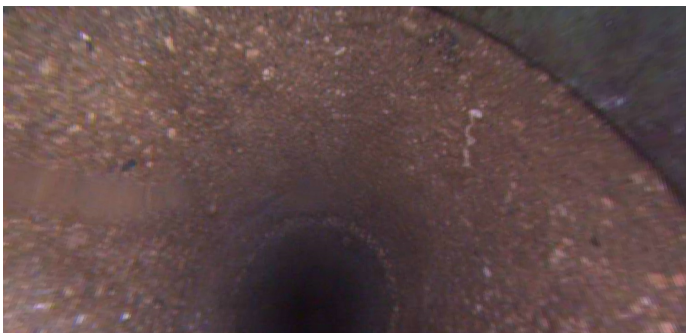
Code: **SAP**
Description: **Surface Aggregate Projecting**

Distance (ft): **6.8**
Structural Grade: **3**
O&M Grade: **0**
Clock Start/From: **7**
Clock To: **5**
1st Value:
2nd Value:
Value Percent:
Continuous Index: **S01**
Within 8" of Joint:
Remarks:

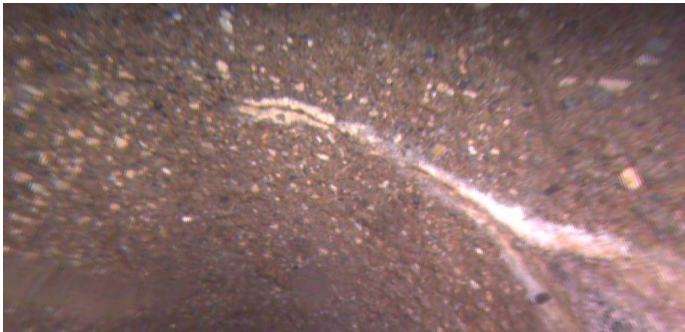
Code: **CC**
Description: **Crack Circumferential**

Distance (ft): **27.0**
Structural Grade: **1**
O&M Grade: **0**
Clock Start/From: **7**
Clock To: **5**
1st Value:
2nd Value:
Value Percent:
Continuous Index:
Within 8" of Joint:
Remarks:

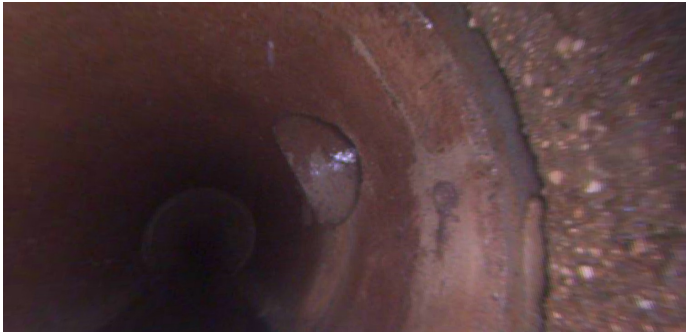
Code: **SAP**
Description: **Surface Aggregate Projecting**

Distance (ft): **29.4**
Structural Grade: **3**
O&M Grade: **0**
Clock Start/From: **7**
Clock To: **5**
1st Value:
2nd Value:
Value Percent:
Continuous Index: **F01**
Within 8" of Joint:
Remarks:

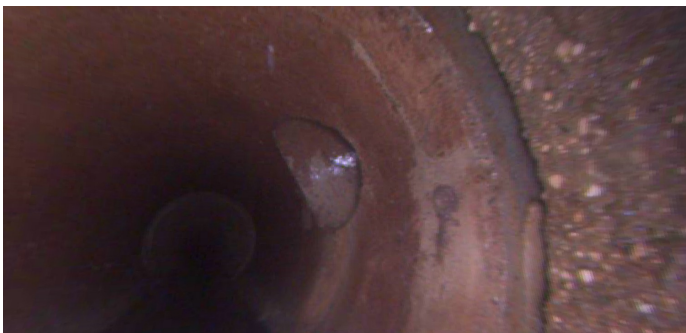
Code: **MMC**
Description: **Material Change**

Distance (ft): **29.4**
Structural Grade: **0**
O&M Grade: **0**
Clock Start/From:
Clock To:
1st Value:
2nd Value:
Value Percent:
Continuous Index:
Within 8" of Joint: **NO**
Remarks: **vcp**

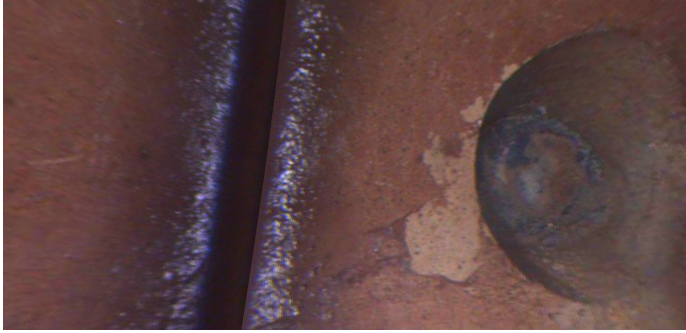
Code: **TFC**
Description: **Tap Factory Capped**

Distance (ft): **31.1**
Structural Grade: **0**
O&M Grade: **0**
Clock Start/From: **2**
Clock To:
1st Value: **4.000**
2nd Value:
Value Percent:
Continuous Index:
Within 8" of Joint: **YES**
Remarks:

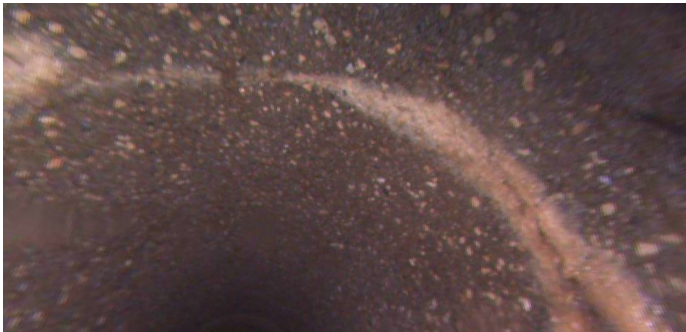
Code: **CC**
Description: **Crack Circumferential**

Distance (ft): **32.8**
Structural Grade: **1**
O&M Grade: **0**
Clock Start/From: **7**
Clock To: **5**
1st Value:
2nd Value:
Value Percent:
Continuous Index:
Within 8" of Joint:
Remarks:

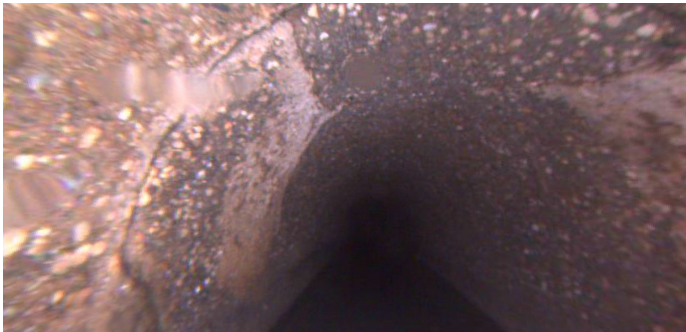
Code: **FM**
Description: **Fracture Multiple**

Distance (ft): **62.2**
Structural Grade: **4**
O&M Grade: **0**
Clock Start/From: **8**
Clock To: **4**
1st Value:
2nd Value:
Value Percent:
Continuous Index:
Within 8" of Joint: **YES**
Remarks:

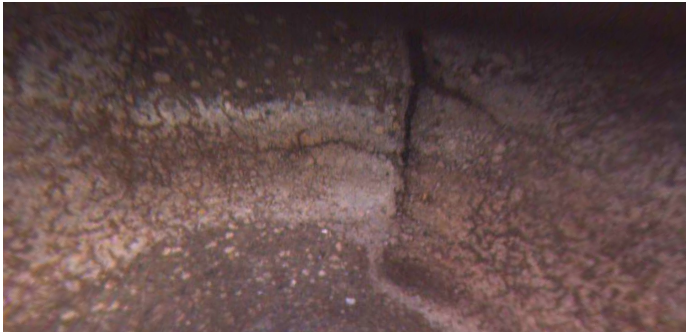
Code: **FM**
Description: **Fracture Multiple**

Distance (ft): **140.6**
Structural Grade: **4**
O&M Grade: **0**
Clock Start/From: **11**
Clock To: **1**
1st Value:
2nd Value:
Value Percent:
Continuous Index:
Within 8" of Joint: **YES**
Remarks:

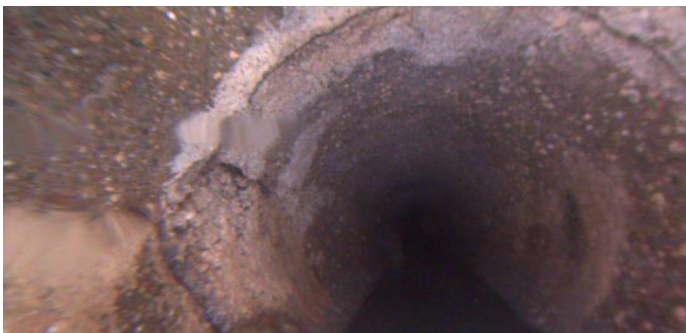
Code: **FM**
Description: **Fracture Multiple**

Distance (ft): **148.6**
Structural Grade: **4**
O&M Grade: **0**
Clock Start/From: **8**
Clock To: **12**
1st Value:
2nd Value:
Value Percent:
Continuous Index:
Within 8" of Joint: **YES**
Remarks:

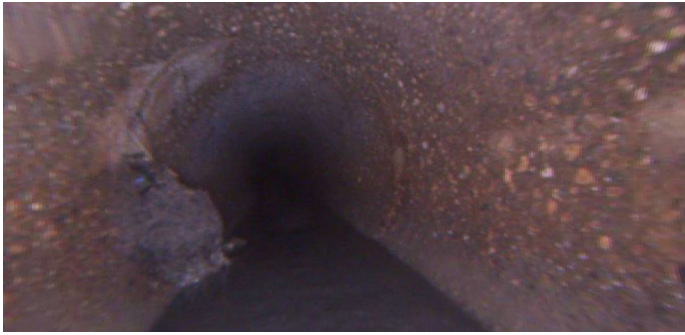
Code: **RMJ**
Description: **Roots Medium Joint**

Distance (ft): **151.1**
Structural Grade: **0**
O&M Grade: **3**
Clock Start/From: **7**
Clock To: **8**
1st Value:
2nd Value:
Value Percent: **5.000**
Continuous Index:
Within 8" of Joint: **YES**
Remarks:

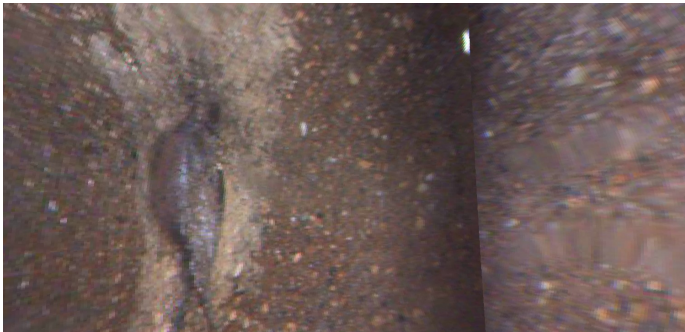
Code: **DAZ**
Description: **Deposits Attached Other**

Distance (ft): **161.8**
Structural Grade: **0**
O&M Grade: **2**
Clock Start/From: **9**
Clock To:
1st Value:
2nd Value:
Value Percent: **5.000**
Continuous Index:
Within 8" of Joint: **YES**
Remarks: **overlay of material**

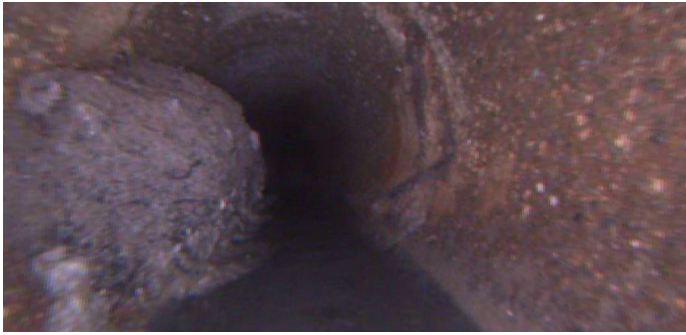
Code: **RMJ**
Description: **Roots Medium Joint**

Distance (ft): **163.3**
Structural Grade: **0**
O&M Grade: **3**
Clock Start/From: **7**
Clock To: **10**
1st Value:
2nd Value:
Value Percent: **25.000**
Continuous Index:
Within 8" of Joint: **YES**
Remarks:

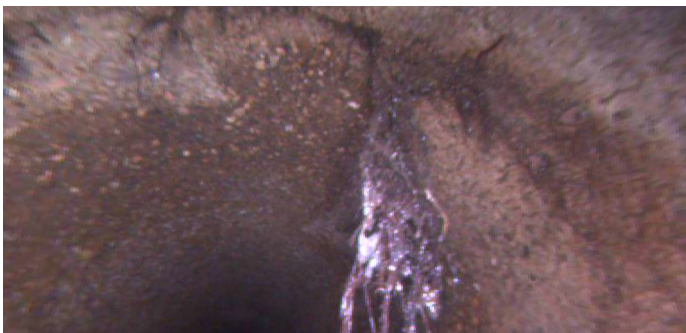
Code: **RMJ**
Description: **Roots Medium Joint**

Distance (ft): **172.3**
Structural Grade: **0**
O&M Grade: **3**
Clock Start/From: **7**
Clock To: **5**
1st Value:
2nd Value:
Value Percent: **5.000**
Continuous Index:
Within 8" of Joint: **YES**
Remarks:

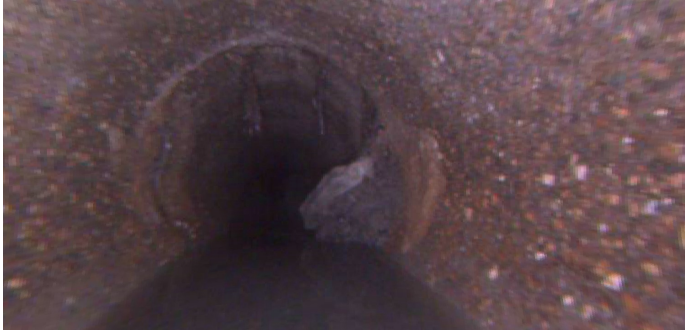
Code: **RFJ**
Description: **Roots Fine Joint**

Distance (ft): **180.2**
Structural Grade: **0**
O&M Grade: **1**
Clock Start/From: **7**
Clock To: **1**
1st Value:
2nd Value:
Value Percent:
Continuous Index:
Within 8" of Joint: **YES**
Remarks:

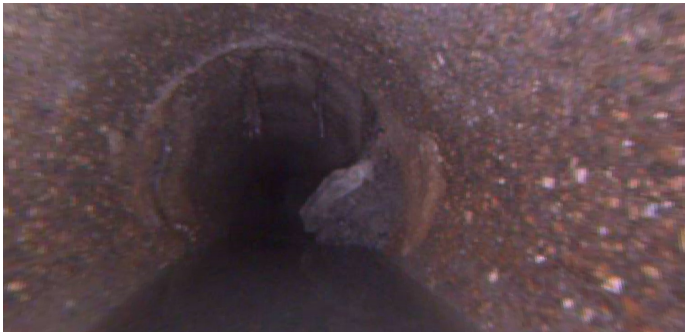
Code: **RMJ**
Description: **Roots Medium Joint**

Distance (ft): **180.2**
Structural Grade: **0**
O&M Grade: **3**
Clock Start/From: **3**
Clock To: **5**
1st Value:
2nd Value:
Value Percent: **5.000**
Continuous Index:
Within 8" of Joint: **YES**
Remarks:

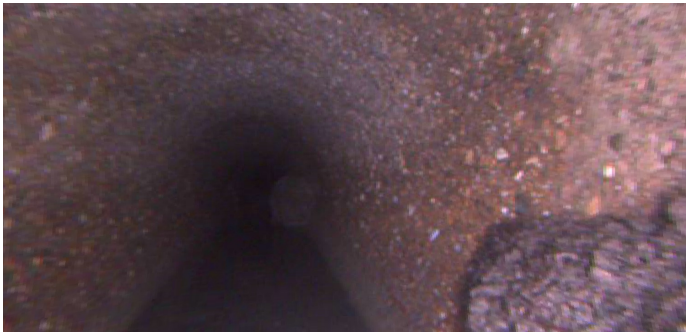
Code: **MSA**
Description: **Abandoned Survey**

Distance (ft): **182.0**
Structural Grade: **0**
O&M Grade: **0**
Clock Start/From:
Clock To:
1st Value:
2nd Value:
Value Percent:
Continuous Index:
Within 8" of Joint: **NO**
Remarks: **rmj**
