Profile/Photo Observation Report

Location Details:		Direction of Survey:	Downstream
US MH:	M-504-131	DS MH:	M-504-132
		Total Length Surveyed (ft):	39.3

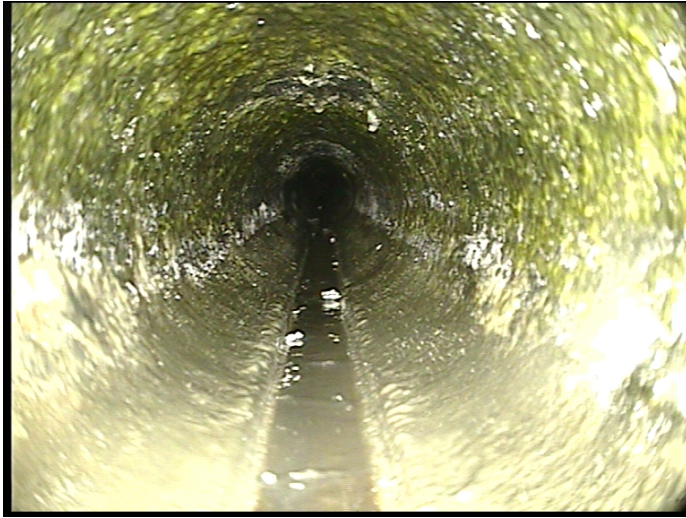
Code: **MWL**
Description: **Water Level**

Distance (ft): **.0**
Structural Grade: **0**
O&M Grade: **0**
Clock Start/From:
Clock To:
1st Value:
2nd Value:
Value Percent: **5.000**
Continuous Index:
Within 8" of Joint: **NO**
Remarks:
