## Profile/Photo Observation Report

Street:	<b>Off Virginia Street</b>	Flow Control:	<b>Not Controlled</b>
City:	<b>Hobart, IN</b>	Year Renewed:	
Location:	<b>Light Highway</b>	Tape/Media #:	<b>DEP 40</b>
Purpose:	<b>Routine Assessment</b>	Dia/Height:	<b>6"</b>
Use:	<b>Sanitary</b>	Material:	<b>VCP</b>
Drain Area:		Lining:	
Category:	<b>NA</b>		
Comment:

Location Details:		Direction of Survey:	<b>Downstream</b>
US MH:	<b>M-504-131</b>	DS MH:	<b>M-504-132</b>
		Total Length Surveyed (ft):	<b>39.3</b>

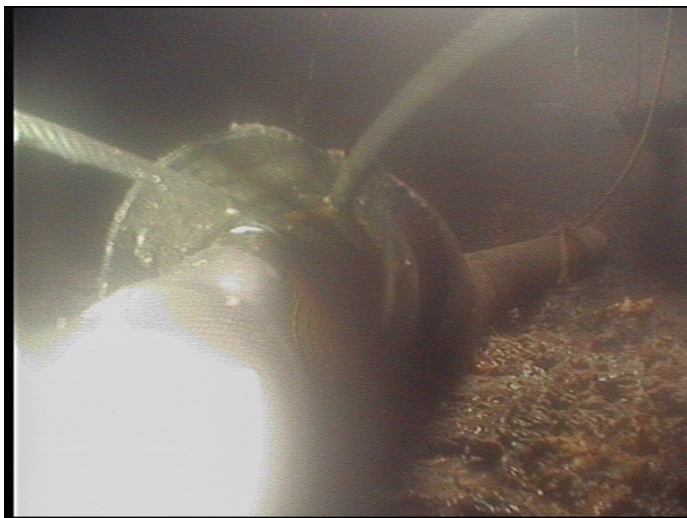
Code: **AMH**  
 Description: **Manhole**

Distance (ft): **.0**  
 Structural Grade: **0**  
 O&M Grade: **0**  
 Clock Start/From:  
 Clock To:  
 1st Value:  
 2nd Value:  
 Value Percent:  
 Continuous Index:  
 Within 8" of Joint: **NO**  
 Remarks: **M-504-131**

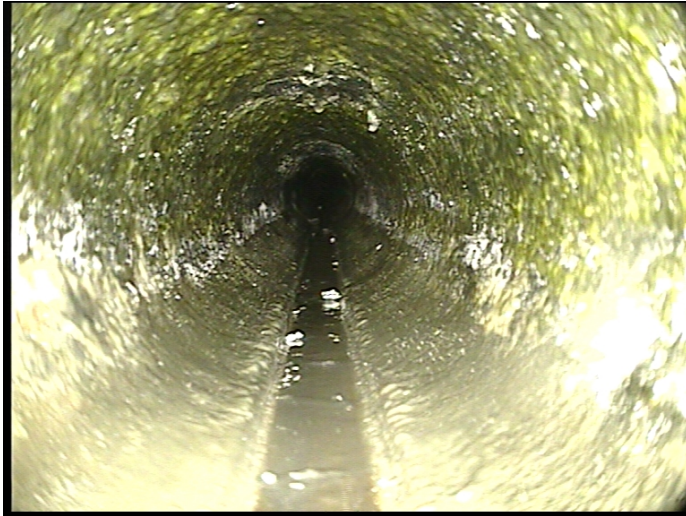
Code: **MWL**  
Description: **Water Level**

Distance (ft): **.0**  
Structural Grade: **0**  
O&M Grade: **0**  
Clock Start/From:  
Clock To:  
1st Value:  
2nd Value:  
Value Percent: **5.000**  
Continuous Index:  
Within 8" of Joint: **NO**  
Remarks:

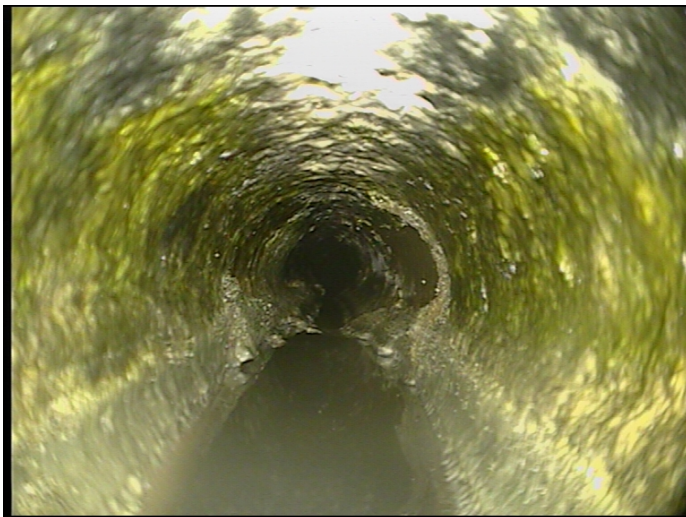
Code: **DAGS**  
Description: **Deposits Attached Grease**

Distance (ft): **15.9**  
Structural Grade: **0**  
O&M Grade: **2**  
Clock Start/From: **8**  
Clock To: **4**  
1st Value:  
2nd Value:  
Value Percent: **10.000**  
Continuous Index: **S01**  
Within 8" of Joint: **YES**  
Remarks:

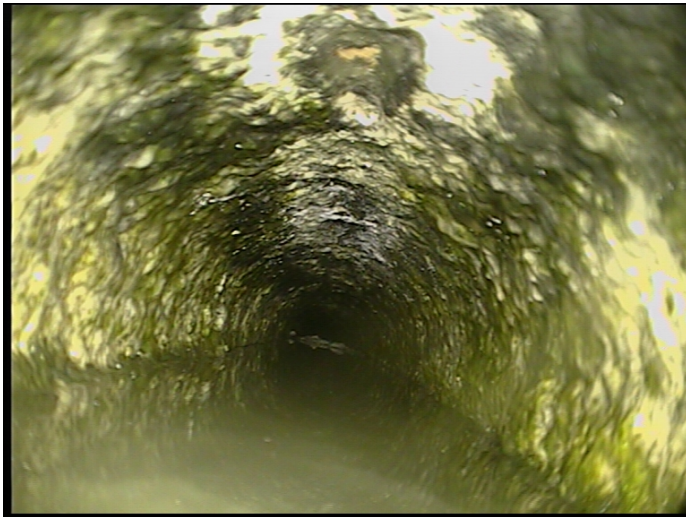
Code: **DAGS**  
Description: **Deposits Attached Grease**

Distance (ft): **39.2**  
Structural Grade: **0**  
O&M Grade: **3**  
Clock Start/From: **8**  
Clock To: **4**  
1st Value:  
2nd Value:  
Value Percent: **15.000**  
Continuous Index: **F01**  
Within 8" of Joint: **NO**  
Remarks:

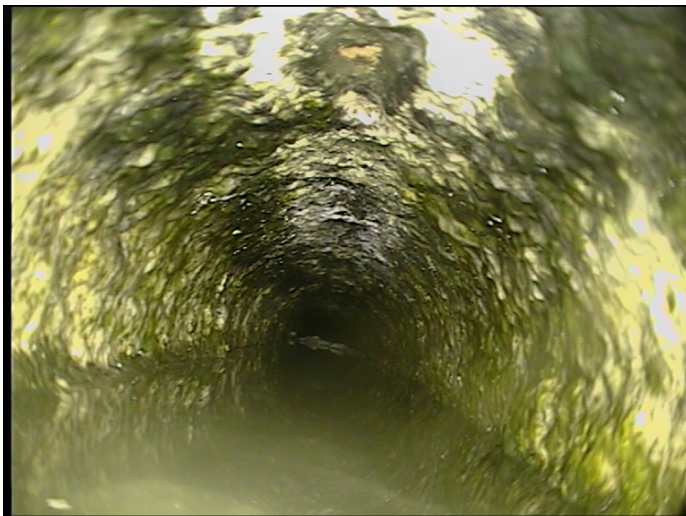
Code: **MSA**  
Description: **Abandoned Survey**

Distance (ft): **39.3**  
Structural Grade: **0**  
O&M Grade: **0**  
Clock Start/From:  
Clock To:  
1st Value:  
2nd Value:  
Value Percent:  
Continuous Index:  
Within 8" of Joint: **NO**  
Remarks: **grease**
