## Profile/Photo Observation Report

Street:	<b>Wisconsin Street</b>	Flow Control:	<b>Not Controlled</b>
City:	<b>Hobart, IN</b>	Year Renewed:	
Location:	<b>Light Highway</b>	Tape/Media #:	<b>DEP 30</b>
Purpose:	<b>Routine Assessment</b>	Dia/Height:	<b>18"</b>
Use:	<b>Sanitary</b>	Material:	<b>VCP</b>
Drain Area:		Lining:	
Category:	<b>NA</b>		
Comment:			
Location Details:		Direction of Survey:	<b>Upstream</b>
US MH:	<b>M-504-133</b>	DS MH:	<b>M-504-020</b>
		Total Length Surveyed (ft):	<b>3.9</b>

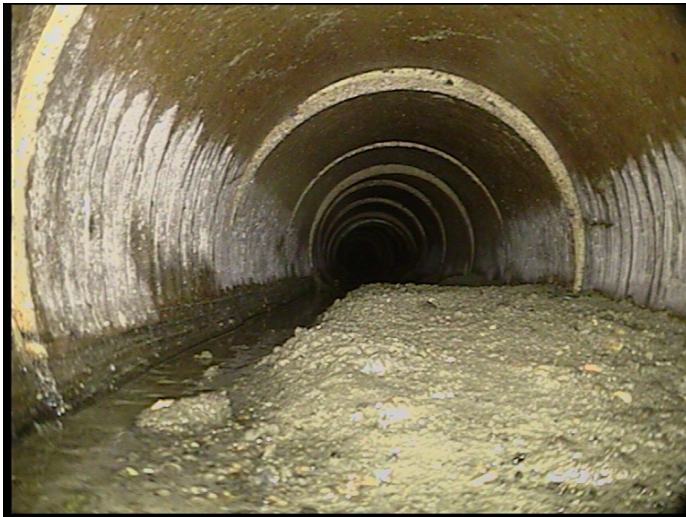
Code:	<b>MSA</b>
Description:	<b>Abandoned Survey</b>
Distance (ft):	<b>3.9</b>
Structural Grade:	<b>0</b>
O&M Grade:	<b>0</b>
Clock Start/From:	
Clock To:	
1st Value:	
2nd Value:	
Value Percent:	
Continuous Index:	
Within 8" of Joint:	<b>NO</b>
Remarks:	<b>heavy sediment</b>
