## Profile/Photo Observation Report

Date:	<b>04/11/2018</b>	Weather:		Coding:	<b>PACP 6.0</b>
Pipe Length (ft):		Owner:	<b>City of Hobart</b>	Pre Clean:	<b>No Pre-Cleaning</b>
P.O.#:	<b>30-2</b>	Surveyor:	<b>M. Pielacha</b>	PSR:	<b>M-504-133-M-504-020</b>
Customer:	<b>City of Hobart</b>	Clean Date:		Shape:	<b>C</b>

Street:	<b>Wisconsin Street</b>	Flow Control:	<b>Not Controlled</b>
City:	<b>Hobart, IN</b>	Year Renewed:	
Location:	<b>Light Highway</b>	Tape/Media #:	<b>DEP 30</b>
Purpose:	<b>Routine Assessment</b>	Dia/Height:	<b>18"</b>
Use:	<b>Sanitary</b>	Material:	<b>VCP</b>
Drain Area:		Lining:	
Category:	<b>NA</b>		
Comment:			
Location Details:		Direction of Survey:	<b>Upstream</b>
US MH:	<b>M-504-133</b>	DS MH:	<b>M-504-020</b>
		Total Length Surveyed (ft):	<b>3.9</b>

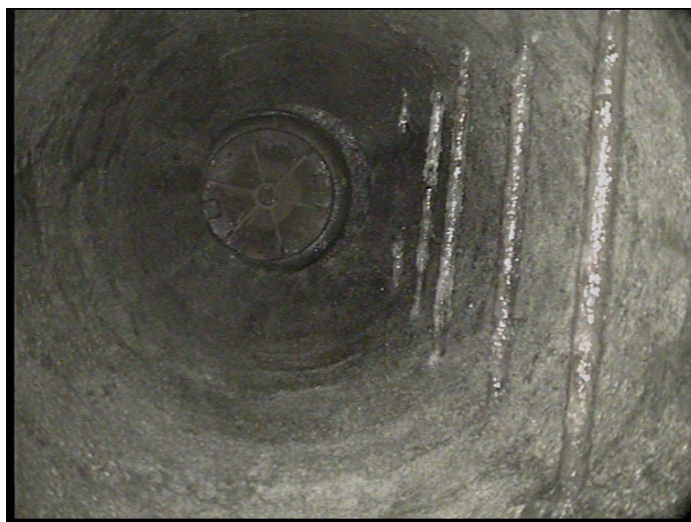
Code: **AMH**  
Description: **Manhole**

Distance (ft): **.0**  
Structural Grade: **0**  
O&M Grade: **0**  
Clock Start/From:  
Clock To:  
1st Value:  
2nd Value:  
Value Percent:  
Continuous Index:  
Within 8" of Joint: **NO**  
Remarks: **M-504-020**

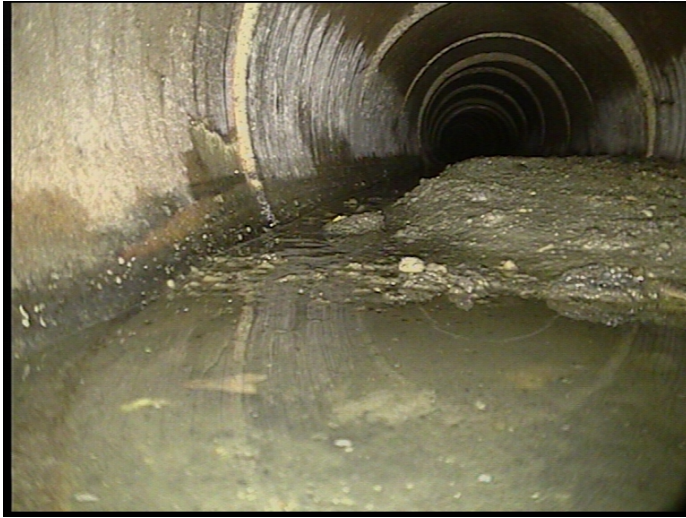
Code: **MWL**  
Description: **Water Level**

Distance (ft): **.0**  
Structural Grade: **0**  
O&M Grade: **0**  
Clock Start/From:  
Clock To:  
1st Value:  
2nd Value:  
Value Percent: **10.000**  
Continuous Index:  
Within 8" of Joint: **NO**  
Remarks:

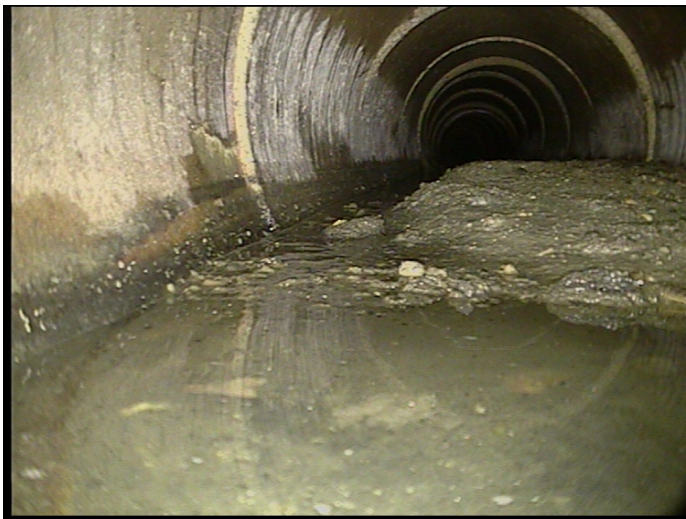
Code: **DSF**  
Description: **Deposits Settled Fine**

Distance (ft): **.0**  
Structural Grade: **0**  
O&M Grade: **4**  
Clock Start/From: **4**  
Clock To: **8**  
1st Value:  
2nd Value:  
Value Percent: **25.000**  
Continuous Index:  
Within 8" of Joint: **YES**  
Remarks:

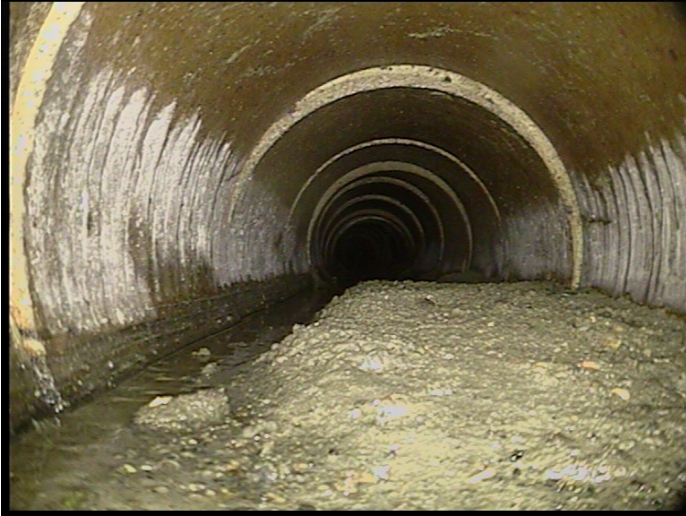
Code:	<b>MSA</b>
Description:	<b>Abandoned Survey</b>
Distance (ft):	<b>3.9</b>
Structural Grade:	<b>0</b>
O&M Grade:	<b>0</b>
Clock Start/From:	
Clock To:	
1st Value:	
2nd Value:	
Value Percent:	
Continuous Index:	
Within 8" of Joint:	<b>NO</b>
Remarks:	<b>heavy sediment</b>
