Profile/Photo Observation Report

Date:	04/26/2018	Weather:		Coding:	PACP 6.0
Pipe Length (ft):		Owner:	City of Hobart	Pre Clean:	No Pre-Cleaning
P.O.#:	98	Surveyor:	M. Pielacha	PSR:	P-505-003-002
Customer:	City of Hobart	Clean Date:		Shape:	C

Street:	3rd Place	Flow Control:	Not Controlled
City:	Hobart, IN	Year Renewed:	
Location:	Light Highway	Tape/Media #:	DEP 98
Purpose:	Routine Assessment	Dia/Height:	15"
Use:	Sanitary	Material:	CP
Drain Area:		Lining:	
Category:	NA		
Comment:	YES501824 Submittal 2		
Location Details:		Direction of Survey:	Downstream
US MH:	M-505-003	DS MH:	M-505-002
		Total Length Surveyed (ft):	189.2

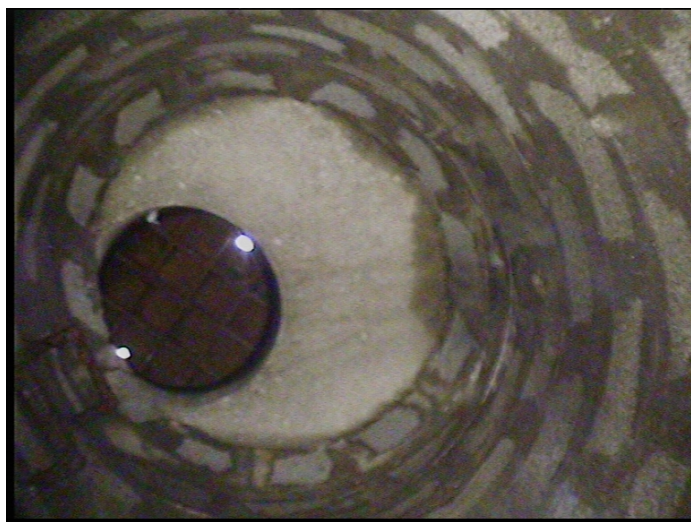
Code: **AMH**
Description: **Manhole**

Distance (ft): **.0**
Structural Grade: **0**
O&M Grade: **0**
Clock Start/From:
Clock To:
1st Value:
2nd Value:
Value Percent:
Continuous Index:
Within 8" of Joint: **NO**
Remarks: **M-505-003**

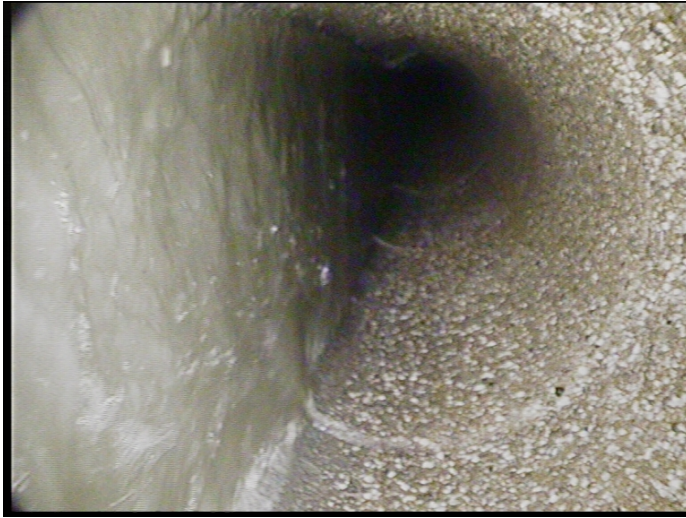
Code: **MWL**
Description: **Water Level**

Distance (ft): **.0**
Structural Grade: **0**
O&M Grade: **0**
Clock Start/From:
Clock To:
1st Value:
2nd Value:
Value Percent: **10.000**
Continuous Index:
Within 8" of Joint: **NO**
Remarks:

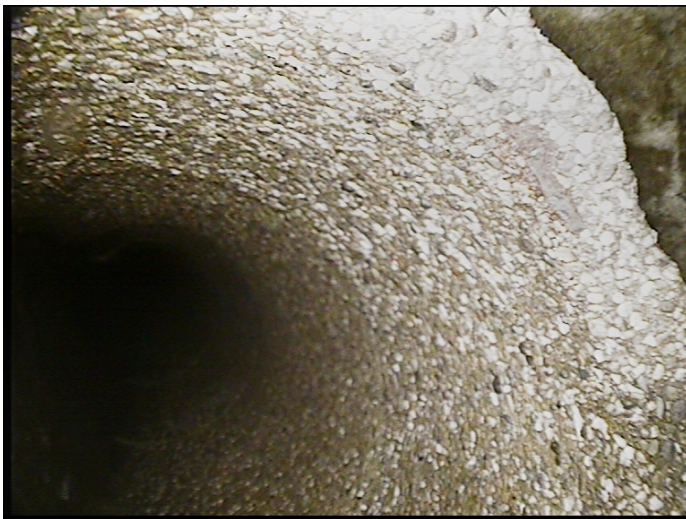
Code: **SAV**
Description: **Surface Aggregate Visible**

Distance (ft): **.0**
Structural Grade: **3**
O&M Grade: **0**
Clock Start/From: **8**
Clock To: **4**
1st Value:
2nd Value:
Value Percent:
Continuous Index: **S01**
Within 8" of Joint: **YES**
Remarks:

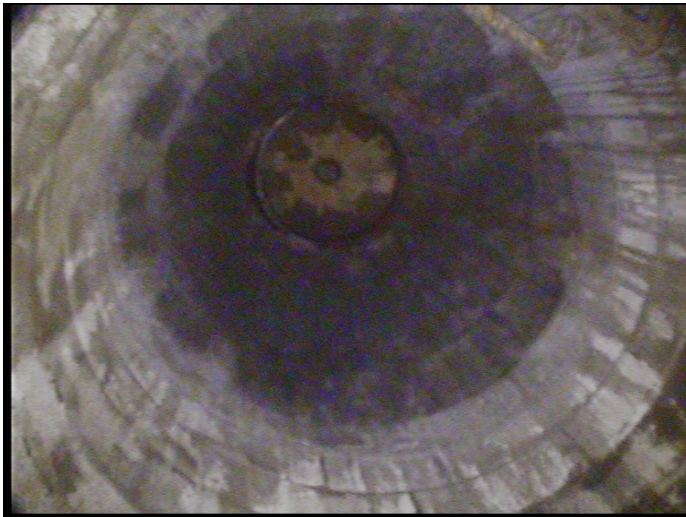
Code: **AMH**
Description: **Manhole**

Distance (ft): **189.2**
Structural Grade: **0**
O&M Grade: **0**
Clock Start/From:
Clock To:
1st Value:
2nd Value:
Value Percent:
Continuous Index:
Within 8" of Joint: **NO**
Remarks: **M-505-002**
