Profile/Photo Observation Report

Date:	04/26/2018	Weather:		Coding:	PACP 6.0
Pipe Length (ft):		Owner:	City of Hobart	Pre Clean:	No Pre-Cleaning
P.O.#:	99	Surveyor:	M. Pielacha	PSR:	P-505-005-004
Customer:	City of Hobart	Clean Date:		Shape:	C

Street:	3rd Place	Flow Control:	Not Controlled
City:	Hobart, IN	Year Renewed:	
Location:	Light Highway	Tape/Media #:	DEP 99
Purpose:	Routine Assessment	Dia/Height:	15"
Use:	Sanitary	Material:	VCP
Drain Area:		Lining:	
Category:	NA		
Comment:	YES501824 Submittal 2		
Location Details:		Direction of Survey:	Upstream
US MH:	M-505-005	DS MH:	M-505-004
		Total Length Surveyed (ft):	122.5

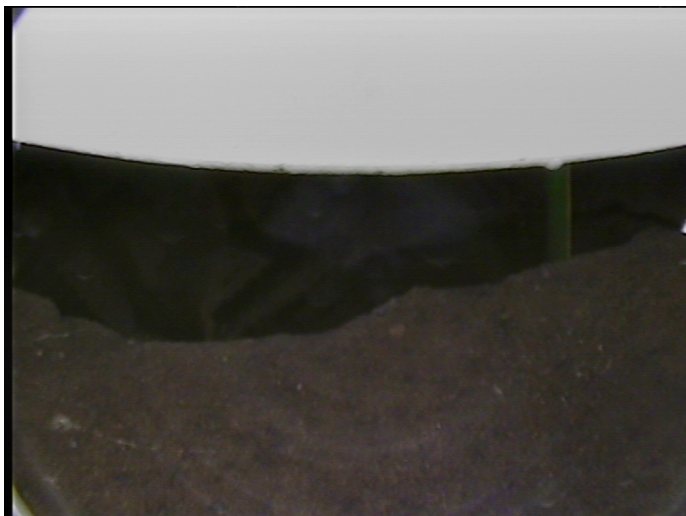
Code: **AMH**
 Description: **Manhole**

Distance (ft): **.0**
 Structural Grade: **0**
 O&M Grade: **0**
 Clock Start/From:
 Clock To:
 1st Value:
 2nd Value:
 Value Percent:
 Continuous Index:
 Within 8" of Joint: **NO**
 Remarks: **M-505-004**

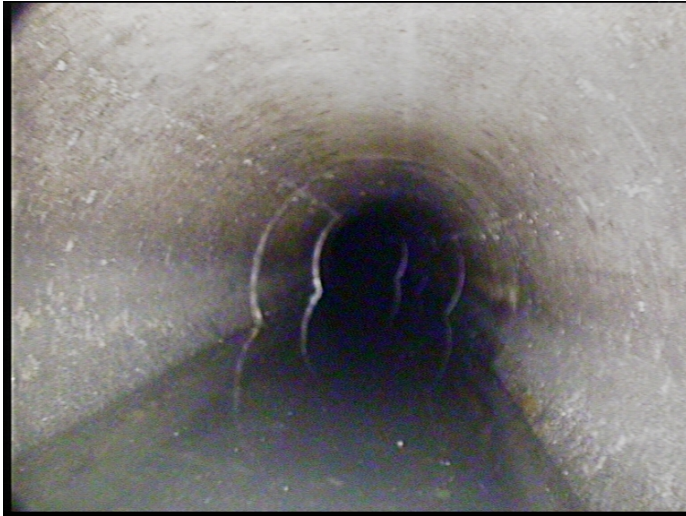
Code: **MWL**
Description: **Water Level**

Distance (ft): **.0**
Structural Grade: **0**
O&M Grade: **0**
Clock Start/From:
Clock To:
1st Value:
2nd Value:
Value Percent: **10.000**
Continuous Index:
Within 8" of Joint: **NO**
Remarks:

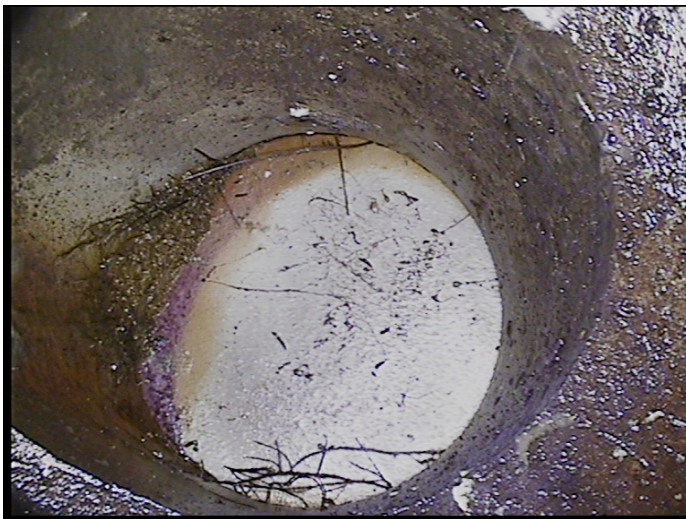
Code: **TFC**
Description: **Tap Factory Capped**

Distance (ft): **15.6**
Structural Grade: **0**
O&M Grade: **0**
Clock Start/From: **9**
Clock To:
1st Value: **4.000**
2nd Value:
Value Percent:
Continuous Index:
Within 8" of Joint: **NO**
Remarks:

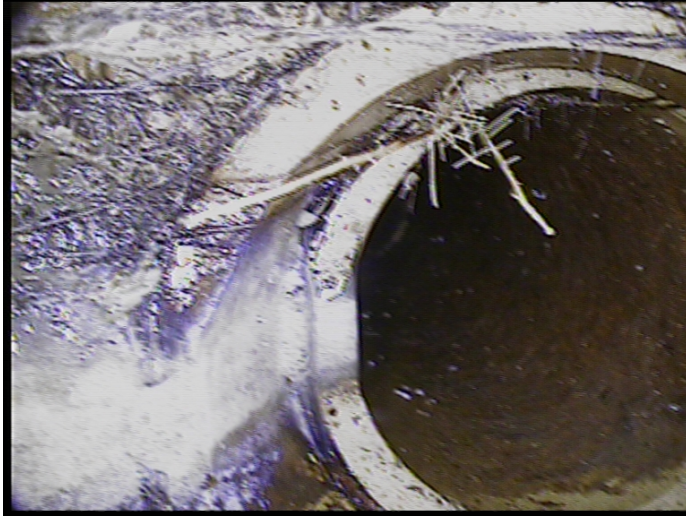
Code: **TBD**
Description: **Tap Break-in Defective**

Distance (ft): **33.8**
Structural Grade: **0**
O&M Grade: **3**
Clock Start/From: **10**
Clock To:
1st Value: **4.000**
2nd Value:
Value Percent:
Continuous Index:
Within 8" of Joint: **NO**
Remarks: **Defective**

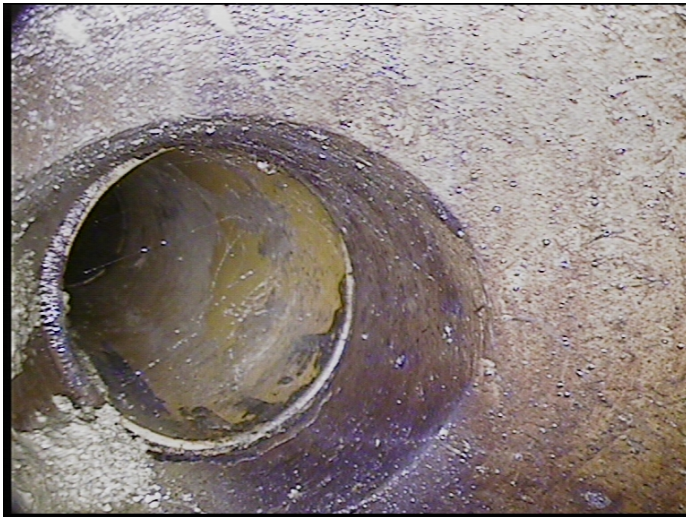
Code: **TF**
Description: **Tap Factory**

Distance (ft): **71.9**
Structural Grade: **0**
O&M Grade: **0**
Clock Start/From: **10**
Clock To:
1st Value: **4.000**
2nd Value:
Value Percent:
Continuous Index:
Within 8" of Joint: **NO**
Remarks:

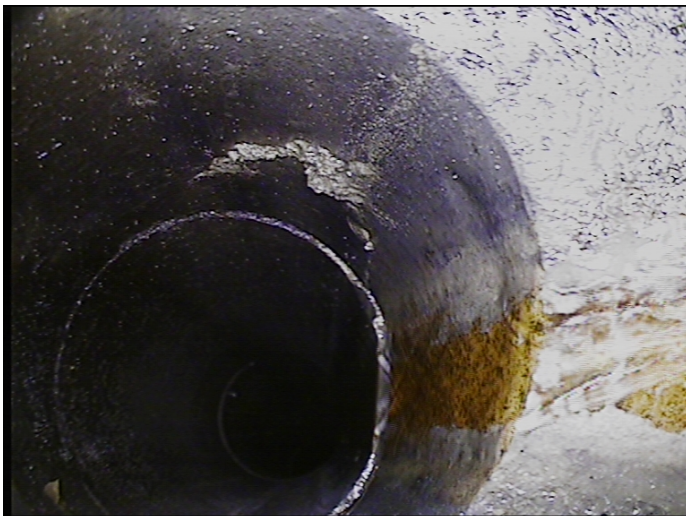
Code: **TFA**
Description: **Tap Factory Active**

Distance (ft): **75.2**
Structural Grade: **0**
O&M Grade: **0**
Clock Start/From: **3**
Clock To:
1st Value: **4.000**
2nd Value:
Value Percent:
Continuous Index:
Within 8" of Joint: **NO**
Remarks:

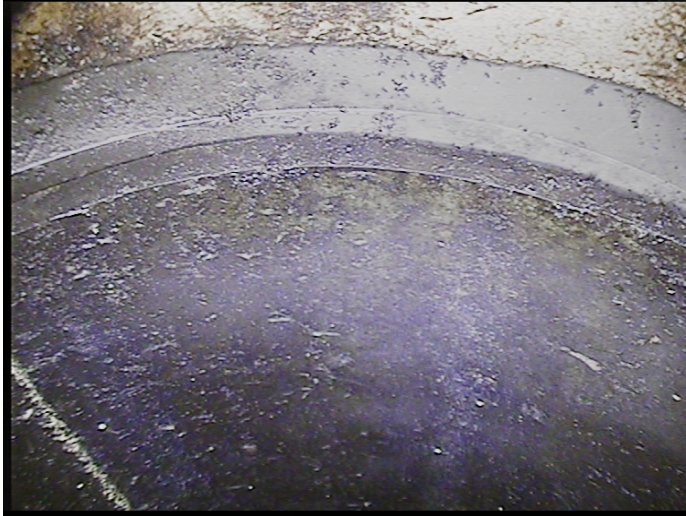
Code:	MMC
Description:	Material Change
Distance (ft):	83.3
Structural Grade:	0
O&M Grade:	0
Clock Start/From:	
Clock To:	
1st Value:	
2nd Value:	
Value Percent:	
Continuous Index:	
Within 8" of Joint:	NO
Remarks:	pvc

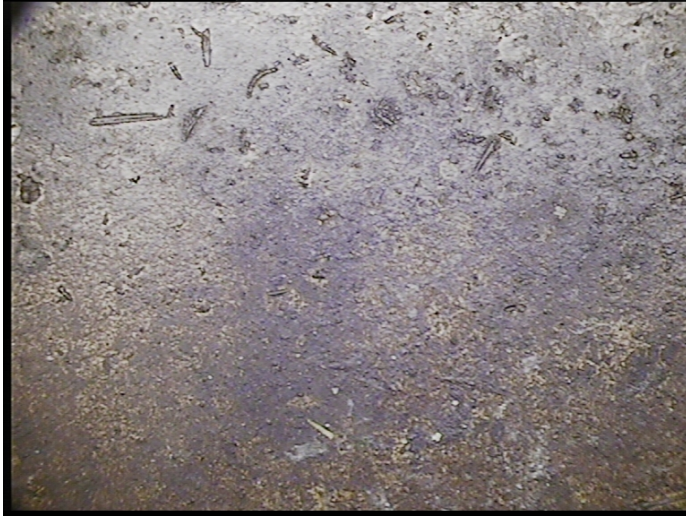
Code: **MMC**
Description: **Material Change**

Distance (ft): **88.5**
Structural Grade: **0**
O&M Grade: **0**
Clock Start/From:
Clock To:
1st Value:
2nd Value:
Value Percent:
Continuous Index:
Within 8" of Joint: **NO**
Remarks: **vcp**

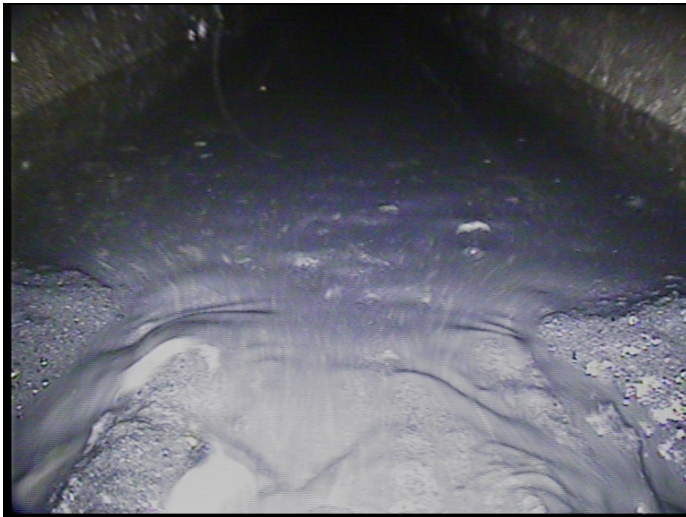
Code: **DSF**
Description: **Deposits Settled Fine**

Distance (ft): **117.8**
Structural Grade: **0**
O&M Grade: **3**
Clock Start/From: **4**
Clock To: **8**
1st Value:
2nd Value:
Value Percent: **15.000**
Continuous Index: **S01**
Within 8" of Joint: **YES**
Remarks:

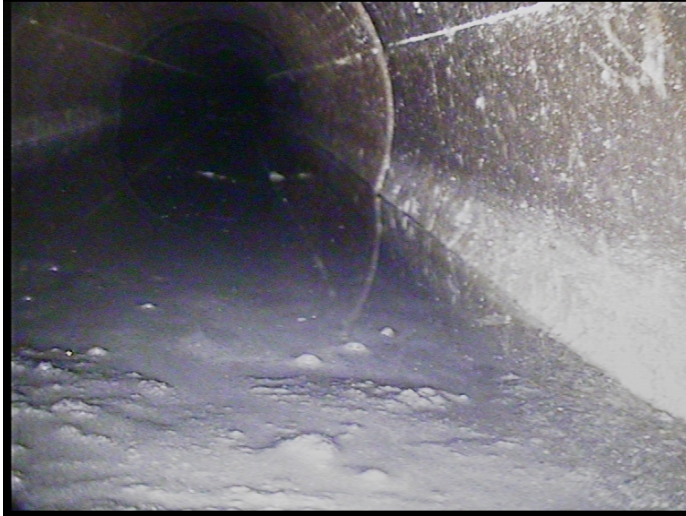
Code: **DSF**
Description: **Deposits Settled Fine**

Distance (ft): **122.5**
Structural Grade: **0**
O&M Grade: **3**
Clock Start/From: **4**
Clock To: **8**
1st Value:
2nd Value:
Value Percent: **20.000**
Continuous Index: **F01**
Within 8" of Joint: **NO**
Remarks:

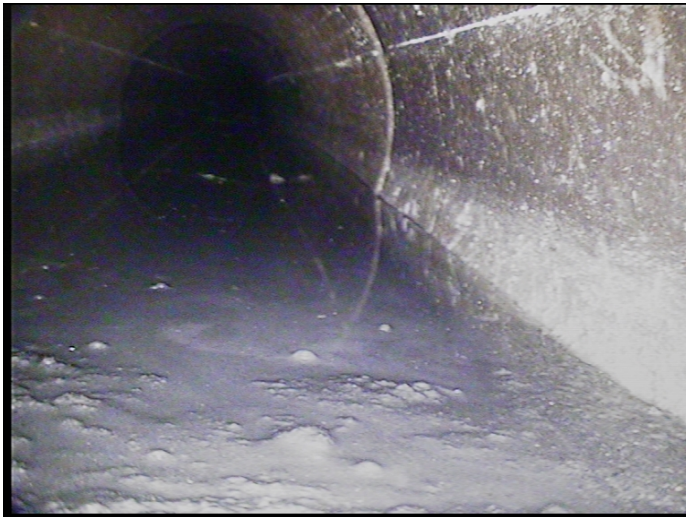
Code: **MSA**
Description: **Abandoned Survey**

Distance (ft): **122.5**
Structural Grade: **0**
O&M Grade: **0**
Clock Start/From:
Clock To:
1st Value:
2nd Value:
Value Percent:
Continuous Index:
Within 8" of Joint: **NO**
Remarks: **sediment**
