Profile/Photo Observation Report

Street:	California Street	Flow Control:	Not Controlled
City:	Hobart, IN	Year Renewed:	
Location:	Light Highway	Tape/Media #:	DEP 134
Purpose:	Routine Assessment	Dia/Height:	15"
Use:	Sanitary	Material:	VCP
Drain Area:		Lining:	
Category:	NA		
Comment:	YES501824 Submittal 2		
Location Details:		Direction of Survey:	Downstream
US MH:	M-505-007	DS MH:	M-505-006
		Total Length Surveyed (ft):	22.0

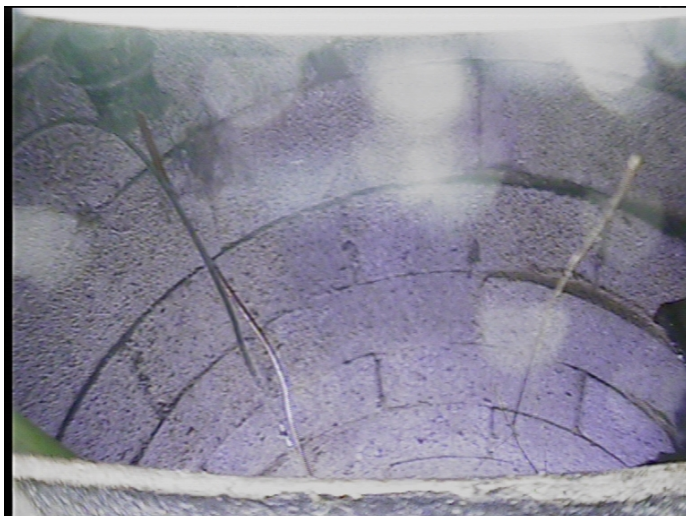
Code: **AMH**
Description: **Manhole**

Distance (ft): **.0**
Structural Grade: **0**
O&M Grade: **0**
Clock Start/From:
Clock To:
1st Value:
2nd Value:
Value Percent:
Continuous Index:
Within 8" of Joint: **NO**
Remarks: **M-505-007**

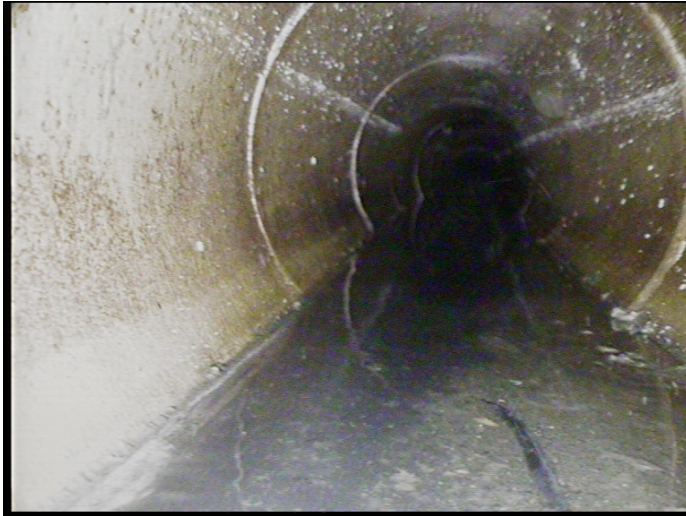
Code: **MWL**
Description: **Water Level**

Distance (ft): **.0**
Structural Grade: **0**
O&M Grade: **0**
Clock Start/From:
Clock To:
1st Value:
2nd Value:
Value Percent: **10.000**
Continuous Index:
Within 8" of Joint: **NO**
Remarks:

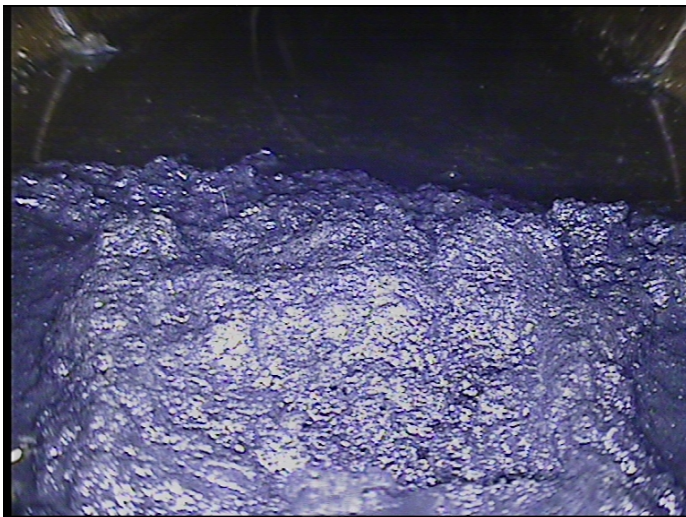
Code: **DSF**
Description: **Deposits Settled Fine**

Distance (ft): **8.5**
Structural Grade: **0**
O&M Grade: **3**
Clock Start/From: **4**
Clock To: **8**
1st Value:
2nd Value:
Value Percent: **15.000**
Continuous Index: **S01**
Within 8" of Joint: **YES**
Remarks:

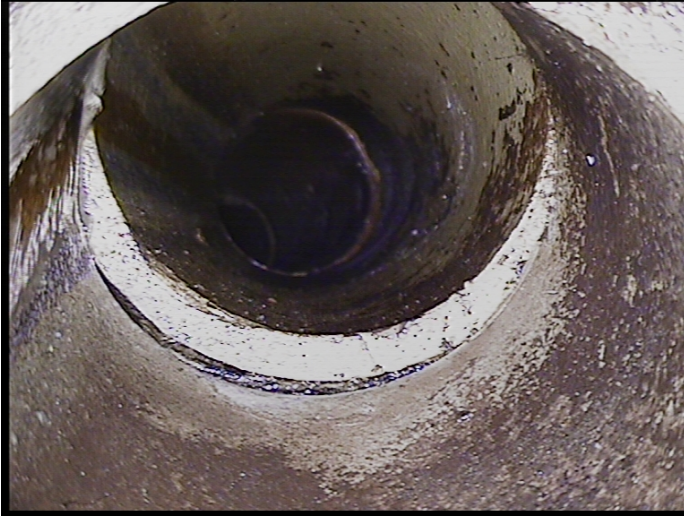
Code: **TF**
Description: **Tap Factory**

Distance (ft): **14.5**
Structural Grade: **0**
O&M Grade: **0**
Clock Start/From: **10**
Clock To:
1st Value: **4.000**
2nd Value:
Value Percent:
Continuous Index:
Within 8" of Joint: **NO**
Remarks:

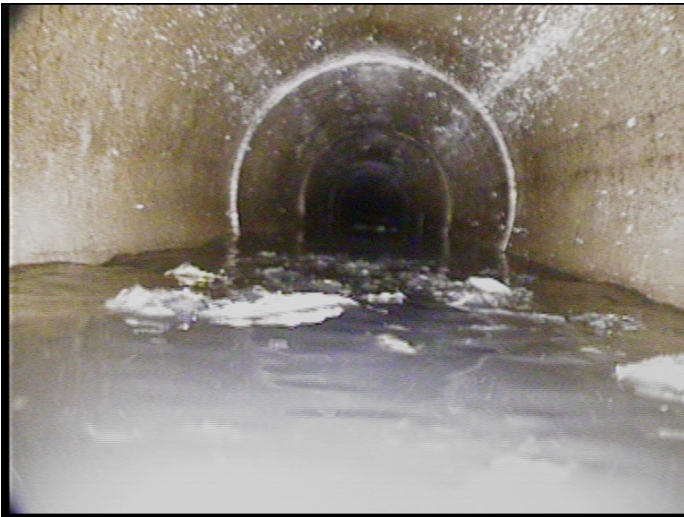
Code: **DSF**
Description: **Deposits Settled Fine**

Distance (ft): **22.0**
Structural Grade: **0**
O&M Grade: **4**
Clock Start/From: **4**
Clock To: **8**
1st Value:
2nd Value:
Value Percent: **25.000**
Continuous Index: **F01**
Within 8" of Joint: **NO**
Remarks:

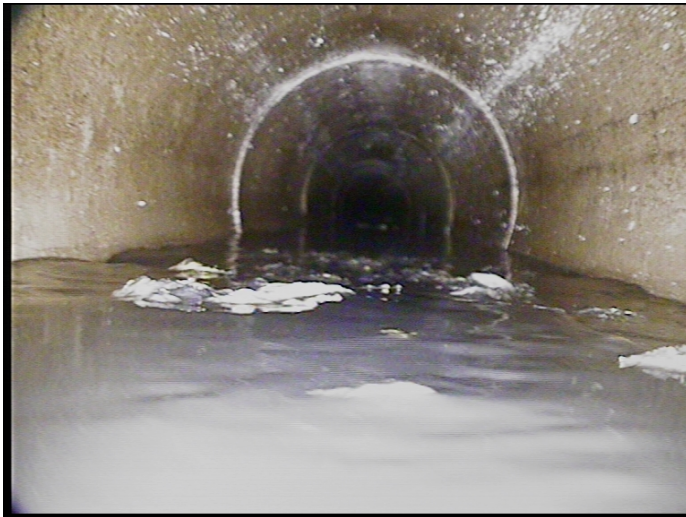
Code:	MSA
Description:	Abandoned Survey
Distance (ft):	22.0
Structural Grade:	0
O&M Grade:	0
Clock Start/From:	
Clock To:	
1st Value:	
2nd Value:	
Value Percent:	
Continuous Index:	
Within 8" of Joint:	NO
Remarks:	sediment
