Profile/Photo Observation Report

Street:	Lake George Road	Flow Control:	Not Controlled
City:	Hobart, IN	Year Renewed:	
Location:	Light Highway	Tape/Media #:	DEP 87
Purpose:	Routine Assessment	Dia/Height:	15"
Use:	Sanitary	Material:	VCP
Drain Area:		Lining:	
Category:	NA		
Comment:	YES501824 Submittal 2		
Location Details:		Direction of Survey:	Downstream
US MH:	M-505-007	DS MH:	M-505-008
		Total Length Surveyed (ft):	22.8

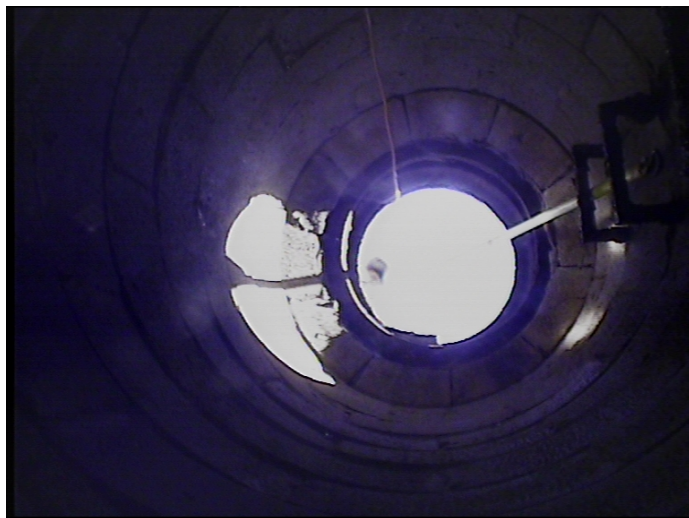
Code: **AMH**
Description: **Manhole**

Distance (ft): **.0**
Structural Grade: **0**
O&M Grade: **0**
Clock Start/From:
Clock To:
1st Value:
2nd Value:
Value Percent:
Continuous Index:
Within 8" of Joint: **NO**
Remarks: **M-505-007**

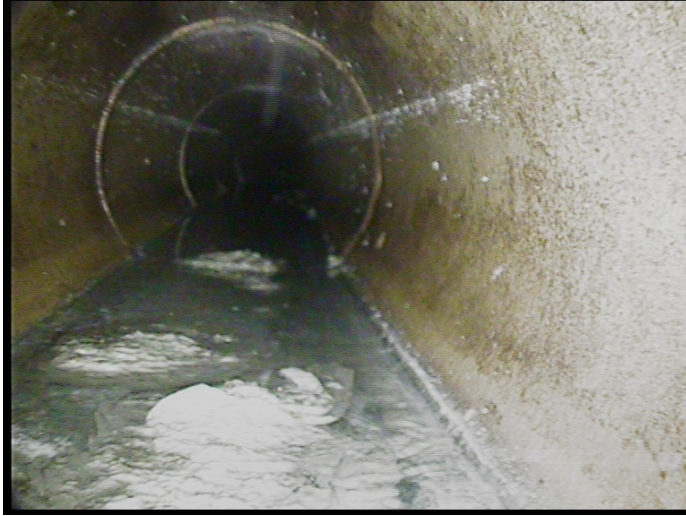
Code:	MWL
Description:	Water Level
Distance (ft):	.0
Structural Grade:	0
O&M Grade:	0
Clock Start/From:	
Clock To:	
1st Value:	
2nd Value:	
Value Percent:	10.000
Continuous Index:	
Within 8" of Joint:	NO
Remarks:

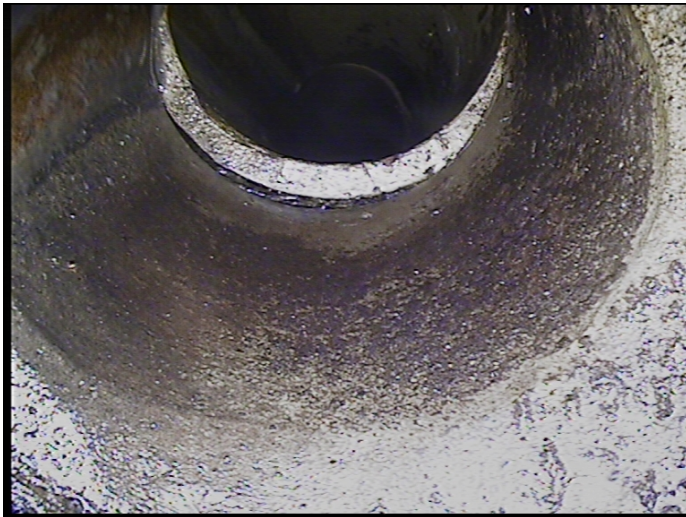
Code:	TF
Description:	Tap Factory
Distance (ft):	14.8
Structural Grade:	0
O&M Grade:	0
Clock Start/From:	9
Clock To:	
1st Value:	4.000
2nd Value:	
Value Percent:	
Continuous Index:	
Within 8" of Joint:	NO
Remarks:

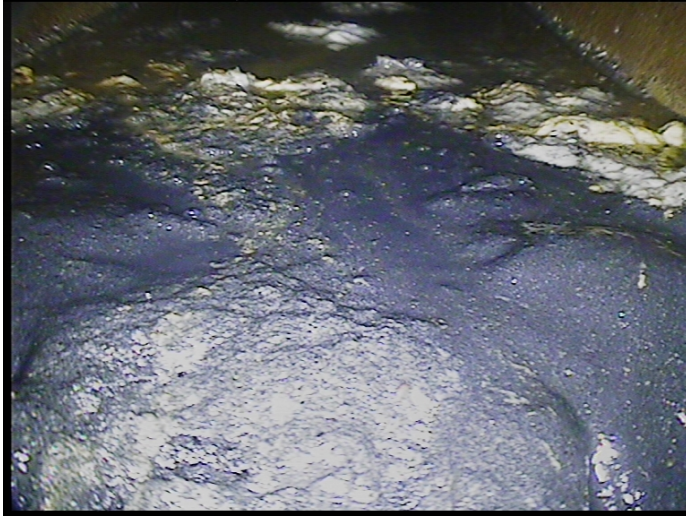
Code: **DSF**
Description: **Deposits Settled Fine**

Distance (ft): **16.7**
Structural Grade: **0**
O&M Grade: **3**
Clock Start/From: **5**
Clock To: **7**
1st Value:
2nd Value:
Value Percent: **15.000**
Continuous Index: **S01**
Within 8" of Joint: **YES**
Remarks:

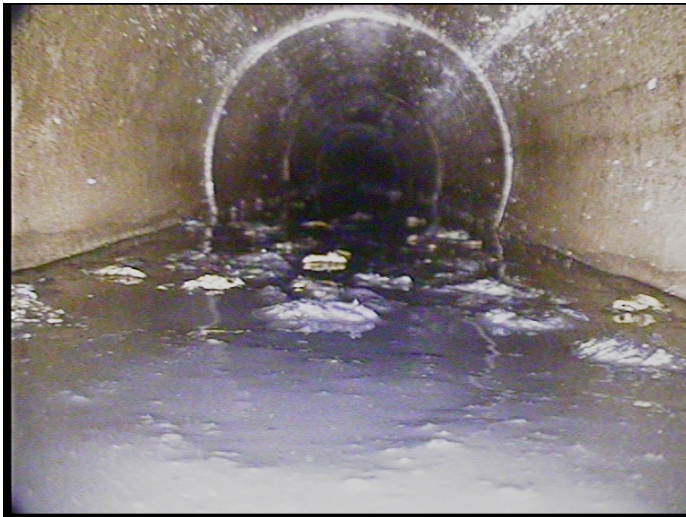
Code: **DSF**
Description: **Deposits Settled Fine**

Distance (ft): **22.8**
Structural Grade: **0**
O&M Grade: **3**
Clock Start/From: **5**
Clock To: **7**
1st Value:
2nd Value:
Value Percent: **20.000**
Continuous Index: **F01**
Within 8" of Joint: **NO**
Remarks:

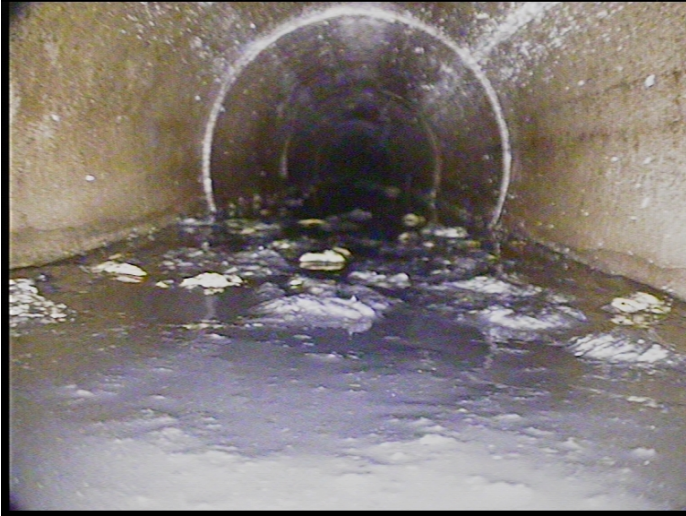
Code:	MSA
Description:	Abandoned Survey
Distance (ft):	22.8
Structural Grade:	0
O&M Grade:	0
Clock Start/From:	
Clock To:	
1st Value:	
2nd Value:	
Value Percent:	
Continuous Index:	
Within 8" of Joint:	NO
Remarks:	sediment
