Profile/Photo Observation Report

Date:	04/25/2018	Weather:		Coding:	PACP 6.0
Pipe Length (ft):		Owner:	City of Hobart	Pre Clean:	No Pre-Cleaning
P.O.#:	89	Surveyor:	M. Pielacha	PSR:	P-505-010-008
Customer:	City of Hobart	Clean Date:		Shape:	C

Street:	Lake George Road	Flow Control:	Not Controlled
City:	Hobart, IN	Year Renewed:	
Location:	Light Highway	Tape/Media #:	DEP 89
Purpose:	Routine Assessment	Dia/Height:	15"
Use:	Sanitary	Material:	VCP
Drain Area:		Lining:	
Category:	NA		
Comment:	YES501824 Submittal 2		
Location Details:		Direction of Survey:	Downstream
US MH:	M-505-008	DS MH:	M-505-010
		Total Length Surveyed (ft):	44.4

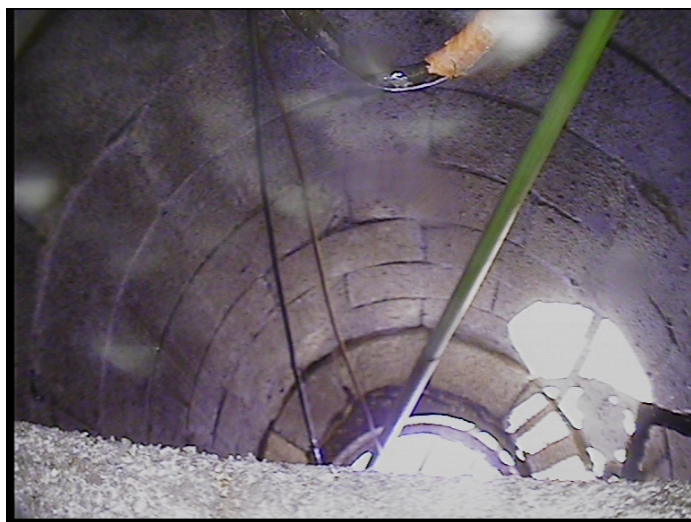
Code: **AMH**
Description: **Manhole**

Distance (ft): **.0**
Structural Grade: **0**
O&M Grade: **0**
Clock Start/From:
Clock To:
1st Value:
2nd Value:
Value Percent:
Continuous Index:
Within 8" of Joint: **NO**
Remarks: **M-505-008**

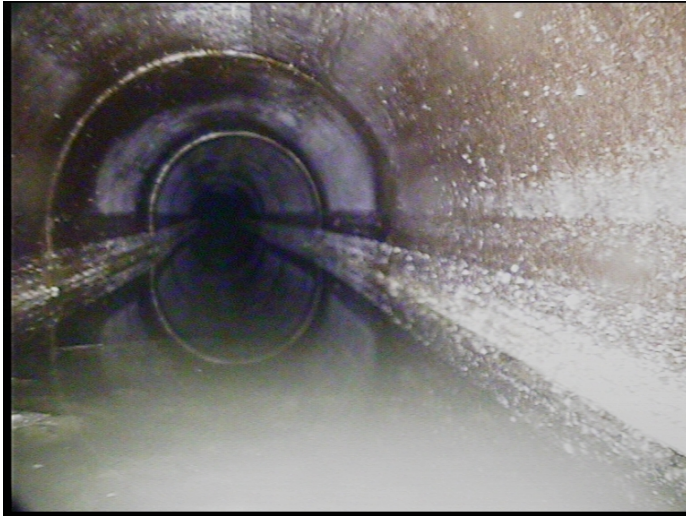
Code: **MWL**
Description: **Water Level**

Distance (ft): **.0**
Structural Grade: **0**
O&M Grade: **0**
Clock Start/From:
Clock To:
1st Value:
2nd Value:
Value Percent: **15.000**
Continuous Index:
Within 8" of Joint: **NO**
Remarks:

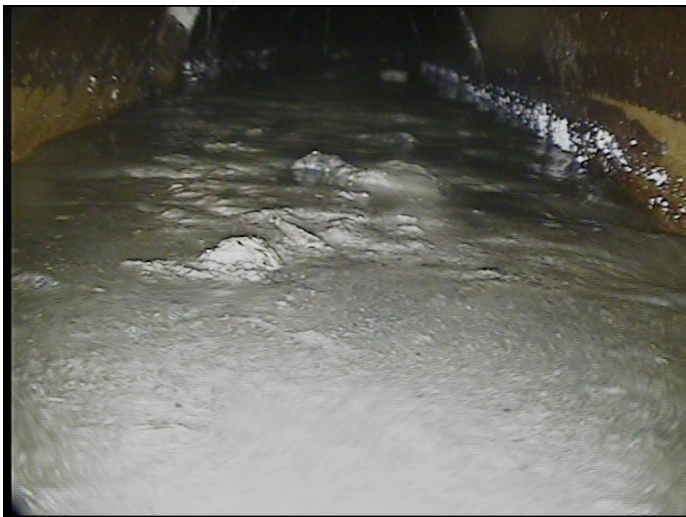
Code: **DSF**
Description: **Deposits Settled Fine**

Distance (ft): **42.3**
Structural Grade: **0**
O&M Grade: **3**
Clock Start/From: **5**
Clock To: **7**
1st Value:
2nd Value:
Value Percent: **20.000**
Continuous Index:
Within 8" of Joint: **YES**
Remarks:

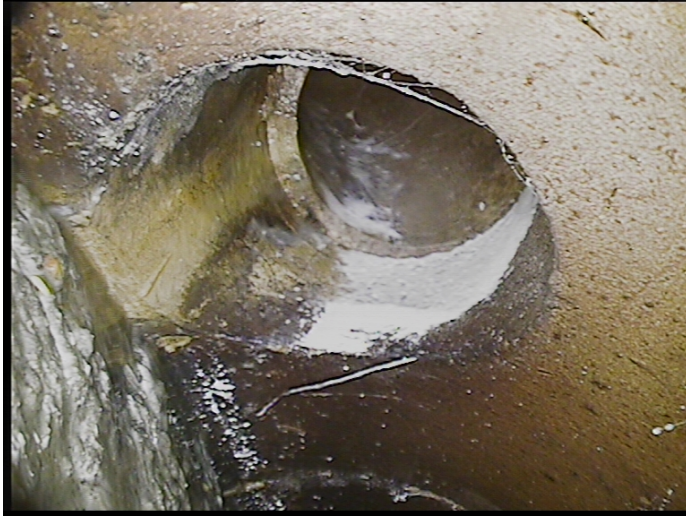
Code: **TF**
Description: **Tap Factory**

Distance (ft): **44.1**
Structural Grade: **0**
O&M Grade: **0**
Clock Start/From: **9**
Clock To:
1st Value: **4.000**
2nd Value:
Value Percent:
Continuous Index:
Within 8" of Joint: **NO**
Remarks:

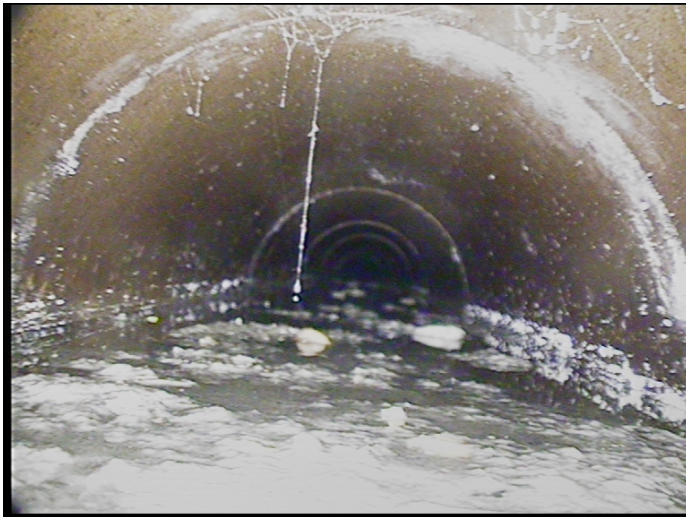
Code: **MSA**
Description: **Abandoned Survey**

Distance (ft): **44.4**
Structural Grade: **0**
O&M Grade: **0**
Clock Start/From:
Clock To:
1st Value:
2nd Value:
Value Percent:
Continuous Index:
Within 8" of Joint: **NO**
Remarks: **sediment**
