Profile/Photo Observation Report

Street:	LAKE GEORGE DR & CHERRY LN	Flow Control:	Not Controlled
City:	Hobart, IN	Year Renewed:	
Location:	Yard	Tape/Media #:	
Purpose:	Routine Assessment	Dia/Height:	10"
Use:	Sanitary	Material:	VCP
Drain Area:	NA	Lining:	
Category:	NA		
Comment:	Flow direction is marked wrong.		
Location Details:		Direction of Survey:	Downstream
US MH:	M-505-011	DS MH:	M-505-012
		Total Length Surveyed (ft):	191.4

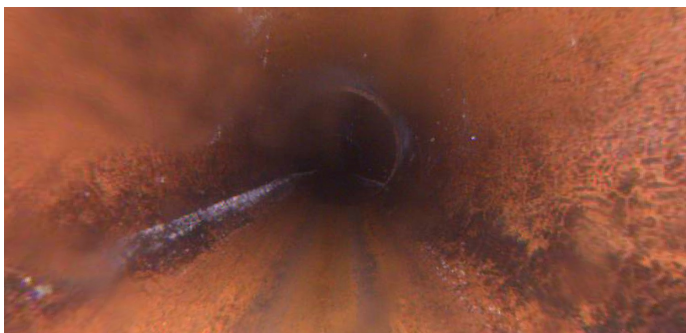
Code: **AMH**
Description: **Manhole**

Distance (ft): **.0**
Structural Grade: **0**
O&M Grade: **0**
Clock Start/From:
Clock To:
1st Value:
2nd Value:
Value Percent:
Continuous Index:
Within 8" of Joint: **NO**
Remarks: **M-505-011**

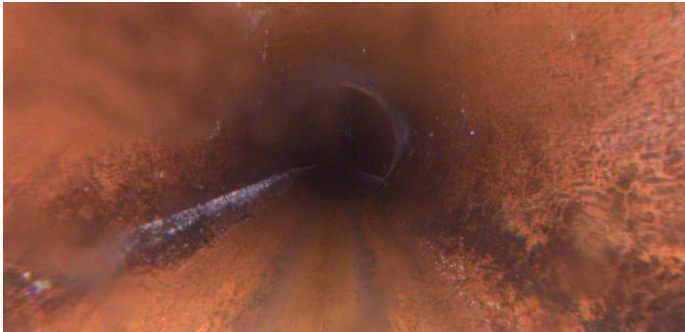
Code:	MWL
Description:	Water Level

Distance (ft):	.0
Structural Grade:	0
O&M Grade:	0
Clock Start/From:	
Clock To:	
1st Value:	
2nd Value:	
Value Percent:	5.000
Continuous Index:	
Within 8" of Joint:	NO
Remarks:

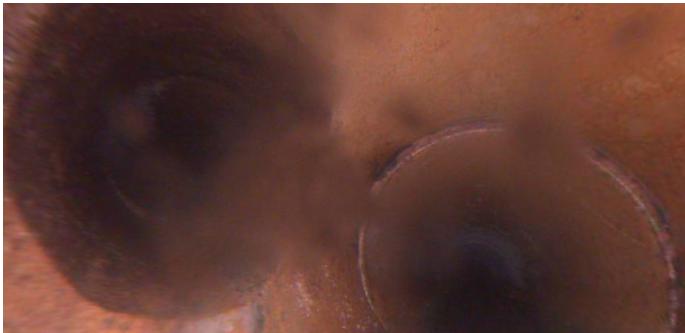
Code:	TF
Description:	Tap Factory

Distance (ft):	7.4
Structural Grade:	0
O&M Grade:	0
Clock Start/From:	10
Clock To:	
1st Value:	4.000
2nd Value:	
Value Percent:	
Continuous Index:	
Within 8" of Joint:	
Remarks:

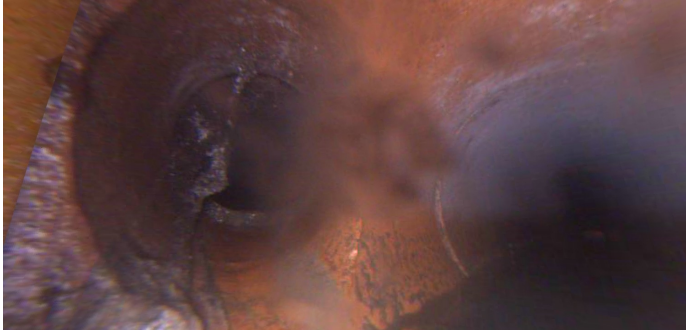
Code: **TF**
Description: **Tap Factory**

Distance (ft): **67.5**
Structural Grade: **0**
O&M Grade: **0**
Clock Start/From: **9**
Clock To:
1st Value: **4.000**
2nd Value:
Value Percent:
Continuous Index:
Within 8" of Joint:
Remarks:

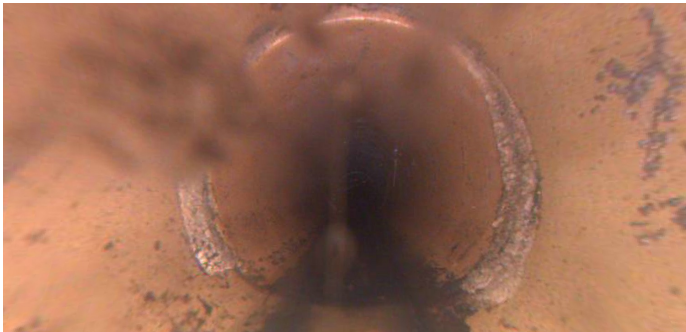
Code: **DAE**
Description: **Deposits Attached Encrustation**

Distance (ft): **88.9**
Structural Grade: **0**
O&M Grade: **2**
Clock Start/From: **8**
Clock To: **4**
1st Value:
2nd Value:
Value Percent: **5.000**
Continuous Index:
Within 8" of Joint: **YES**
Remarks:

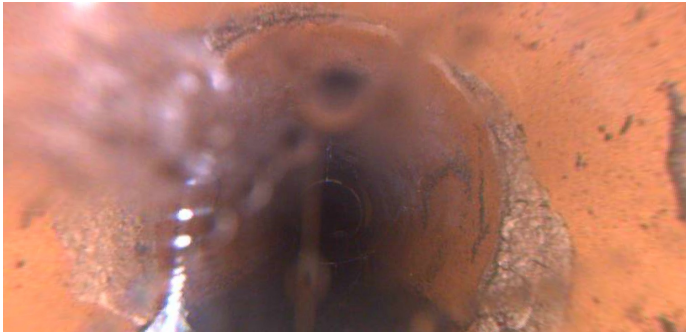
Code: **DAE**
Description: **Deposits Attached Encrustation**

Distance (ft): **92.1**
Structural Grade: **0**
O&M Grade: **2**
Clock Start/From: **8**
Clock To: **4**
1st Value:
2nd Value:
Value Percent: **5.000**
Continuous Index:
Within 8" of Joint: **YES**
Remarks:

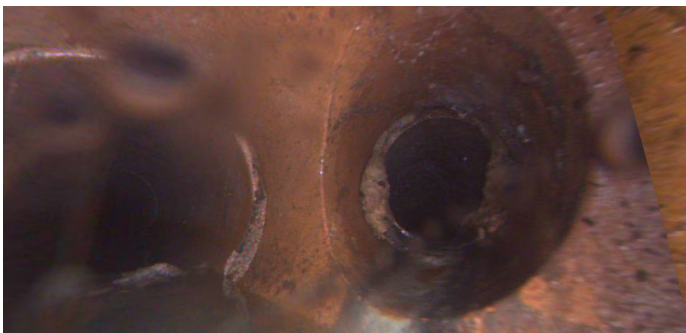
Code: **TF**
Description: **Tap Factory**

Distance (ft): **94.7**
Structural Grade: **0**
O&M Grade: **0**
Clock Start/From: **3**
Clock To:
1st Value: **4.000**
2nd Value:
Value Percent:
Continuous Index:
Within 8" of Joint:
Remarks:

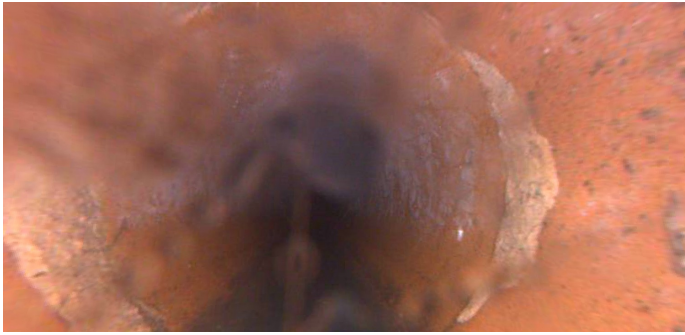
Code: **DAE**
Description: **Deposits Attached Encrustation**

Distance (ft): **107.2**
Structural Grade: **0**
O&M Grade: **2**
Clock Start/From: **8**
Clock To: **4**
1st Value:
2nd Value:
Value Percent: **5.000**
Continuous Index: **S01**
Within 8" of Joint: **YES**
Remarks:

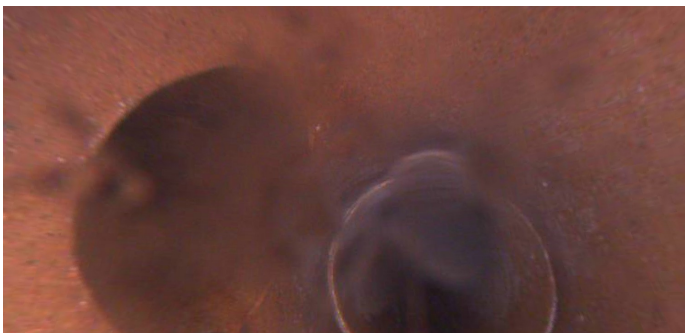
Code: **TF**
Description: **Tap Factory**

Distance (ft): **139.5**
Structural Grade: **0**
O&M Grade: **0**
Clock Start/From: **9**
Clock To:
1st Value: **4.000**
2nd Value:
Value Percent:
Continuous Index:
Within 8" of Joint:
Remarks:

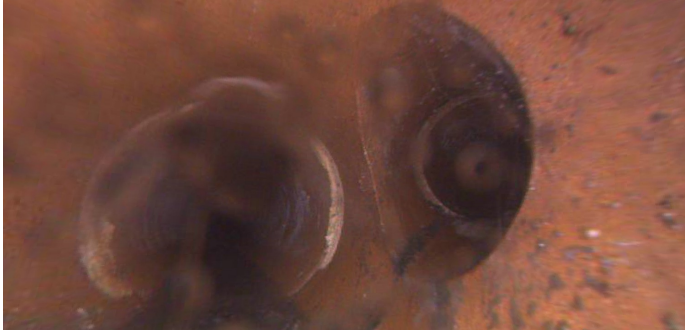
Code: **TF**
Description: **Tap Factory**

Distance (ft): **153.2**
Structural Grade: **0**
O&M Grade: **0**
Clock Start/From: **3**
Clock To:
1st Value: **4.000**
2nd Value:
Value Percent:
Continuous Index:
Within 8" of Joint:
Remarks:

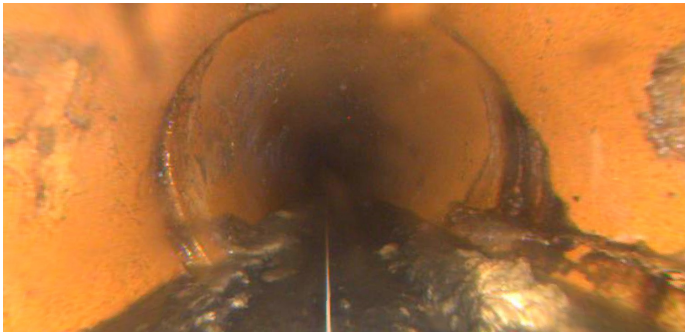
Code: **IW**
Description: **Infil Weeper**

Distance (ft): **182.3**
Structural Grade: **0**
O&M Grade: **2**
Clock Start/From: **8**
Clock To: **4**
1st Value:
2nd Value:
Value Percent:
Continuous Index: **S02**
Within 8" of Joint: **YES**
Remarks:

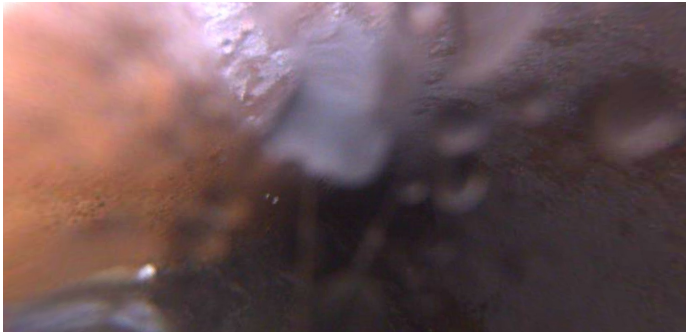
Code: **IW**
Description: **Infil Weeper**

Distance (ft): **191.4**
Structural Grade: **0**
O&M Grade: **2**
Clock Start/From: **8**
Clock To: **4**
1st Value:
2nd Value:
Value Percent:
Continuous Index: **F02**
Within 8" of Joint: **YES**
Remarks:

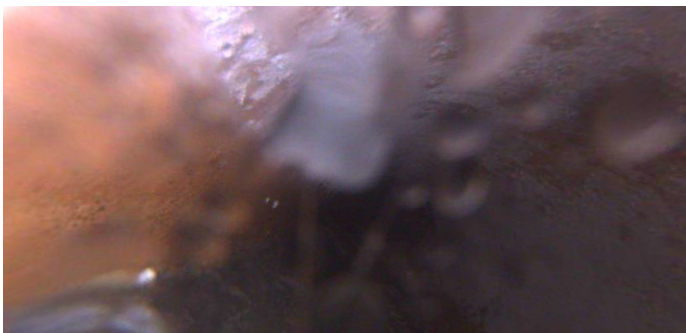
Code: **DAE**
Description: **Deposits Attached Encrustation**

Distance (ft): **191.4**
Structural Grade: **0**
O&M Grade: **2**
Clock Start/From: **8**
Clock To: **4**
1st Value:
2nd Value:
Value Percent: **5.000**
Continuous Index: **F01**
Within 8" of Joint: **YES**
Remarks:

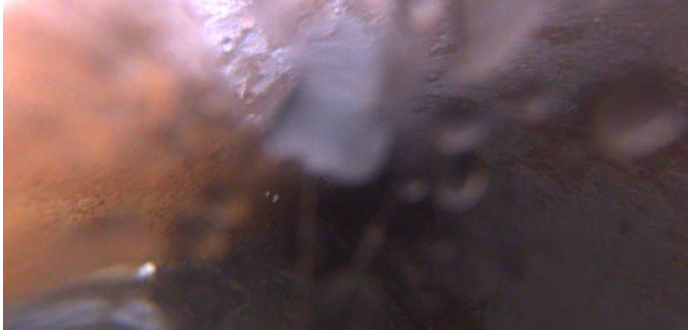
Code:	MSA
Description:	Abandoned Survey
Distance (ft):	191.4
Structural Grade:	0
O&M Grade:	0
Clock Start/From:	
Clock To:	
1st Value:	
2nd Value:	
Value Percent:	
Continuous Index:	
Within 8" of Joint:	NO
Remarks:	debris under water
