Profile/Photo Observation Report

Street:	FOXCROFT STREET	Flow Control:	Not Controlled
City:	Hobart, IN	Year Renewed:	
Location:	Yard	Tape/Media #:	
Purpose:	Routine Assessment	Dia/Height:	10"
Use:	Sanitary	Material:	VCP
Drain Area:	NA	Lining:	
Category:	NA		
Comment:	Flow direction is marked wrong.		
Location Details:		Direction of Survey:	Downstream
US MH:	M-505-011	DS MH:	M-505-012
		Total Length Surveyed (ft):	191.4

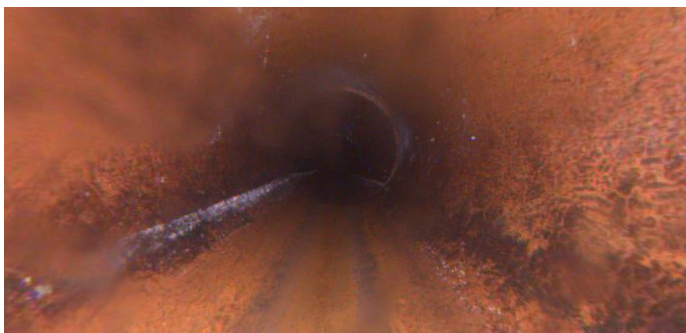
Code: **AMH**
Description: **Manhole**

Distance (ft): **.0**
Structural Grade: **0**
O&M Grade: **0**
Clock Start/From:
Clock To:
1st Value:
2nd Value:
Value Percent:
Continuous Index:
Within 8" of Joint: **NO**
Remarks: **M-505-011**

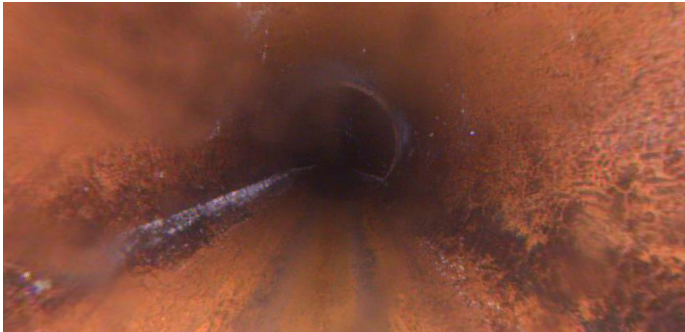
Code:	MWL
Description:	Water Level

Distance (ft):	.0
Structural Grade:	0
O&M Grade:	0
Clock Start/From:	
Clock To:	
1st Value:	
2nd Value:	
Value Percent:	5.000
Continuous Index:	
Within 8" of Joint:	NO
Remarks:

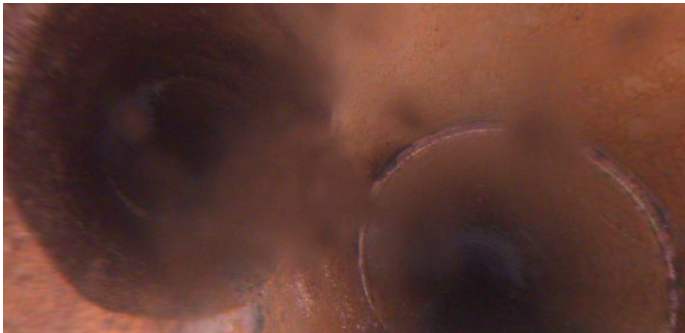
Code:	TF
Description:	Tap Factory

Distance (ft):	7.4
Structural Grade:	0
O&M Grade:	0
Clock Start/From:	10
Clock To:	
1st Value:	4.000
2nd Value:	
Value Percent:	
Continuous Index:	
Within 8" of Joint:	
Remarks:

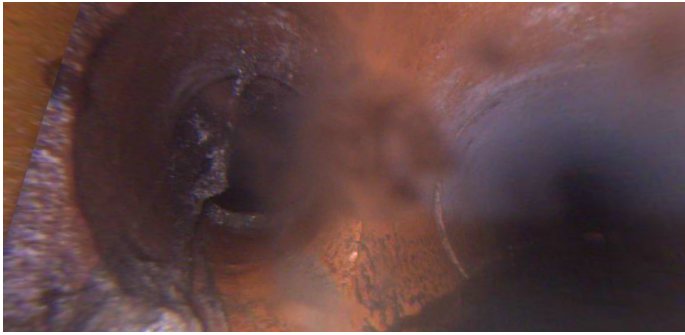
Code: **TF**
Description: **Tap Factory**

Distance (ft): **67.5**
Structural Grade: **0**
O&M Grade: **0**
Clock Start/From: **9**
Clock To:
1st Value: **4.000**
2nd Value:
Value Percent:
Continuous Index:
Within 8" of Joint:
Remarks:

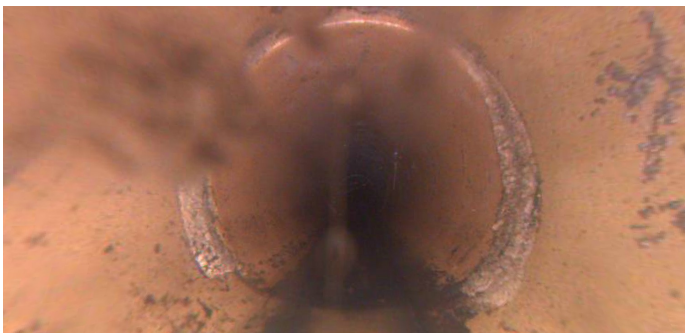
Code: **DAE**
Description: **Deposits Attached Encrustation**

Distance (ft): **88.9**
Structural Grade: **0**
O&M Grade: **2**
Clock Start/From: **8**
Clock To: **4**
1st Value:
2nd Value:
Value Percent: **5.000**
Continuous Index:
Within 8" of Joint: **YES**
Remarks:

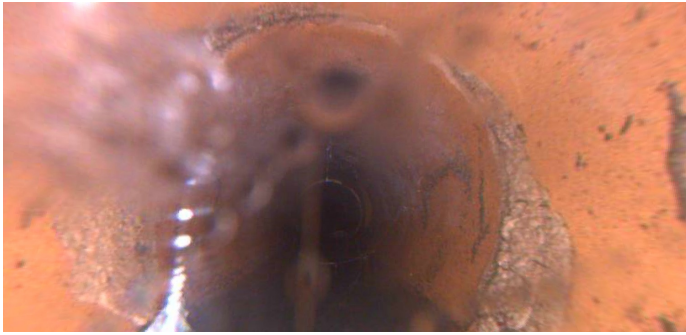
Code: **DAE**
Description: **Deposits Attached Encrustation**

Distance (ft): **92.1**
Structural Grade: **0**
O&M Grade: **2**
Clock Start/From: **8**
Clock To: **4**
1st Value:
2nd Value:
Value Percent: **5.000**
Continuous Index:
Within 8" of Joint: **YES**
Remarks:

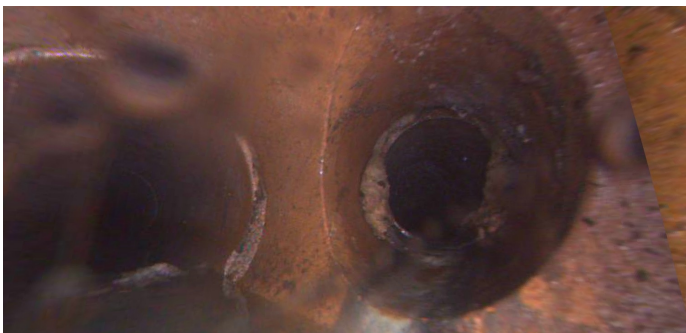
Code: **TF**
Description: **Tap Factory**

Distance (ft): **94.7**
Structural Grade: **0**
O&M Grade: **0**
Clock Start/From: **3**
Clock To:
1st Value: **4.000**
2nd Value:
Value Percent:
Continuous Index:
Within 8" of Joint:
Remarks:

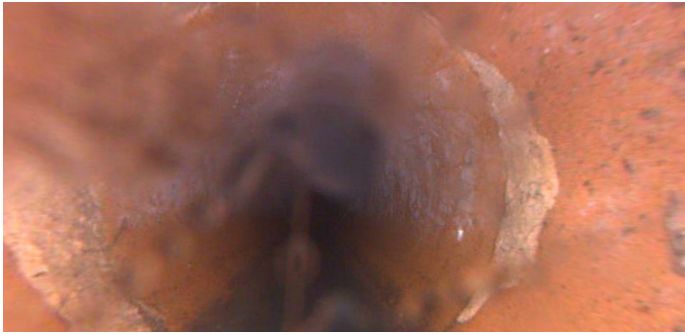
Code: **DAE**
Description: **Deposits Attached Encrustation**

Distance (ft): **107.2**
Structural Grade: **0**
O&M Grade: **2**
Clock Start/From: **8**
Clock To: **4**
1st Value:
2nd Value:
Value Percent: **5.000**
Continuous Index: **S01**
Within 8" of Joint: **YES**
Remarks:

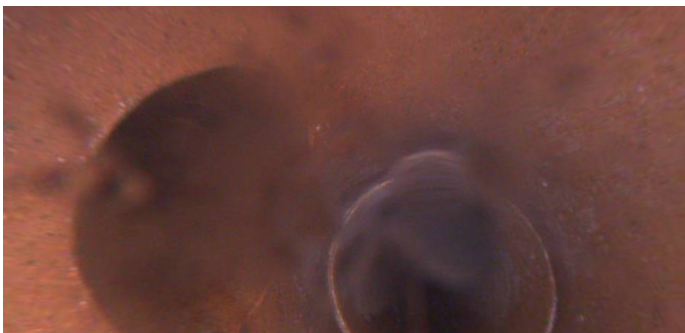
Code: **TF**
Description: **Tap Factory**

Distance (ft): **139.5**
Structural Grade: **0**
O&M Grade: **0**
Clock Start/From: **9**
Clock To:
1st Value: **4.000**
2nd Value:
Value Percent:
Continuous Index:
Within 8" of Joint:
Remarks:

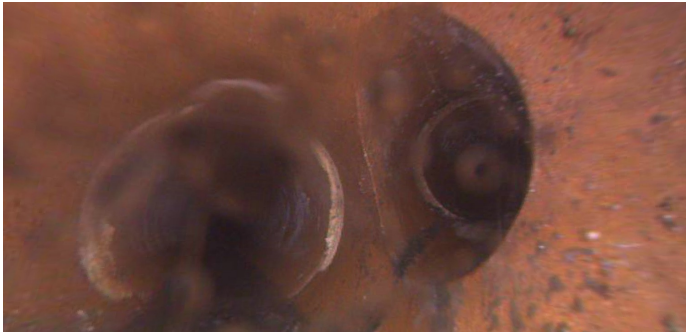
Code: **TF**
Description: **Tap Factory**

Distance (ft): **153.2**
Structural Grade: **0**
O&M Grade: **0**
Clock Start/From: **3**
Clock To:
1st Value: **4.000**
2nd Value:
Value Percent:
Continuous Index:
Within 8" of Joint:
Remarks:

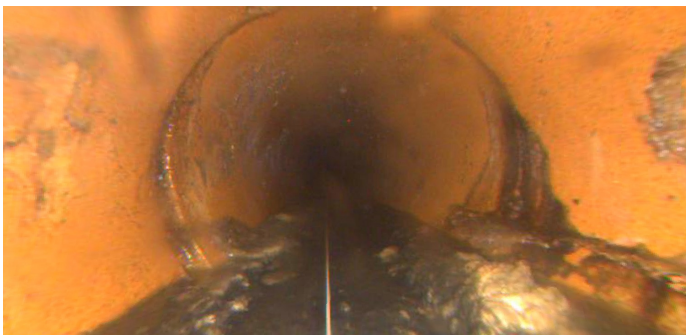
Code: **IW**
Description: **Infil Weeper**

Distance (ft): **182.3**
Structural Grade: **0**
O&M Grade: **2**
Clock Start/From: **8**
Clock To: **4**
1st Value:
2nd Value:
Value Percent:
Continuous Index: **S02**
Within 8" of Joint: **YES**
Remarks:

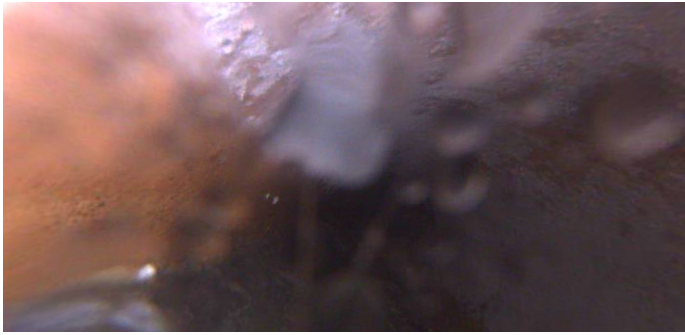
Code: **IW**
Description: **Infil Weeper**

Distance (ft): **191.4**
Structural Grade: **0**
O&M Grade: **2**
Clock Start/From: **8**
Clock To: **4**
1st Value:
2nd Value:
Value Percent:
Continuous Index: **F02**
Within 8" of Joint: **YES**
Remarks:

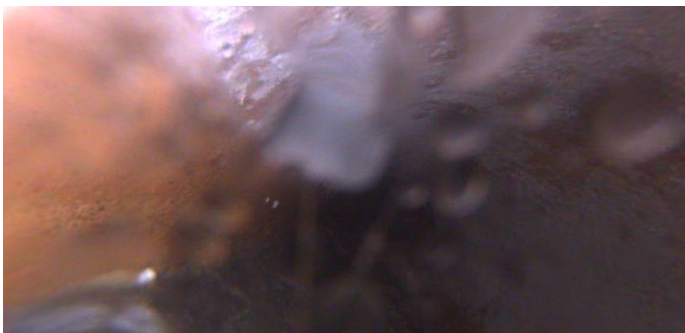
Code: **DAE**
Description: **Deposits Attached Encrustation**

Distance (ft): **191.4**
Structural Grade: **0**
O&M Grade: **2**
Clock Start/From: **8**
Clock To: **4**
1st Value:
2nd Value:
Value Percent: **5.000**
Continuous Index: **F01**
Within 8" of Joint: **YES**
Remarks:

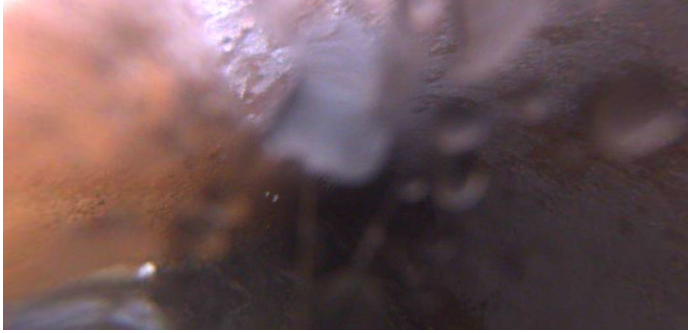
Code:	MSA
Description:	Abandoned Survey
Distance (ft):	191.4
Structural Grade:	0
O&M Grade:	0
Clock Start/From:	
Clock To:	
1st Value:	
2nd Value:	
Value Percent:	
Continuous Index:	
Within 8" of Joint:	NO
Remarks:	debris under water
