Profile/Photo Observation Report

Date:	01/21/2022	Weather:		Coding:	PACP 7.0
Pipe Length (ft):	219.8	Owner:	City of Hobart	Pre Clean:	Heavy Cleaning
P.O.#:	YES502259	Surveyor:	S. Bucklin	PSR:	P-505-012-011
Customer:	City of Hobart	Clean Date:	01/19/2022	Shape:	C

Street:	Cherry Lane	Flow Control:	Not Controlled
City:	Hobart, IN	Year Renewed:	
Location:	Local rural streets with light traffic, t	Tape/Media #:	
Purpose:	Routine Assessment	Dia/Height:	10"
Use:	Sanitary Sewage Pipe	Material:	VCP
Drain Area:		Lining:	None
Category:	NA		
Comment:			
Location Details:		Direction of Survey:	Downstream
US MH:	M-505-011	DS MH:	M-505-012
		Total Length Surveyed (ft):	219.8

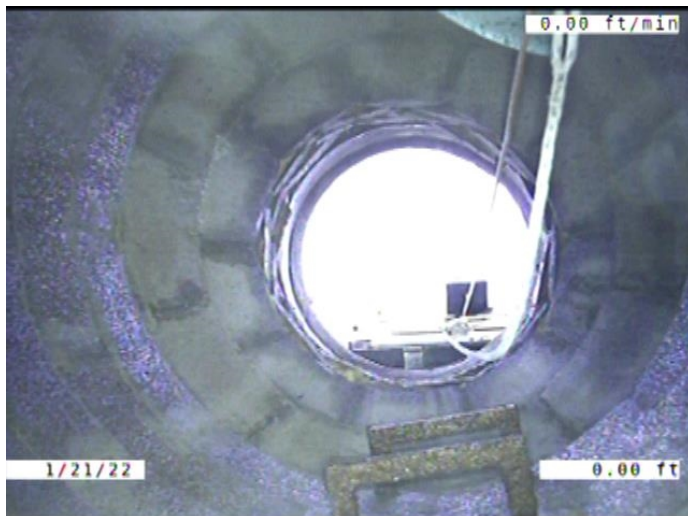
Code: **AMH**
 Description: **Manhole**

Distance (ft): **.0**
 Structural Grade: **0**
 O&M Grade: **0**
 Clock Start/From:
 Clock To:
 1st Value:
 2nd Value:
 Value Percent:
 Continuous Index:
 Within 8" of Joint: **NO**
 Remarks: **M-505-011**

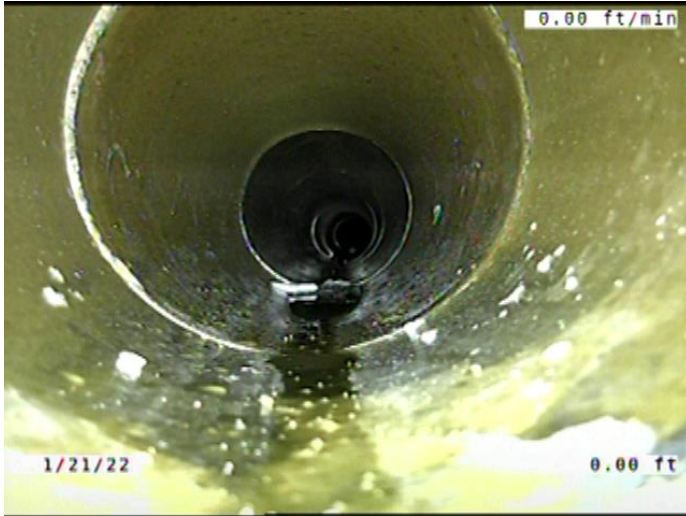
Code:	MWL
Description:	Miscellaneous Water Level
Distance (ft):	.0
Structural Grade:	0
O&M Grade:	0
Clock Start/From:	
Clock To:	
1st Value:	
2nd Value:	
Value Percent:	5.000
Continuous Index:	
Within 8" of Joint:	NO
Remarks:

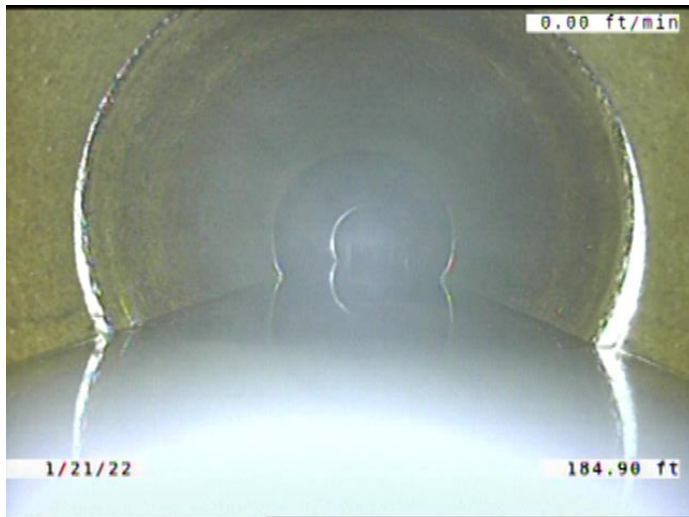
Code: **MWL**
 Description: **Miscellaneous Water Level**

Distance (ft): **184.9**
 Structural Grade: **0**
 O&M Grade: **0**
 Clock Start/From:
 Clock To:
 1st Value:
 2nd Value:
 Value Percent: **15.000**
 Continuous Index:
 Within 8" of Joint: **NO**
 Remarks:

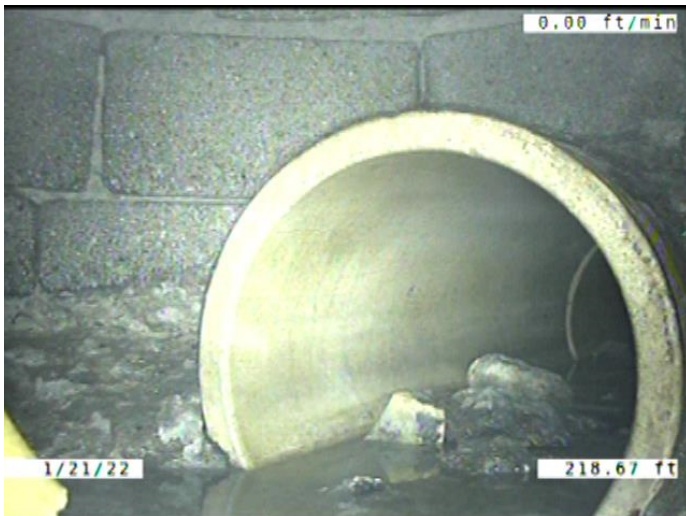
Code: **DSF**
Description: **Deposits Settled Fine**

Distance (ft): **218.7**
Structural Grade: **0**
O&M Grade: **2**
Clock Start/From: **5**
Clock To: **7**
1st Value:
2nd Value:
Value Percent: **5.000**
Continuous Index: **F01**
Within 8" of Joint: **YES**
Remarks:
