## Profile/Photo Observation Report

Date:	<b>04/26/2018</b>	Weather:		Coding:	<b>PACP 6.0</b>
Pipe Length (ft):		Owner:	<b>City of Hobart</b>	Pre Clean:	<b>No Pre-Cleaning</b>
P.O.#:	<b>97</b>	Surveyor:	<b>M. Pielacha</b>	PSR:	<b>P-505-013-004</b>
Customer:	<b>City of Hobart</b>	Clean Date:		Shape:	<b>C</b>

Street:	<b>Virginia Street</b>	Flow Control:	<b>Not Controlled</b>
City:	<b>Hobart, IN</b>	Year Renewed:	
Location:	<b>Light Highway</b>	Tape/Media #:	<b>DEP 97</b>
Purpose:	<b>Routine Assessment</b>	Dia/Height:	<b>18"</b>
Use:	<b>Sanitary</b>	Material:	<b>CP</b>
Drain Area:		Lining:	
Category:	<b>NA</b>		
Comment:	<b>YES501824 Submittal 2</b>		
Location Details:		Direction of Survey:	<b>Downstream</b>
US MH:	<b>M-505-013</b>	DS MH:	<b>M-505-004</b>
		Total Length Surveyed (ft):	<b>274.9</b>

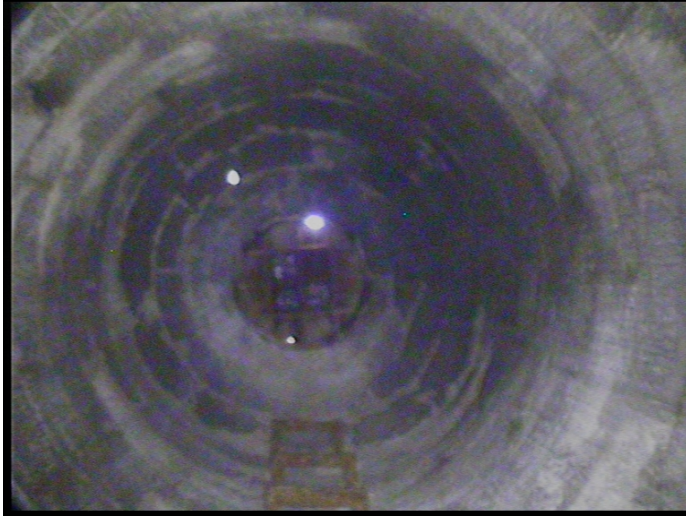
Code: **AMH**  
Description: **Manhole**

Distance (ft): **.0**  
Structural Grade: **0**  
O&M Grade: **0**  
Clock Start/From:  
Clock To:  
1st Value:  
2nd Value:  
Value Percent:  
Continuous Index:  
Within 8" of Joint: **NO**  
Remarks: **M-505-013**

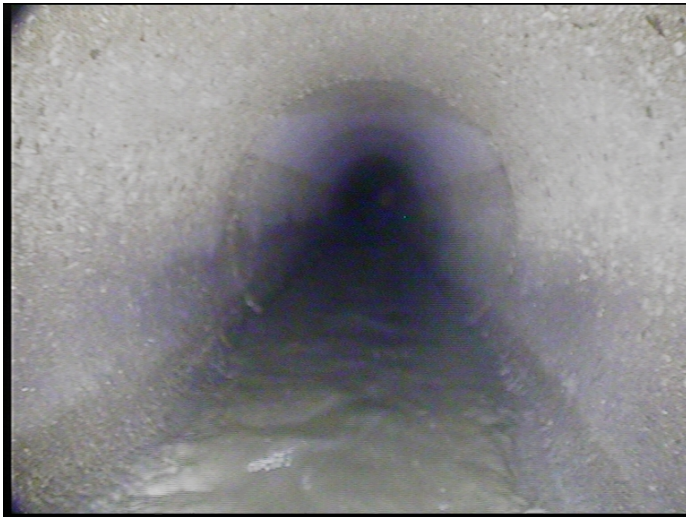
Code: **MWL**  
Description: **Water Level**

Distance (ft): **.0**  
Structural Grade: **0**  
O&M Grade: **0**  
Clock Start/From:  
Clock To:  
1st Value:  
2nd Value:  
Value Percent: **10.000**  
Continuous Index:  
Within 8" of Joint: **NO**  
Remarks:

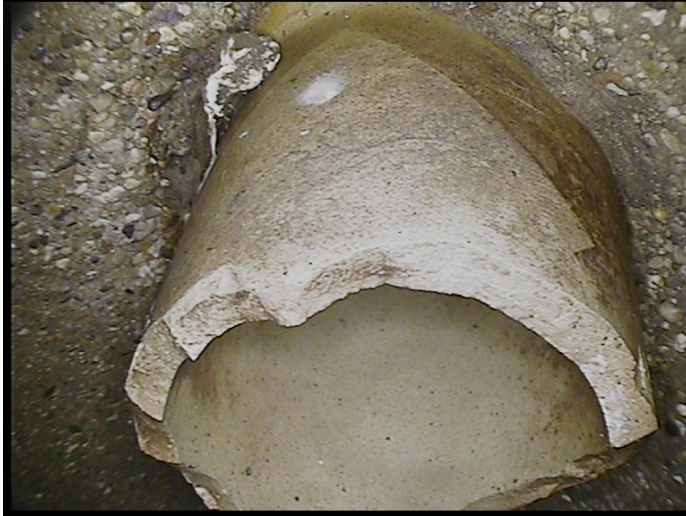
Code:	<b>TBI</b>
Description:	<b>Tap Break-in Intruding</b>
Distance (ft):	<b>19.8</b>
Structural Grade:	<b>0</b>
O&M Grade:	<b>2</b>
Clock Start/From:	<b>2</b>
Clock To:	
1st Value:	<b>4.000</b>
2nd Value:	<b>2.000</b>
Value Percent:	
Continuous Index:	
Within 8" of Joint:	<b>NO</b>
Remarks:

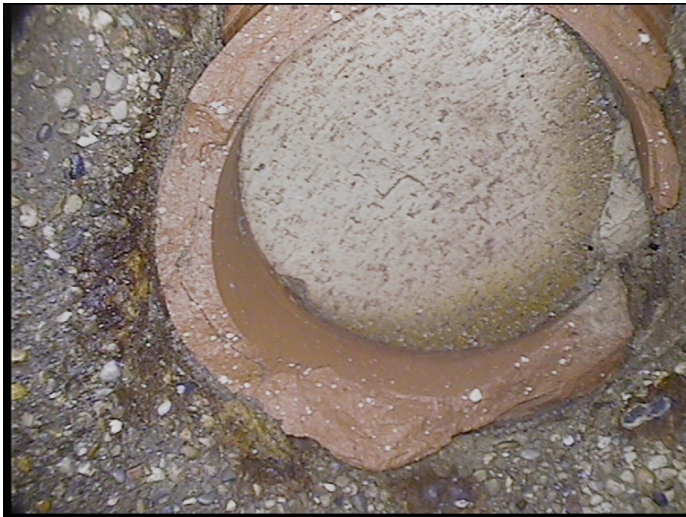
Code:	<b>TBC</b>
Description:	<b>Tap Break-in Capped</b>
Distance (ft):	<b>23.4</b>
Structural Grade:	<b>0</b>
O&M Grade:	<b>2</b>
Clock Start/From:	<b>10</b>
Clock To:	
1st Value:	<b>4.000</b>
2nd Value:	
Value Percent:	
Continuous Index:	
Within 8" of Joint:	<b>NO</b>
Remarks:

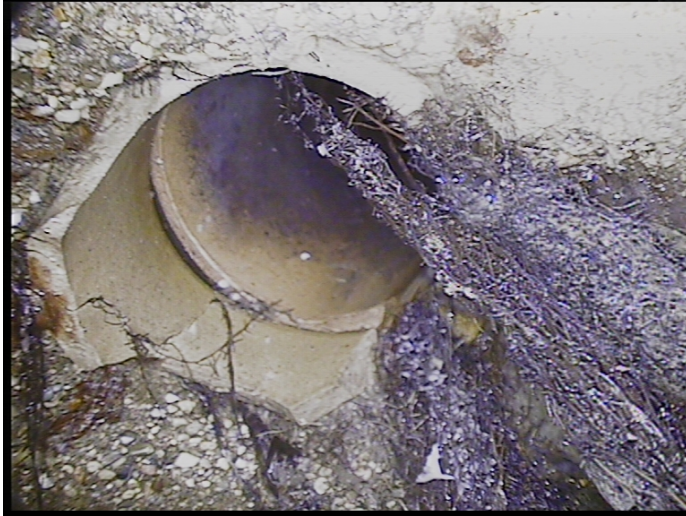
Code: **TBD**  
Description: **Tap Break-in Defective**

Distance (ft): **25.3**  
Structural Grade: **0**  
O&M Grade: **3**  
Clock Start/From: **2**  
Clock To:  
1st Value: **4.000**  
2nd Value:  
Value Percent:  
Continuous Index:  
Within 8" of Joint: **NO**  
Remarks: **Defective**

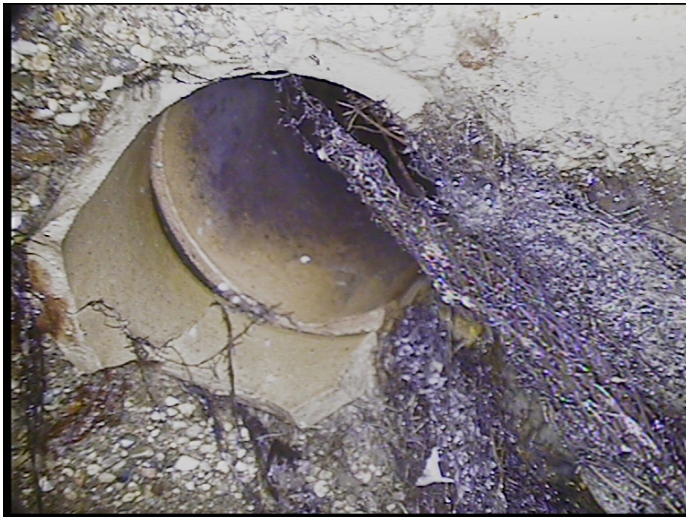
Code: **RML**  
Description: **Roots Medium Lateral**

Distance (ft): **25.3**  
Structural Grade: **0**  
O&M Grade: **3**  
Clock Start/From: **2**  
Clock To:  
1st Value:  
2nd Value:  
Value Percent: **10.000**  
Continuous Index:  
Within 8" of Joint: **NO**  
Remarks:

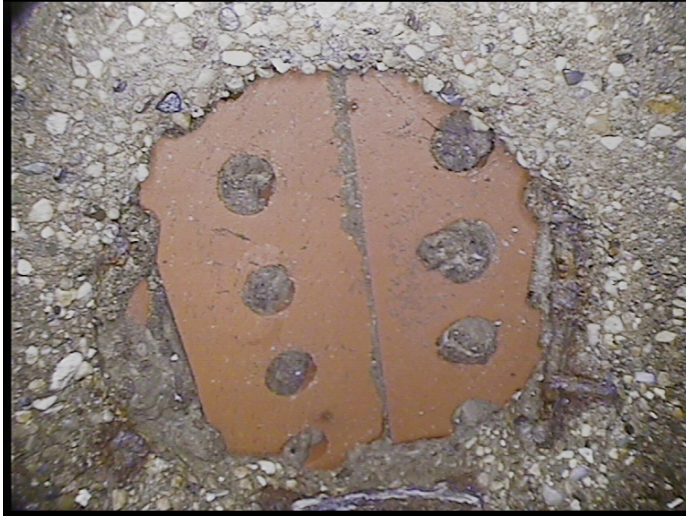
Code: **TBC**  
Description: **Tap Break-in Capped**

Distance (ft): **41.3**  
Structural Grade: **0**  
O&M Grade: **2**  
Clock Start/From: **10**  
Clock To:  
1st Value: **4.000**  
2nd Value:  
Value Percent:  
Continuous Index:  
Within 8" of Joint: **NO**  
Remarks:

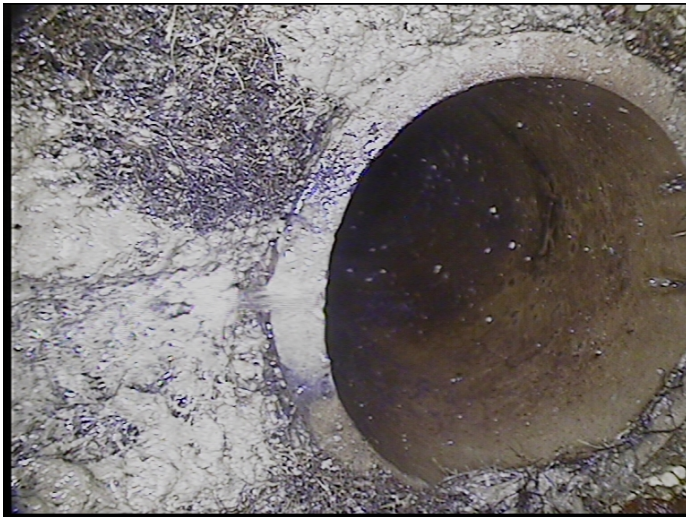
Code: **TBD**  
Description: **Tap Break-in Defective**

Distance (ft): **48.1**  
Structural Grade: **0**  
O&M Grade: **3**  
Clock Start/From: **10**  
Clock To:  
1st Value: **4.000**  
2nd Value:  
Value Percent:  
Continuous Index:  
Within 8" of Joint: **NO**  
Remarks: **Defective**

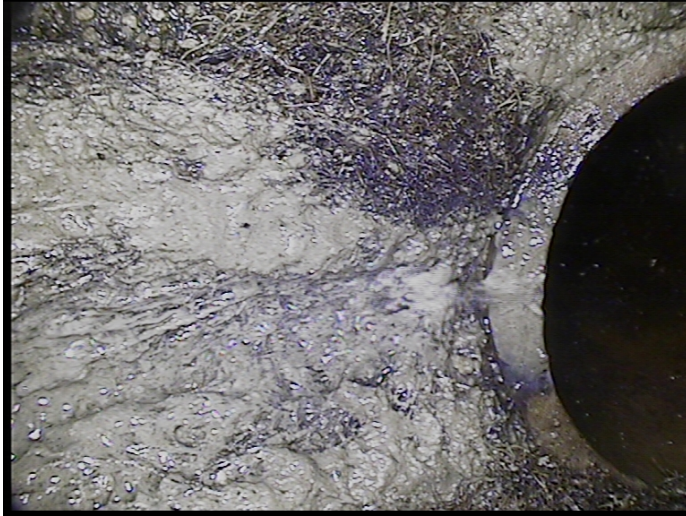
Code: **RFL**  
Description: **Roots Fine Lateral**

Distance (ft): **48.1**  
Structural Grade: **0**  
O&M Grade: **1**  
Clock Start/From: **9**  
Clock To:  
1st Value:  
2nd Value:  
Value Percent:  
Continuous Index:  
Within 8" of Joint: **NO**  
Remarks:

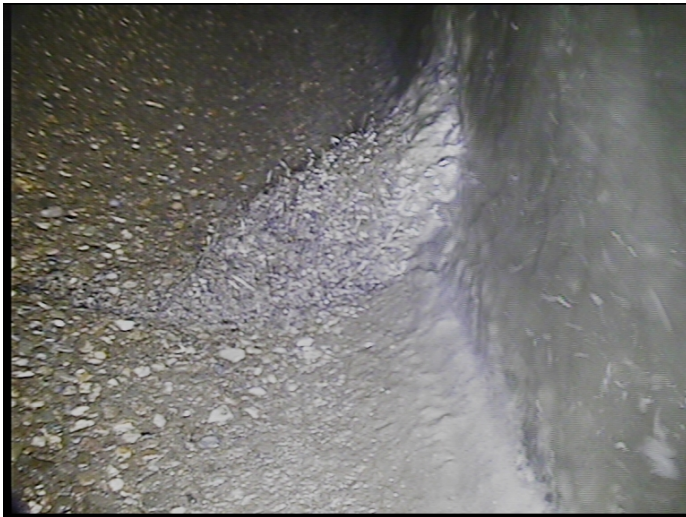
Code: **RFJ**  
Description: **Roots Fine Joint**

Distance (ft): **75.9**  
Structural Grade: **0**  
O&M Grade: **1**  
Clock Start/From: **8**  
Clock To:  
1st Value:  
2nd Value:  
Value Percent:  
Continuous Index:  
Within 8" of Joint: **YES**  
Remarks:

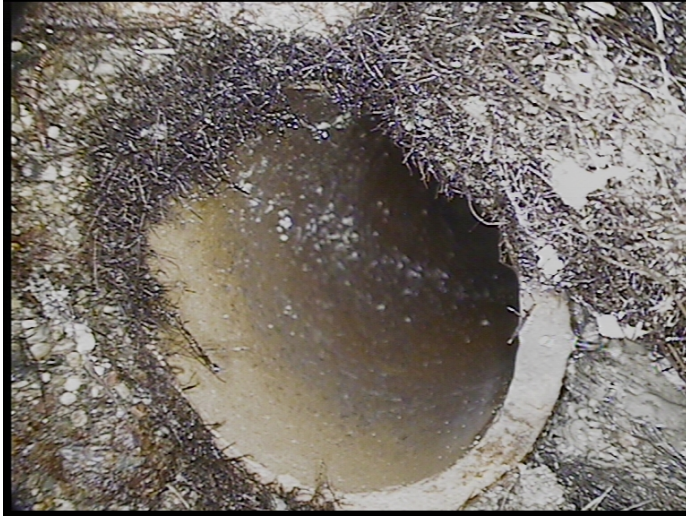
Code: **TBD**  
Description: **Tap Break-in Defective**

Distance (ft): **84.0**  
Structural Grade: **0**  
O&M Grade: **3**  
Clock Start/From: **2**  
Clock To:  
1st Value: **4.000**  
2nd Value:  
Value Percent:  
Continuous Index:  
Within 8" of Joint: **NO**  
Remarks: **Defective**

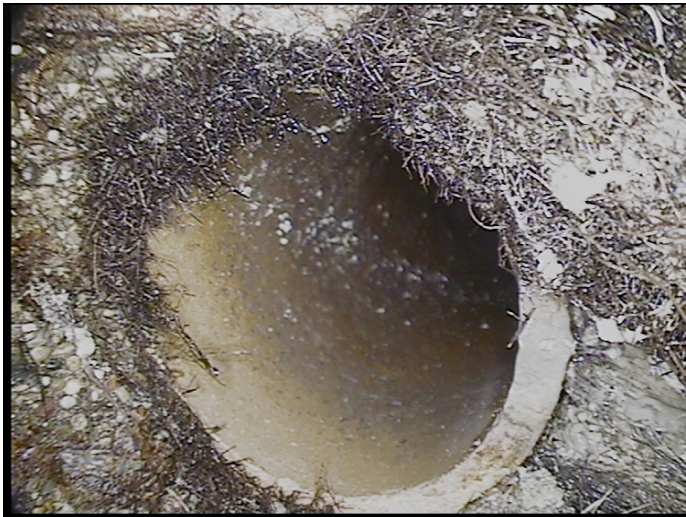
Code: **RML**  
Description: **Roots Medium Lateral**

Distance (ft): **84.0**  
Structural Grade: **0**  
O&M Grade: **3**  
Clock Start/From: **2**  
Clock To:  
1st Value:  
2nd Value:  
Value Percent: **5.000**  
Continuous Index:  
Within 8" of Joint: **NO**  
Remarks:

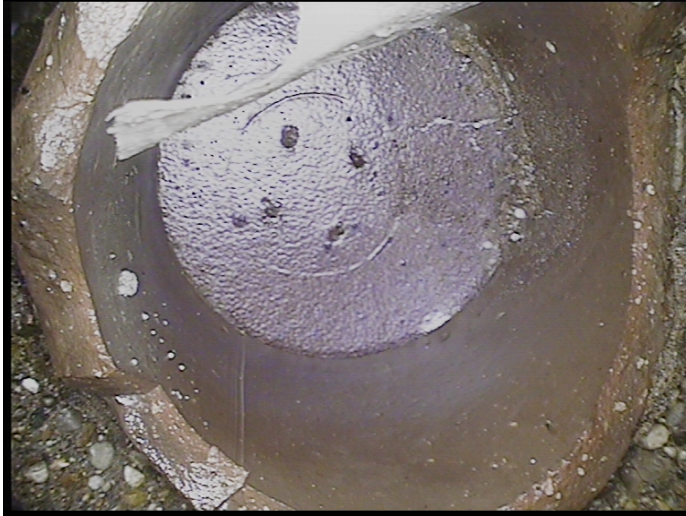
Code: **TBI**  
Description: **Tap Break-in Intruding**

Distance (ft): **96.3**  
Structural Grade: **0**  
O&M Grade: **2**  
Clock Start/From: **10**  
Clock To:  
1st Value: **4.000**  
2nd Value: **2.000**  
Value Percent:  
Continuous Index:  
Within 8" of Joint: **NO**  
Remarks:

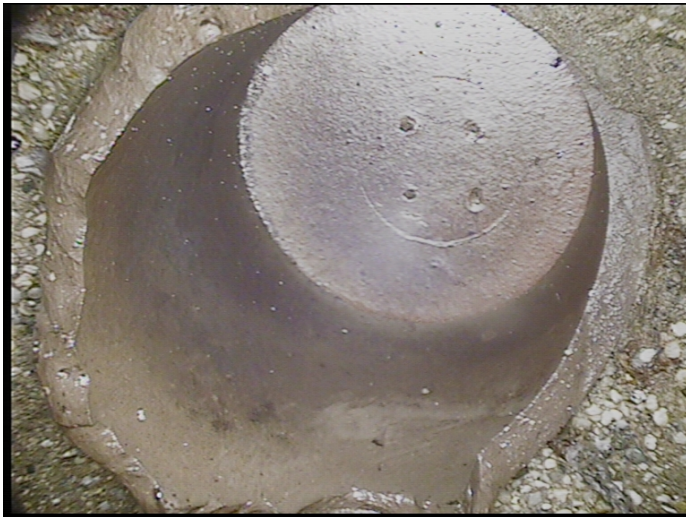
Code: **TBC**  
Description: **Tap Break-in Capped**

Distance (ft): **99.1**  
Structural Grade: **0**  
O&M Grade: **2**  
Clock Start/From: **2**  
Clock To:  
1st Value: **4.000**  
2nd Value:  
Value Percent:  
Continuous Index:  
Within 8" of Joint: **NO**  
Remarks:

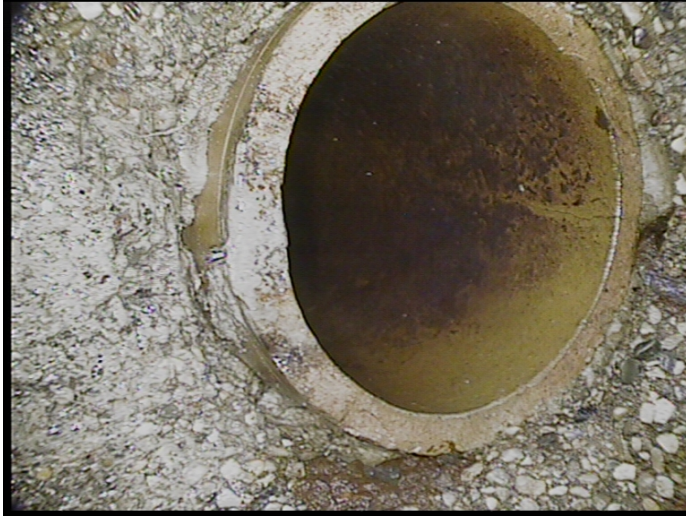
Code:	<b>TBA</b>
Description:	<b>Tap Break-in Active</b>
Distance (ft):	<b>106.3</b>
Structural Grade:	<b>0</b>
O&M Grade:	<b>0</b>
Clock Start/From:	<b>10</b>
Clock To:	
1st Value:	<b>4.000</b>
2nd Value:	
Value Percent:	
Continuous Index:	
Within 8" of Joint:	<b>NO</b>
Remarks:

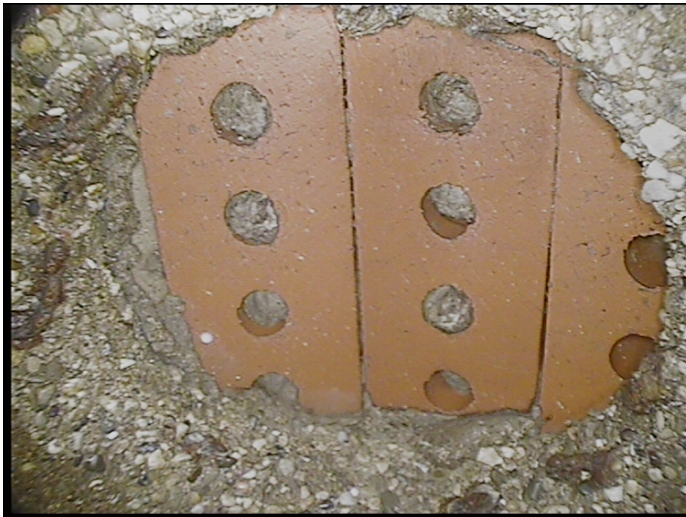
Code:	<b>TBC</b>
Description:	<b>Tap Break-in Capped</b>
Distance (ft):	<b>142.3</b>
Structural Grade:	<b>0</b>
O&M Grade:	<b>2</b>
Clock Start/From:	<b>2</b>
Clock To:	
1st Value:	<b>4.000</b>
2nd Value:	
Value Percent:	
Continuous Index:	
Within 8" of Joint:	<b>NO</b>
Remarks:

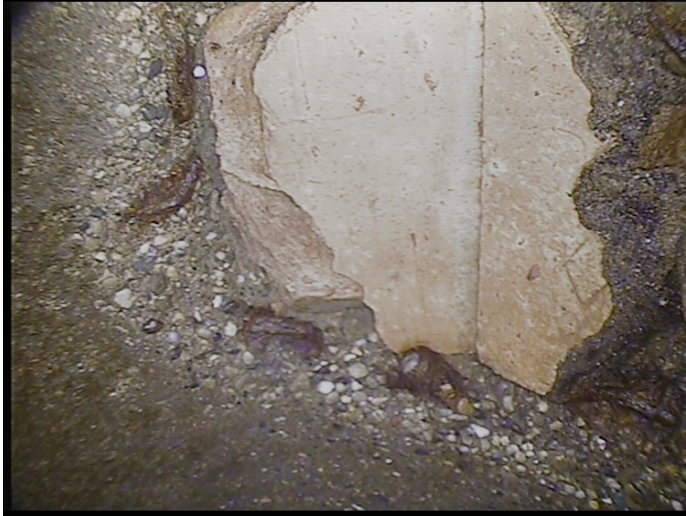
Code: **TBC**  
Description: **Tap Break-in Capped**

Distance (ft): **160.5**  
Structural Grade: **0**  
O&M Grade: **2**  
Clock Start/From: **2**  
Clock To:  
1st Value: **4.000**  
2nd Value:  
Value Percent:  
Continuous Index:  
Within 8" of Joint: **NO**  
Remarks:

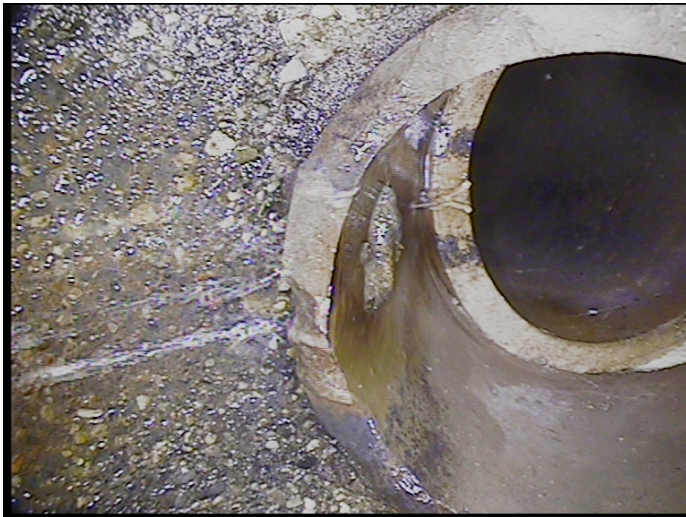
Code: **TBA**  
Description: **Tap Break-in Active**

Distance (ft): **166.8**  
Structural Grade: **0**  
O&M Grade: **0**  
Clock Start/From: **10**  
Clock To:  
1st Value: **4.000**  
2nd Value:  
Value Percent:  
Continuous Index:  
Within 8" of Joint: **NO**  
Remarks:

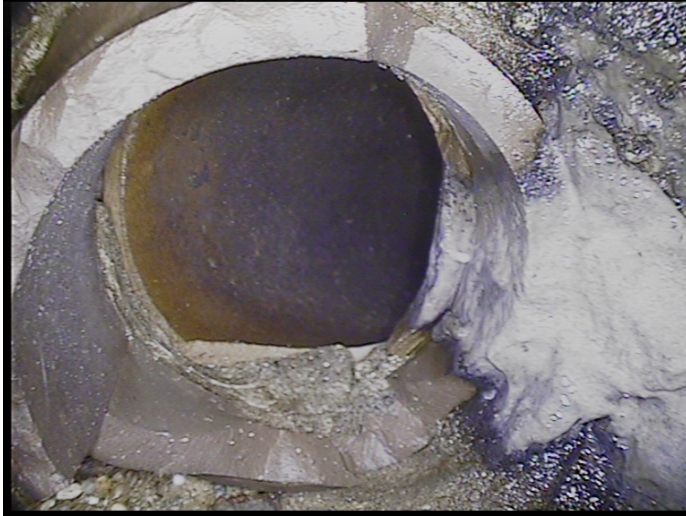
Code: **TB**  
Description: **Tap Break-in**

Distance (ft): **169.8**  
Structural Grade: **0**  
O&M Grade: **0**  
Clock Start/From: **2**  
Clock To:  
1st Value: **4.000**  
2nd Value:  
Value Percent:  
Continuous Index:  
Within 8" of Joint: **NO**  
Remarks:

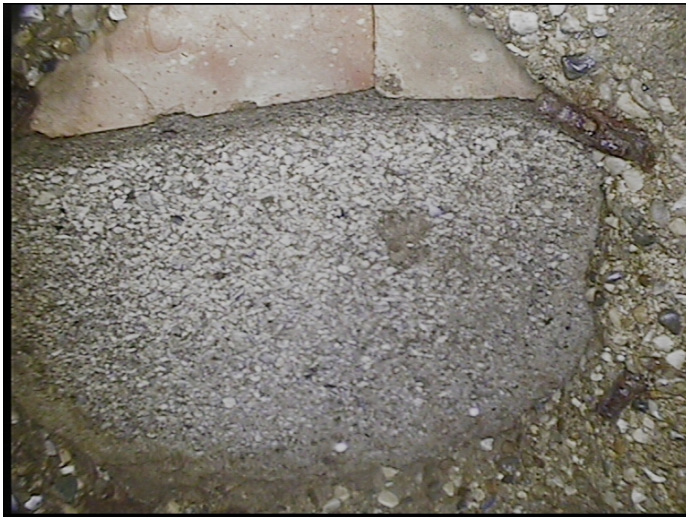
Code: **TBC**  
Description: **Tap Break-in Capped**

Distance (ft): **200.1**  
Structural Grade: **0**  
O&M Grade: **2**  
Clock Start/From: **10**  
Clock To:  
1st Value: **4.000**  
2nd Value:  
Value Percent:  
Continuous Index:  
Within 8" of Joint: **NO**  
Remarks:

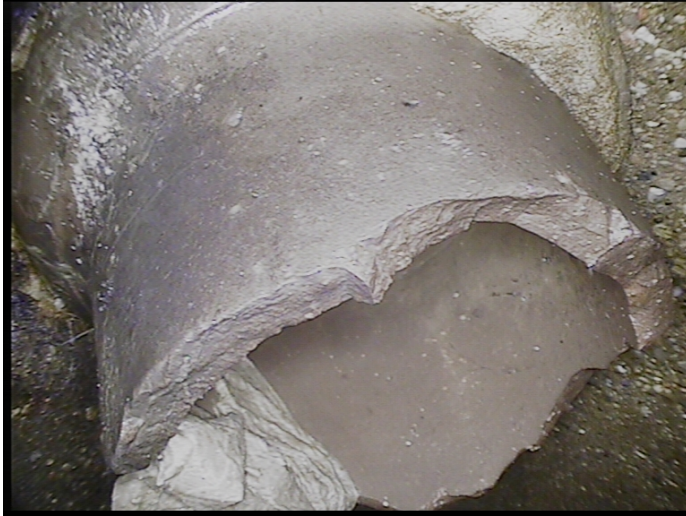
Code: **TBI**  
Description: **Tap Break-in Intruding**

Distance (ft): **230.0**  
Structural Grade: **0**  
O&M Grade: **2**  
Clock Start/From: **10**  
Clock To:  
1st Value: **4.000**  
2nd Value: **3.000**  
Value Percent:  
Continuous Index:  
Within 8" of Joint: **NO**  
Remarks:

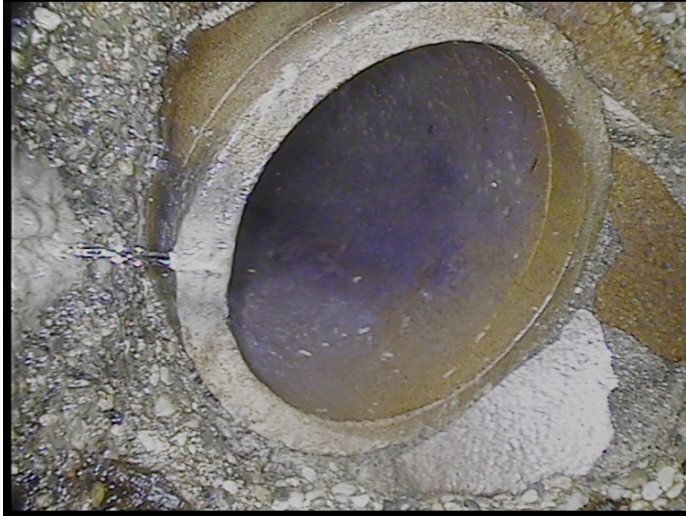
Code: **TBA**  
Description: **Tap Break-in Active**

Distance (ft): **253.0**  
Structural Grade: **0**  
O&M Grade: **0**  
Clock Start/From: **10**  
Clock To:  
1st Value: **4.000**  
2nd Value:  
Value Percent:  
Continuous Index:  
Within 8" of Joint: **NO**  
Remarks:

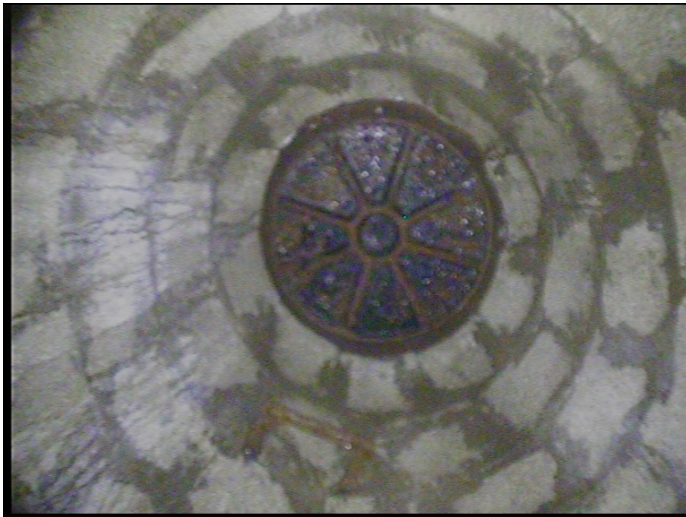
Code: **AMH**  
Description: **Manhole**

Distance (ft): **274.9**  
Structural Grade: **0**  
O&M Grade: **0**  
Clock Start/From:  
Clock To:  
1st Value:  
2nd Value:  
Value Percent:  
Continuous Index:  
Within 8" of Joint: **NO**  
Remarks: **M-505-004**
