Profile/Photo Observation Report

Date:	04/26/2018	Weather:		Coding:	PACP 6.0
Pipe Length (ft):		Owner:	City of Hobart	Pre Clean:	No Pre-Cleaning
P.O.#:	97	Surveyor:	M. Pielacha	PSR:	P-505-014-013
Customer:	City of Hobart	Clean Date:		Shape:	C

Street:	Birginia Street	Flow Control:	Not Controlled
City:	Hobart, IN	Year Renewed:	
Location:	Light Highway	Tape/Media #:	DEP 97
Purpose:	Routine Assessment	Dia/Height:	18"
Use:	Sanitary	Material:	CP
Drain Area:		Lining:	
Category:	NA		
Comment:	YES501824 Submittal 2		
Location Details:		Direction of Survey:	Downstream
US MH:	M-505-014	DS MH:	M-505-013
		Total Length Surveyed (ft):	280.9

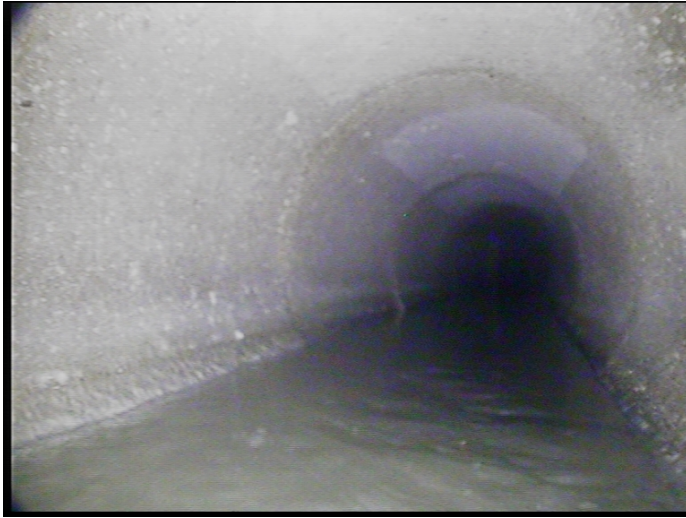
Code: **MWL**
Description: **Water Level**

Distance (ft): **.0**
Structural Grade: **0**
O&M Grade: **0**
Clock Start/From:
Clock To:
1st Value:
2nd Value:
Value Percent: **10.000**
Continuous Index:
Within 8" of Joint: **NO**
Remarks:

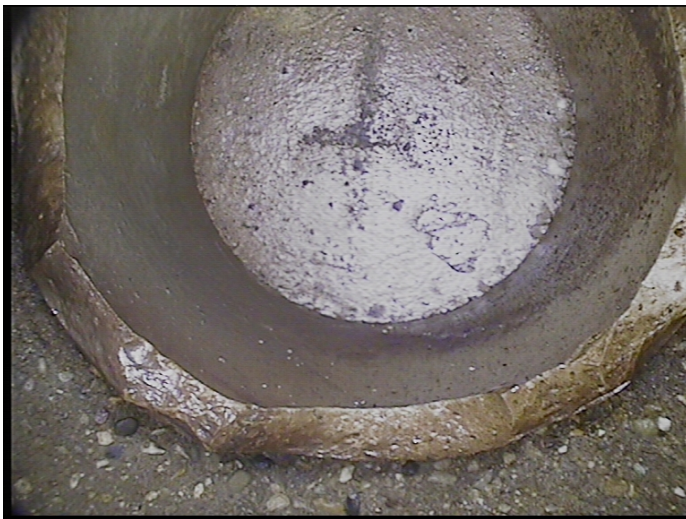
Code: **TBI**
Description: **Tap Break-in Intruding**

Distance (ft): **26.4**
Structural Grade: **0**
O&M Grade: **2**
Clock Start/From: **10**
Clock To:
1st Value: **4.000**
2nd Value: **2.000**
Value Percent:
Continuous Index:
Within 8" of Joint: **NO**
Remarks:

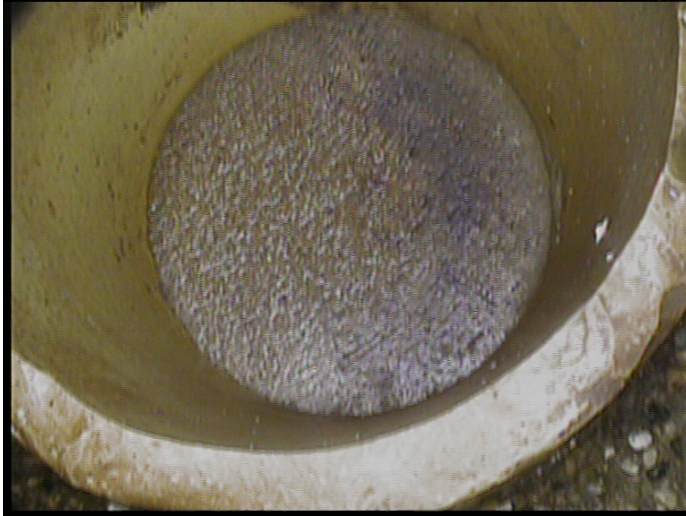
Code: **TBI**
Description: **Tap Break-in Intruding**

Distance (ft): **29.4**
Structural Grade: **0**
O&M Grade: **2**
Clock Start/From: **2**
Clock To:
1st Value: **4.000**
2nd Value: **2.000**
Value Percent:
Continuous Index:
Within 8" of Joint: **NO**
Remarks:

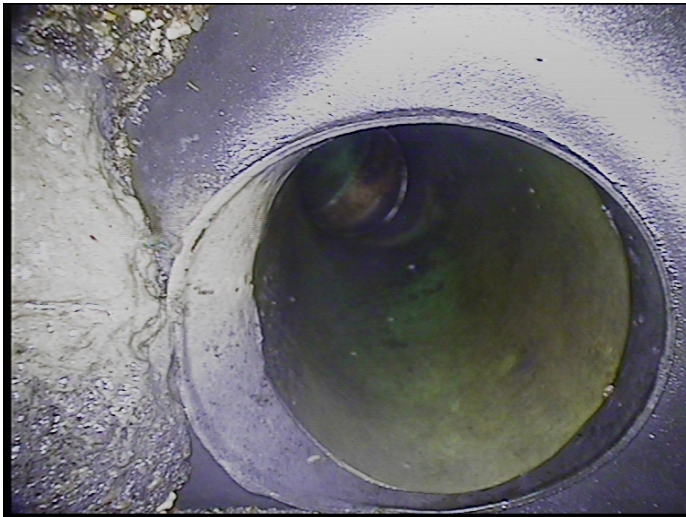
Code: **TBA**
Description: **Tap Break-in Active**

Distance (ft): **78.9**
Structural Grade: **0**
O&M Grade: **0**
Clock Start/From: **11**
Clock To:
1st Value: **4.000**
2nd Value:
Value Percent:
Continuous Index:
Within 8" of Joint: **NO**
Remarks:

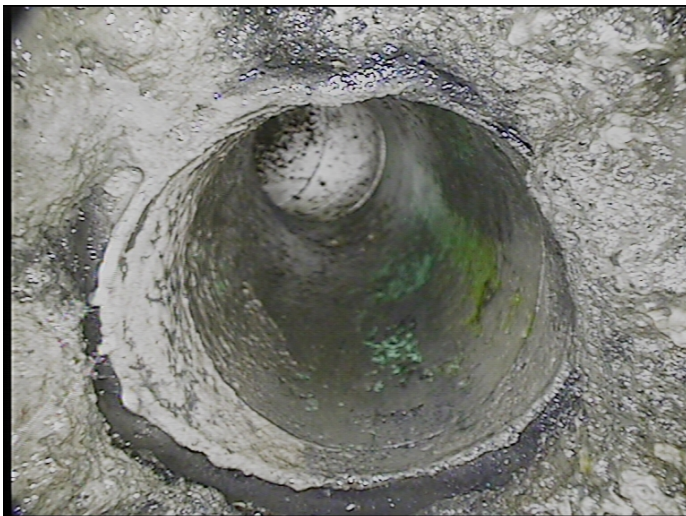
Code: **TBA**
Description: **Tap Break-in Active**

Distance (ft): **82.5**
Structural Grade: **0**
O&M Grade: **0**
Clock Start/From: **10**
Clock To:
1st Value: **4.000**
2nd Value:
Value Percent:
Continuous Index:
Within 8" of Joint: **NO**
Remarks:

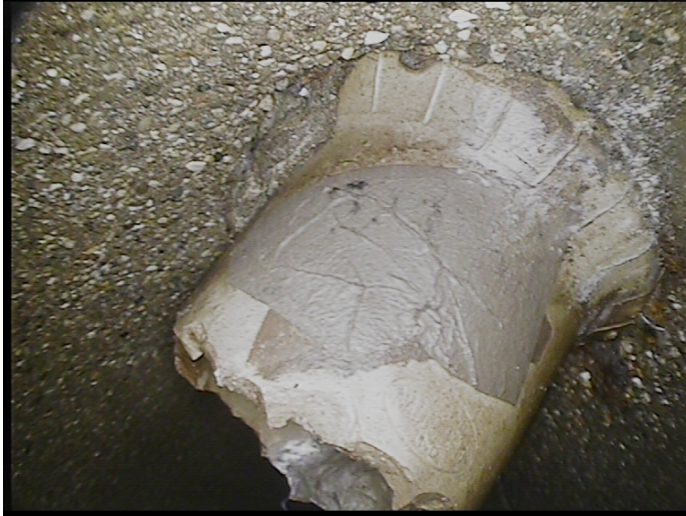
Code: **TBI**
Description: **Tap Break-in Intruding**

Distance (ft): **106.7**
Structural Grade: **0**
O&M Grade: **2**
Clock Start/From: **2**
Clock To:
1st Value: **4.000**
2nd Value: **3.000**
Value Percent:
Continuous Index:
Within 8" of Joint: **NO**
Remarks:

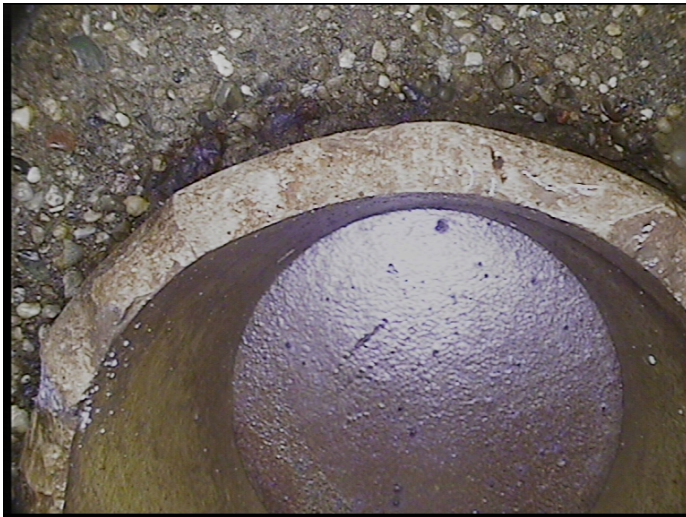
Code: **TBI**
Description: **Tap Break-in Intruding**

Distance (ft): **110.9**
Structural Grade: **0**
O&M Grade: **2**
Clock Start/From: **10**
Clock To:
1st Value: **4.000**
2nd Value: **2.000**
Value Percent:
Continuous Index:
Within 8" of Joint: **NO**
Remarks:

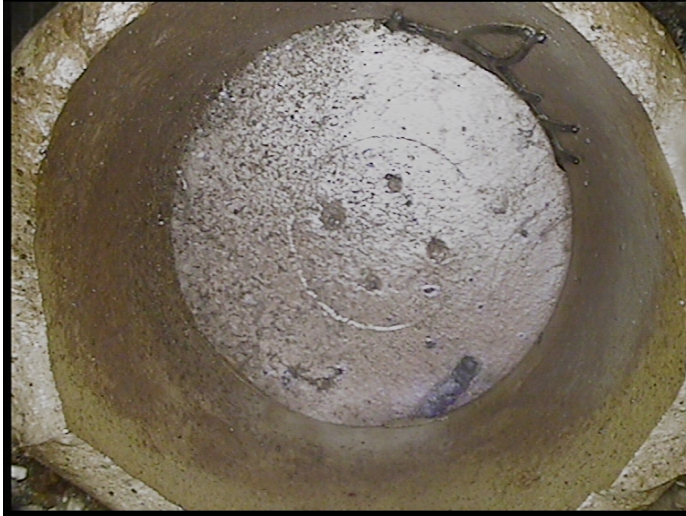
Code: **TBC**
Description: **Tap Break-in Capped**

Distance (ft): **174.9**
Structural Grade: **0**
O&M Grade: **2**
Clock Start/From: **2**
Clock To:
1st Value: **4.000**
2nd Value:
Value Percent:
Continuous Index:
Within 8" of Joint: **NO**
Remarks:

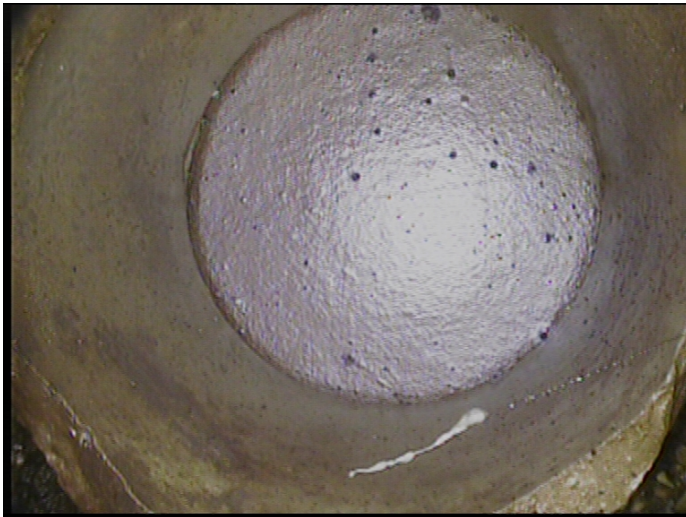
Code: **TBC**
Description: **Tap Break-in Capped**

Distance (ft): **177.9**
Structural Grade: **0**
O&M Grade: **2**
Clock Start/From: **10**
Clock To:
1st Value: **4.000**
2nd Value:
Value Percent:
Continuous Index:
Within 8" of Joint: **NO**
Remarks:

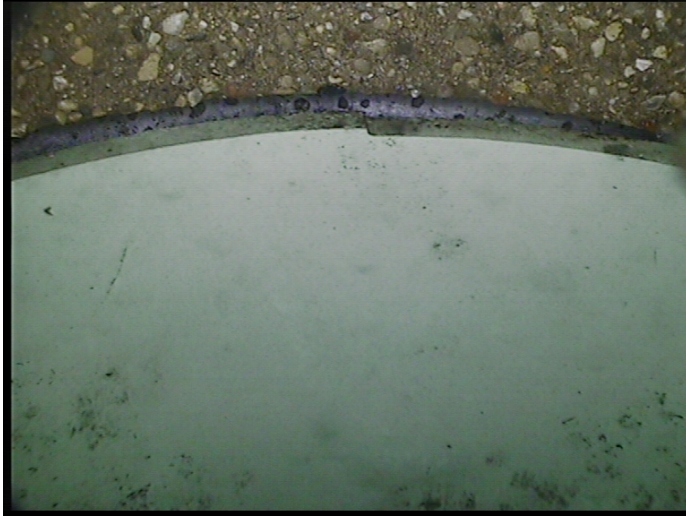
Code: **MMC**
Description: **Material Change**

Distance (ft): **178.6**
Structural Grade: **0**
O&M Grade: **0**
Clock Start/From:
Clock To:
1st Value:
2nd Value:
Value Percent:
Continuous Index:
Within 8" of Joint: **NO**
Remarks: **pvc**

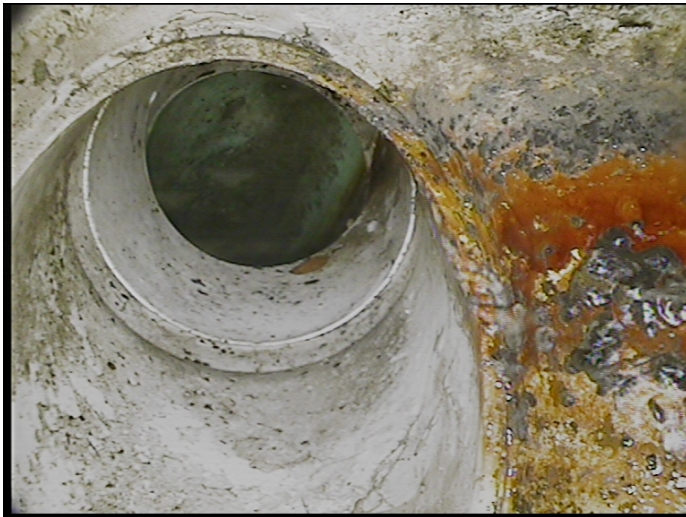
Code: **TBA**
Description: **Tap Break-in Active**

Distance (ft): **181.6**
Structural Grade: **0**
O&M Grade: **0**
Clock Start/From: **2**
Clock To:
1st Value: **4.000**
2nd Value:
Value Percent:
Continuous Index:
Within 8" of Joint: **NO**
Remarks:

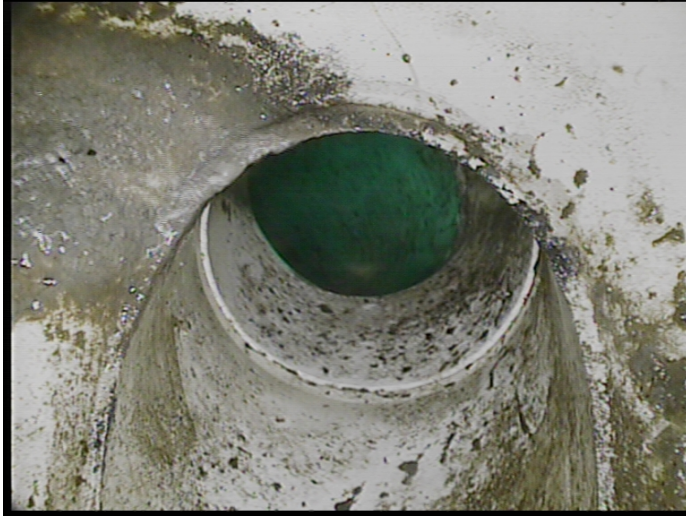
Code: **TBA**
Description: **Tap Break-in Active**

Distance (ft): **184.2**
Structural Grade: **0**
O&M Grade: **0**
Clock Start/From: **10**
Clock To:
1st Value: **4.000**
2nd Value:
Value Percent:
Continuous Index:
Within 8" of Joint: **NO**
Remarks:

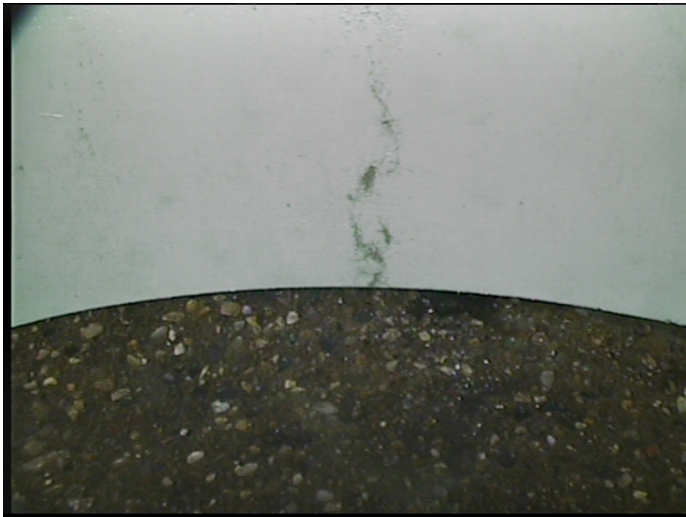
Code: **MMC**
Description: **Material Change**

Distance (ft): **185.9**
Structural Grade: **0**
O&M Grade: **0**
Clock Start/From:
Clock To:
1st Value:
2nd Value:
Value Percent:
Continuous Index:
Within 8" of Joint: **NO**
Remarks: **cp**

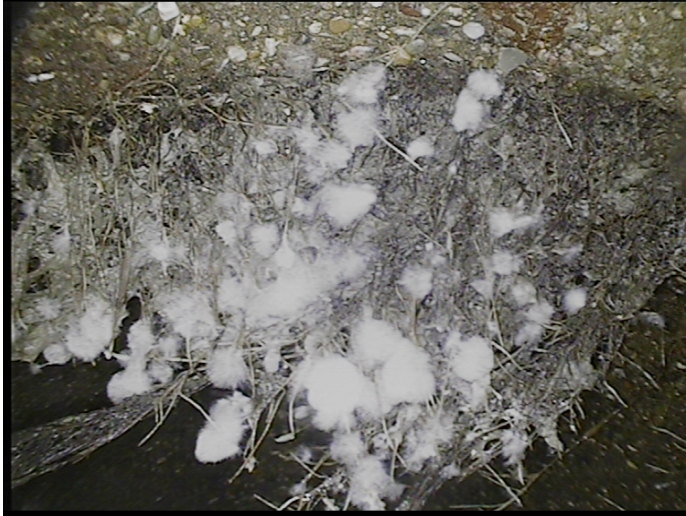
Code: **RMJ**
Description: **Roots Medium Joint**

Distance (ft): **188.3**
Structural Grade: **0**
O&M Grade: **3**
Clock Start/From: **8**
Clock To: **4**
1st Value:
2nd Value:
Value Percent: **5.000**
Continuous Index: **S01**
Within 8" of Joint: **YES**
Remarks:

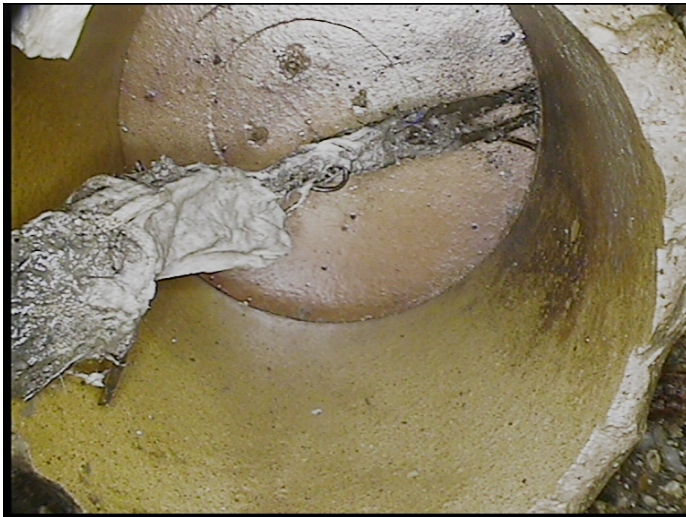
Code: **TBI**
Description: **Tap Break-in Intruding**

Distance (ft): **241.4**
Structural Grade: **0**
O&M Grade: **2**
Clock Start/From: **10**
Clock To:
1st Value: **4.000**
2nd Value: **2.000**
Value Percent:
Continuous Index:
Within 8" of Joint: **NO**
Remarks:

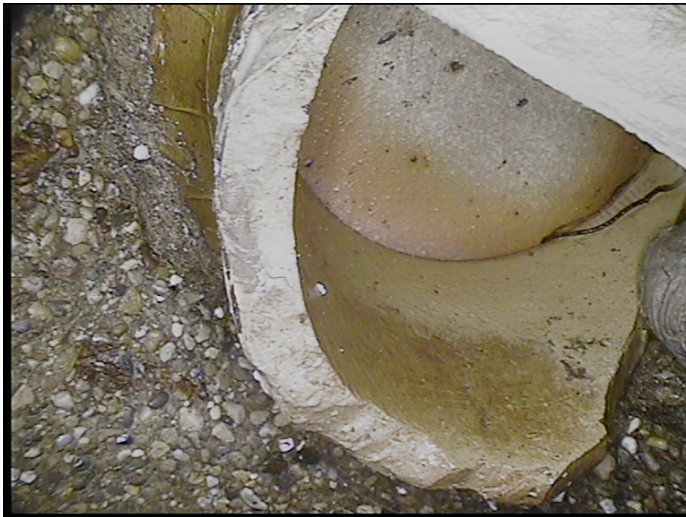
Code: **TBI**
Description: **Tap Break-in Intruding**

Distance (ft): **244.4**
Structural Grade: **0**
O&M Grade: **2**
Clock Start/From: **2**
Clock To:
1st Value: **4.000**
2nd Value: **2.000**
Value Percent:
Continuous Index:
Within 8" of Joint: **NO**
Remarks:

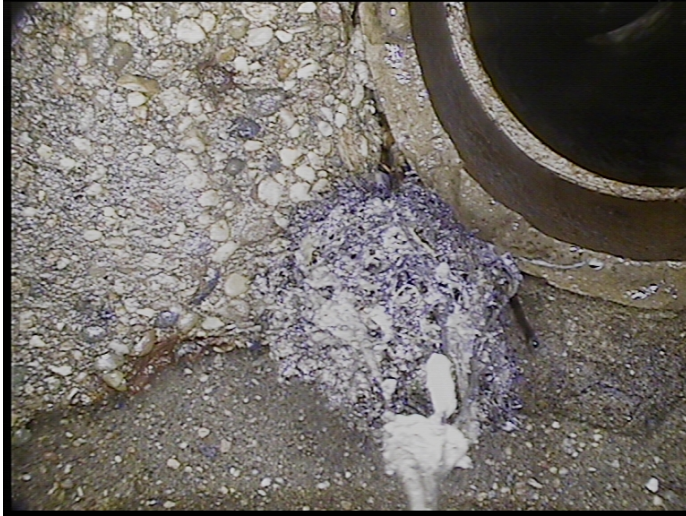
Code: **TBD**
Description: **Tap Break-in Defective**

Distance (ft): **249.1**
Structural Grade: **0**
O&M Grade: **3**
Clock Start/From: **2**
Clock To:
1st Value: **4.000**
2nd Value:
Value Percent:
Continuous Index:
Within 8" of Joint: **NO**
Remarks: **roots**

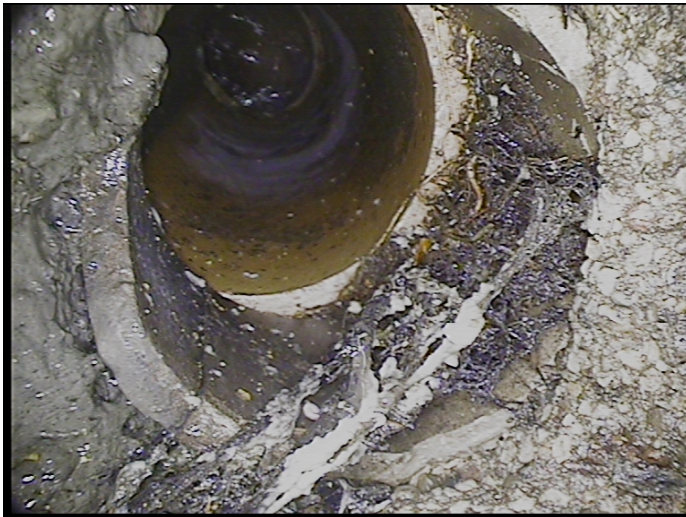
Code: **TBD**
Description: **Tap Break-in Defective**

Distance (ft): **251.8**
Structural Grade: **0**
O&M Grade: **3**
Clock Start/From: **10**
Clock To:
1st Value: **4.000**
2nd Value:
Value Percent:
Continuous Index:
Within 8" of Joint: **NO**
Remarks: **roots**

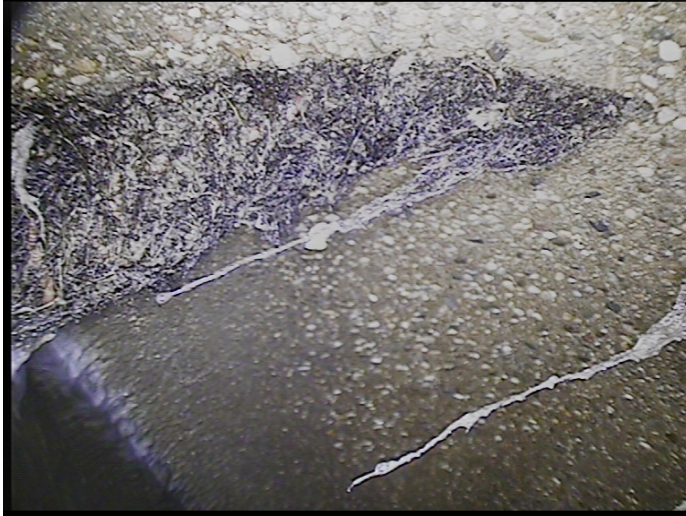
Code:	RMJ
Description:	Roots Medium Joint
Distance (ft):	258.1
Structural Grade:	0
O&M Grade:	3
Clock Start/From:	8
Clock To:	1
1st Value:	
2nd Value:	
Value Percent:	5.000
Continuous Index:	
Within 8" of Joint:	YES
Remarks:

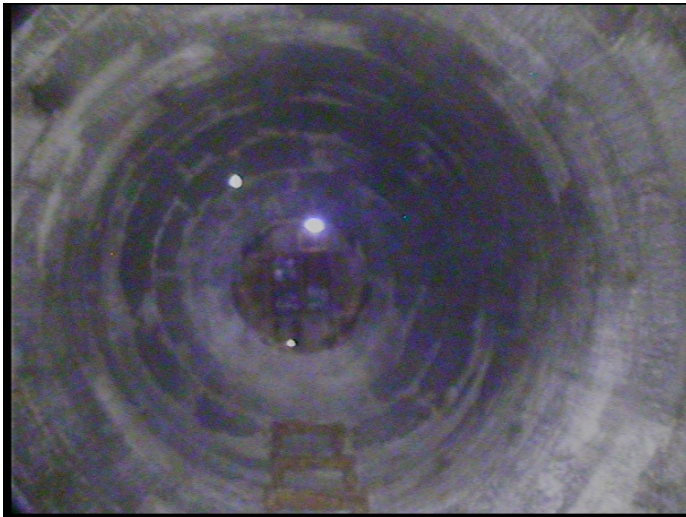
Code:	AMH
Description:	Manhole
Distance (ft):	280.9
Structural Grade:	0
O&M Grade:	0
Clock Start/From:	
Clock To:	
1st Value:	
2nd Value:	
Value Percent:	
Continuous Index:	
Within 8" of Joint:	NO
Remarks:	M-505-013
