Profile/Photo Observation Report

Street:	Virginia Street	Flow Control:	Not Controlled
City:	Hobart, IN	Year Renewed:	
Location:	Light Highway	Tape/Media #:	DEP 96
Purpose:	Routine Assessment	Dia/Height:	18"
Use:	Sanitary	Material:	CP
Drain Area:		Lining:	
Category:	NA		
Comment:	YES501824 Submittal 2		
Location Details:		Direction of Survey:	Upstream
US MH:	M-505-015	DS MH:	M-505-014
		Total Length Surveyed (ft):	156.3

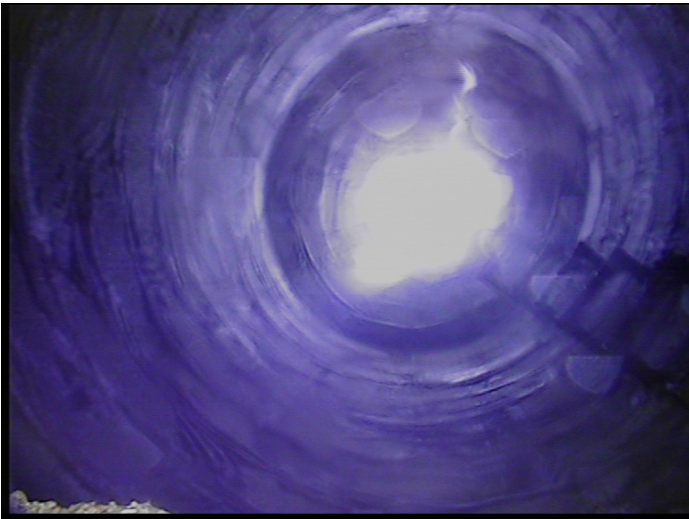
AMH

Manhole

.0

M-505-014

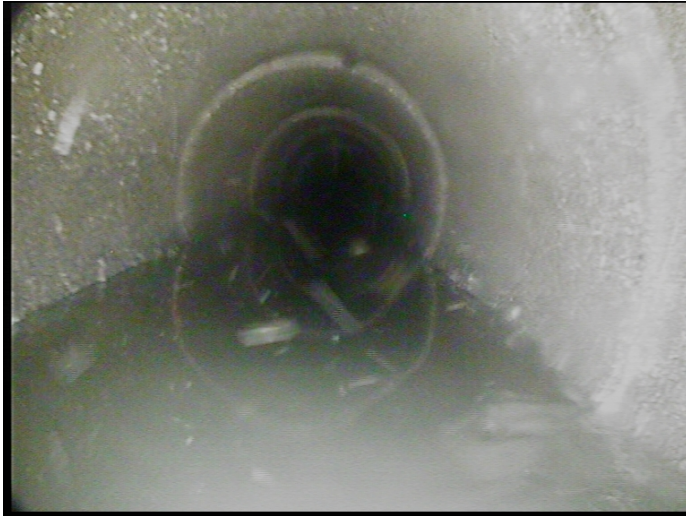
Code: **MWL**
Description: **Water Level**

Distance (ft): **.0**
Structural Grade: **0**
O&M Grade: **0**
Clock Start/From:
Clock To:
1st Value:
2nd Value:
Value Percent: **15.000**
Continuous Index:
Within 8" of Joint: **NO**
Remarks:

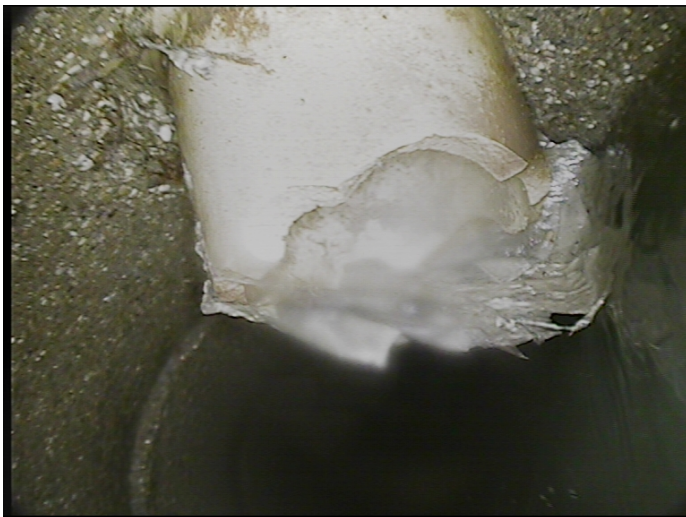
Code: **TBI**
Description: **Tap Break-in Intruding**

Distance (ft): **49.6**
Structural Grade: **0**
O&M Grade: **2**
Clock Start/From: **3**
Clock To:
1st Value: **4.000**
2nd Value: **4.000**
Value Percent:
Continuous Index:
Within 8" of Joint: **NO**
Remarks:

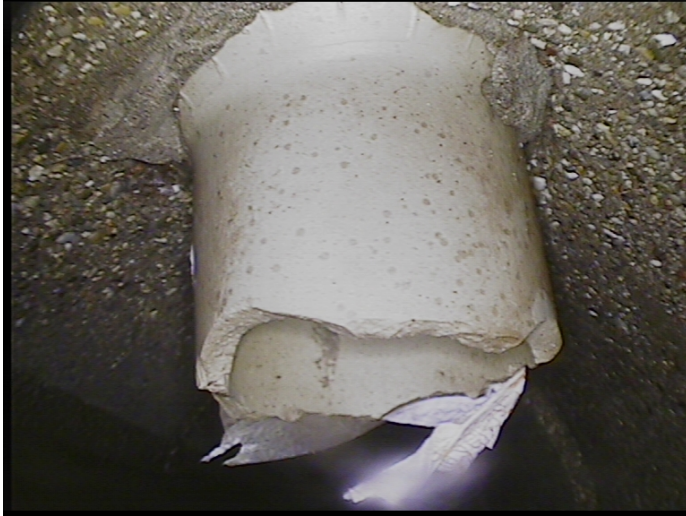
Code:	TBI
Description:	Tap Break-in Intruding
Distance (ft):	83.0
Structural Grade:	0
O&M Grade:	2
Clock Start/From:	10
Clock To:	
1st Value:	4.000
2nd Value:	4.000
Value Percent:	
Continuous Index:	
Within 8" of Joint:	NO
Remarks:

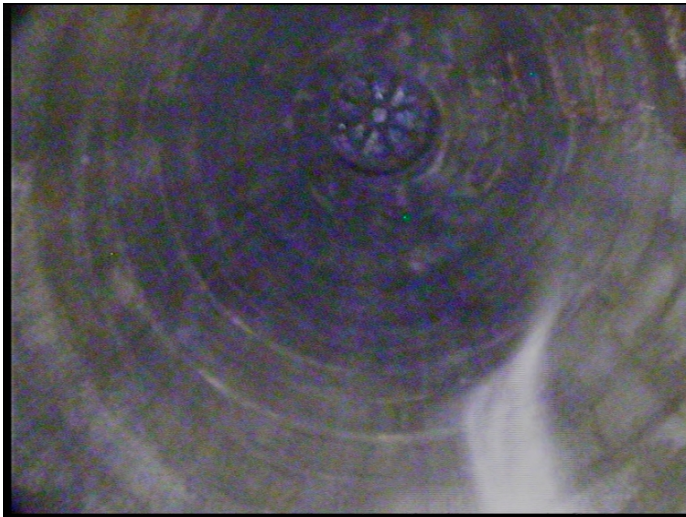
Code:	AMH
Description:	Manhole
Distance (ft):	156.3
Structural Grade:	0
O&M Grade:	0
Clock Start/From:	
Clock To:	
1st Value:	
2nd Value:	
Value Percent:	
Continuous Index:	
Within 8" of Joint:	NO
Remarks:	M-505-015
