## Profile/Photo Observation Report

Date:	<b>04/26/2018</b>	Weather:		Coding:	<b>PACP 6.0</b>
Pipe Length (ft):		Owner:	<b>City of Hobart</b>	Pre Clean:	<b>No Pre-Cleaning</b>
P.O.#:	<b>95</b>	Surveyor:	<b>M. Pielacha</b>	PSR:	<b>P-505-016-015</b>
Customer:	<b>City of Hobart</b>	Clean Date:		Shape:	<b>C</b>

Street:	<b>3rd Street</b>	Flow Control:	<b>Not Controlled</b>
City:	<b>Hobart, IN</b>	Year Renewed:	
Location:	<b>Light Highway</b>	Tape/Media #:	<b>DEP 95</b>
Purpose:	<b>Routine Assessment</b>	Dia/Height:	<b>18"</b>
Use:	<b>Sanitary</b>	Material:	<b>CP</b>
Drain Area:		Lining:	
Category:	<b>NA</b>		
Comment:	<b>YES501824 Submittal 2</b>		
Location Details:		Direction of Survey:	<b>Downstream</b>
US MH:	<b>M-505-016</b>	DS MH:	<b>M-505-015</b>
		Total Length Surveyed (ft):	<b>310.9</b>

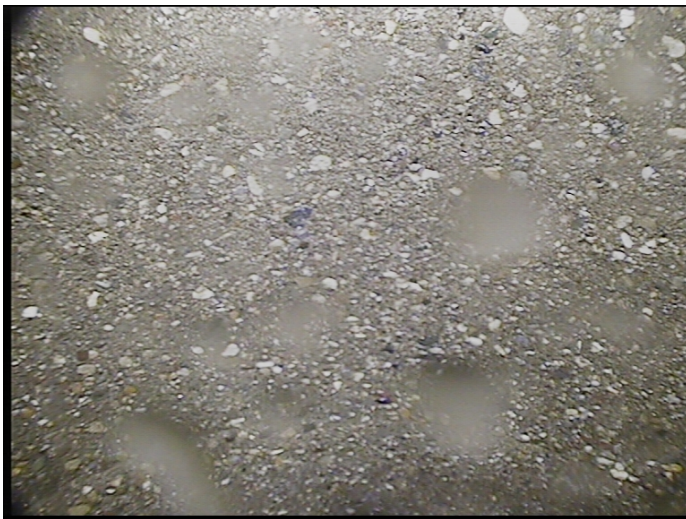
Code: **SAV**  
Description: **Surface Aggregate Visible**

Distance (ft): **1.3**  
Structural Grade: **3**  
O&M Grade: **0**  
Clock Start/From: **8**  
Clock To: **4**  
1st Value:  
2nd Value:  
Value Percent:  
Continuous Index: **S01**  
Within 8" of Joint: **YES**  
Remarks:

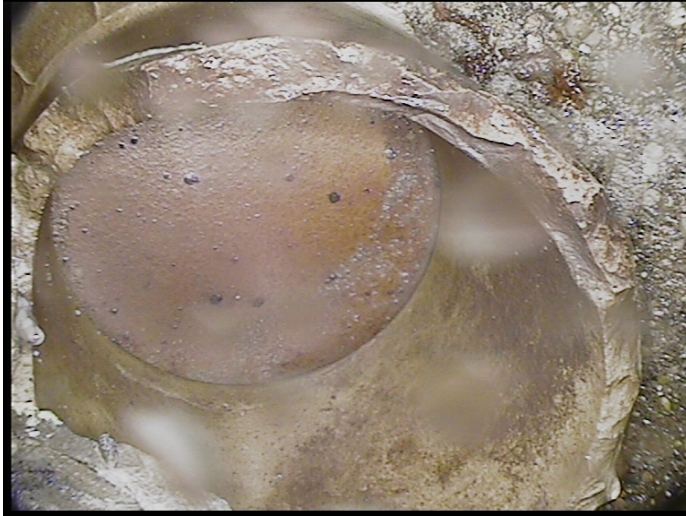
Code: **TBC**  
Description: **Tap Break-in Capped**

Distance (ft): **21.4**  
Structural Grade: **0**  
O&M Grade: **2**  
Clock Start/From: **2**  
Clock To:  
1st Value: **4.000**  
2nd Value:  
Value Percent:  
Continuous Index:  
Within 8" of Joint: **NO**  
Remarks:

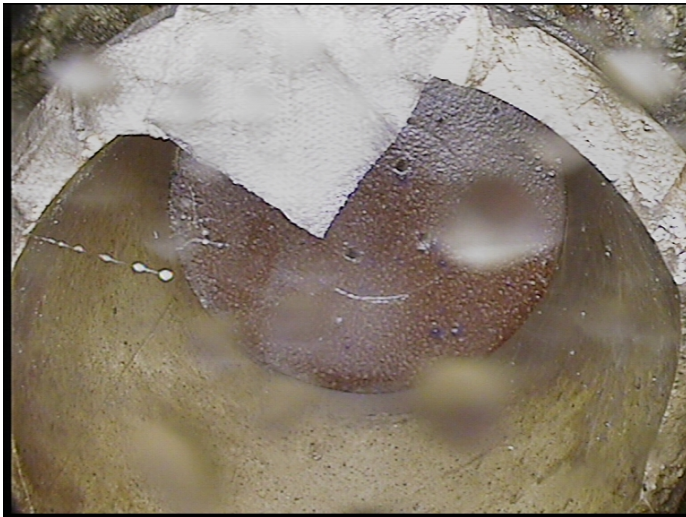
Code: **TFC**  
Description: **Tap Factory Capped**

Distance (ft): **61.0**  
Structural Grade: **0**  
O&M Grade: **0**  
Clock Start/From: **2**  
Clock To:  
1st Value: **4.000**  
2nd Value:  
Value Percent:  
Continuous Index:  
Within 8" of Joint: **NO**  
Remarks:

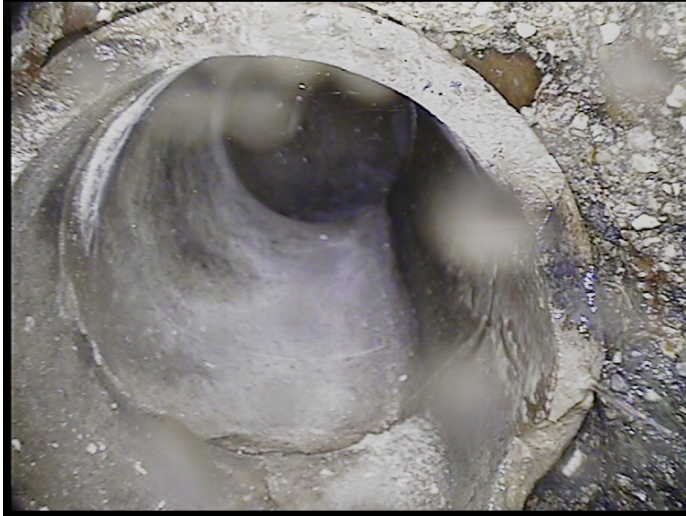
Code: **TBA**  
Description: **Tap Break-in Active**

Distance (ft): **82.8**  
Structural Grade: **0**  
O&M Grade: **0**  
Clock Start/From: **2**  
Clock To:  
1st Value: **4.000**  
2nd Value:  
Value Percent:  
Continuous Index:  
Within 8" of Joint: **NO**  
Remarks:

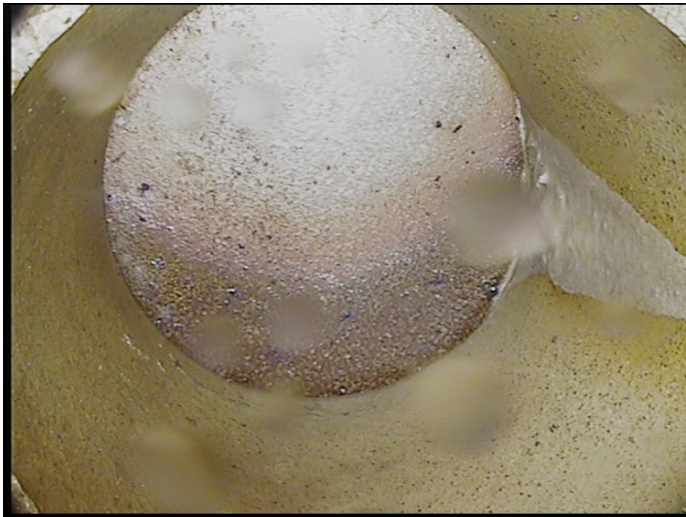
Code: **TBC**  
Description: **Tap Break-in Capped**

Distance (ft): **182.2**  
Structural Grade: **0**  
O&M Grade: **2**  
Clock Start/From: **2**  
Clock To:  
1st Value: **4.000**  
2nd Value:  
Value Percent:  
Continuous Index:  
Within 8" of Joint: **NO**  
Remarks:

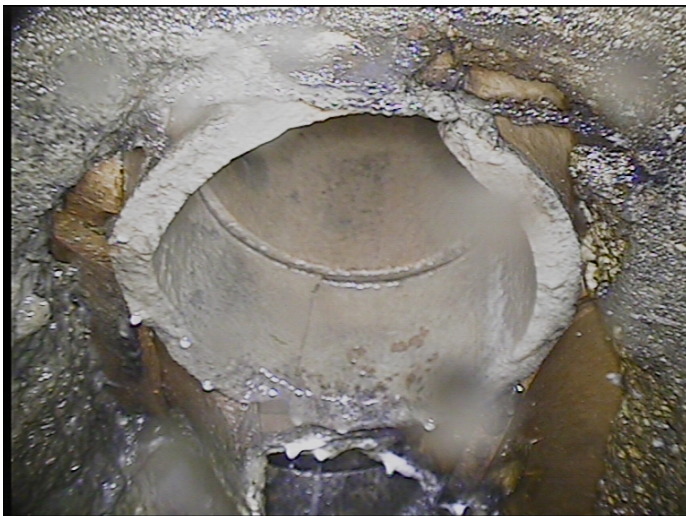
Code: **TBA**  
Description: **Tap Break-in Active**

Distance (ft): **230.1**  
Structural Grade: **0**  
O&M Grade: **0**  
Clock Start/From: **12**  
Clock To:  
1st Value: **6.000**  
2nd Value:  
Value Percent:  
Continuous Index:  
Within 8" of Joint: **NO**  
Remarks:
