Profile/Photo Observation Report

Street:	S CALIFORNIA ST	Flow Control:	Not Controlled
City:	Hobart, IN	Year Renewed:	
Location:	Other	Tape/Media #:	
Purpose:	Not Known	Dia/Height:	12"
Use:	Sanitary	Material:	VCP
Drain Area:	NA	Lining:	Cured in Place
Category:	NA		
Comment:	Flow direction wrong.

Location Details:		Direction of Survey:	Upstream
US MH:	M-505-036	DS MH:	M-505-035
		Total Length Surveyed (ft):	35.8

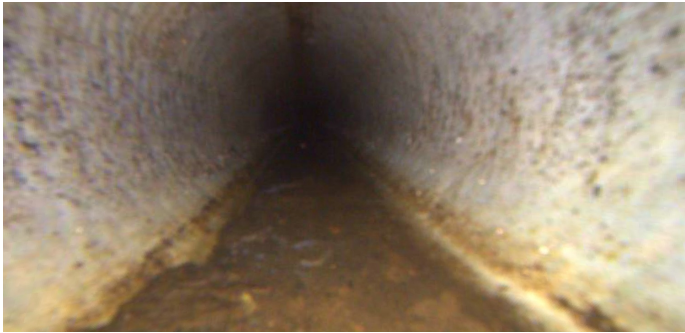
Code:	MWL
Description:	Water Level

Distance (ft):	.0
Structural Grade:	0
O&M Grade:	0
Clock Start/From:	
Clock To:	
1st Value:	
2nd Value:	
Value Percent:	5.000
Continuous Index:	
Within 8" of Joint:	NO
Remarks:

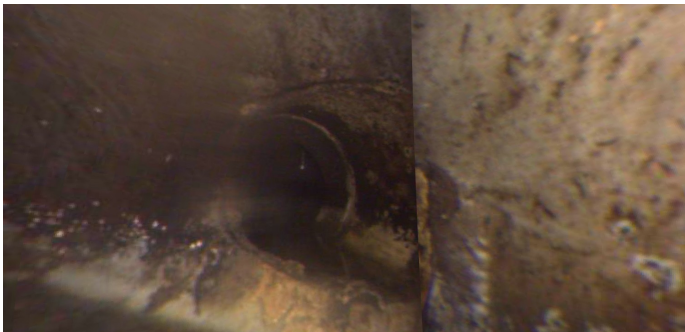
Code:	TB
Description:	Tap Break-in

Distance (ft):	9.8
Structural Grade:	0
O&M Grade:	0
Clock Start/From:	9
Clock To:	
1st Value:	4.000
2nd Value:	
Value Percent:	
Continuous Index:	
Within 8" of Joint:	
Remarks:

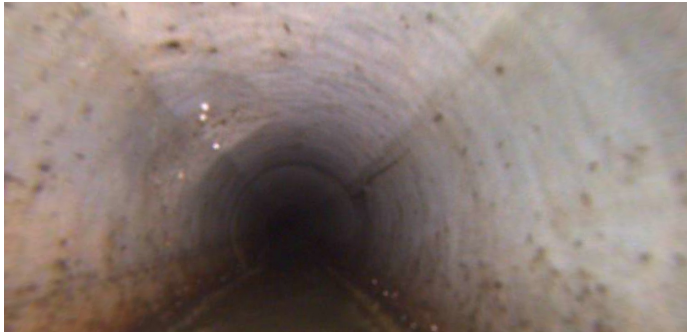
Code:	LFAC
Description:	Lining Failure Abandoned Connection
Distance (ft):	22.0
Structural Grade:	0
O&M Grade:	0
Clock Start/From:	10
Clock To:	
1st Value:	
2nd Value:	
Value Percent:	
Continuous Index:	
Within 8" of Joint:	NO
Remarks:

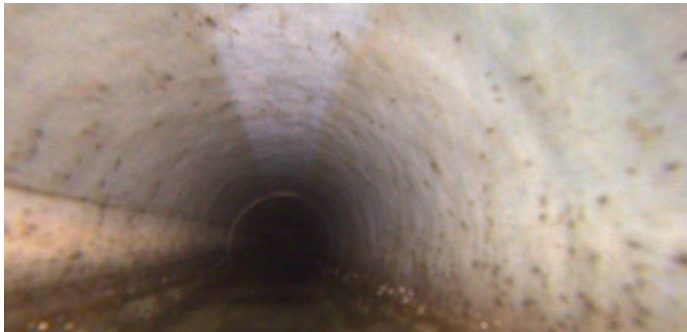
Code:	MSA
Description:	Abandoned Survey
Distance (ft):	35.8
Structural Grade:	0
O&M Grade:	0
Clock Start/From:	
Clock To:	
1st Value:	
2nd Value:	
Value Percent:	
Continuous Index:	
Within 8" of Joint:	NO
Remarks:	UNKNOWN
