Profile/Photo Observation Report

Street:	S CALIFORNIA ST	Flow Control:	Not Controlled
City:	Hobart, IN	Year Renewed:	
Location:	Other	Tape/Media #:	
Purpose:	Not Known	Dia/Height:	12"
Use:	Sanitary	Material:	VCP
Drain Area:	NA	Lining:	Cured in Place
Category:	NA		
Comment:	Flow direction wrong. Reverse setup.		
Location Details:		Direction of Survey:	Downstream
US MH:	M-505-036	DS MH:	M-505-035
		Total Length Surveyed (ft):	36.2

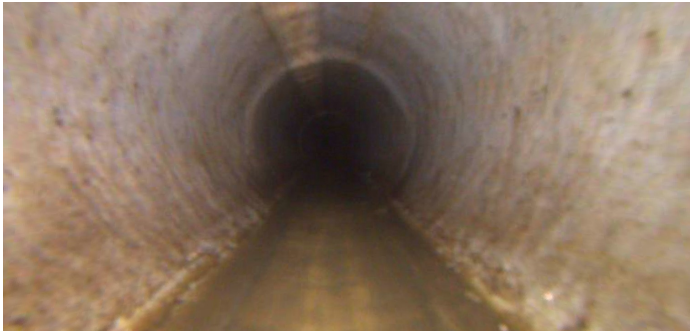
Code: AMH

Description: Manhole

Distance (ft): .0

Remarks: M-505-036

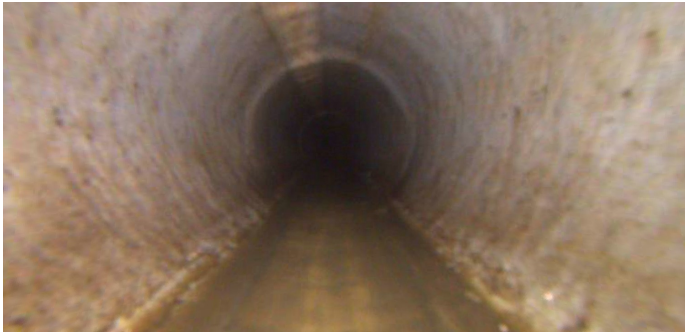
Code:	MWL
Description:	Water Level

Distance (ft):	.0
Structural Grade:	0
O&M Grade:	0
Clock Start/From:	
Clock To:	
1st Value:	
2nd Value:	
Value Percent:	5.000
Continuous Index:	
Within 8" of Joint:	NO
Remarks:

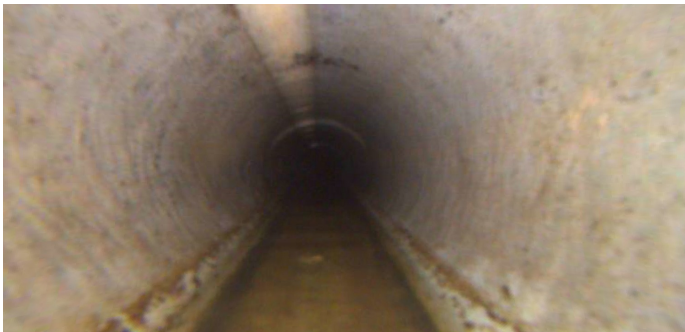
Code:	MSA
Description:	Abandoned Survey

Distance (ft):	36.2
Structural Grade:	0
O&M Grade:	0
Clock Start/From:	
Clock To:	
1st Value:	
2nd Value:	
Value Percent:	
Continuous Index:	
Within 8" of Joint:	NO
Remarks:	unknown
