Profile/Photo Observation Report

Street:	W 2ND ST & S CALIFORNIA ST	Flow Control:	Not Controlled
City:	Hobart, IN	Year Renewed:	
Location:	Light Highway	Tape/Media #:	
Purpose:	Not Known	Dia/Height:	12"
Use:	Sanitary	Material:	PVC
Drain Area:	NA	Lining:	Cured in Place
Category:	NA		
Comment:

Location Details:		Direction of Survey:	Downstream
US MH:	M-505-037	DS MH:	M-505-038
		Total Length Surveyed (ft):	240.8

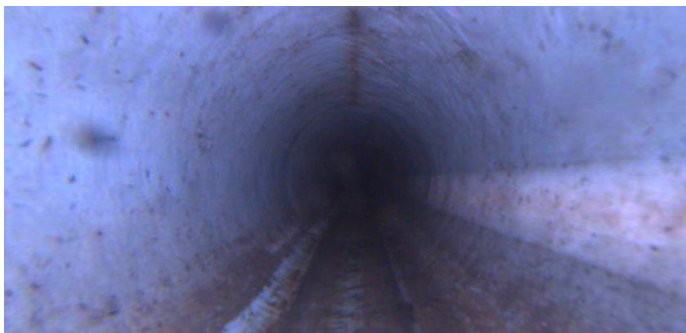
Code: **AMH**
Description: **Manhole**

Distance (ft): **.0**
Structural Grade: **0**
O&M Grade: **0**
Clock Start/From:
Clock To:
1st Value:
2nd Value:
Value Percent:
Continuous Index:
Within 8" of Joint: **NO**
Remarks: **M-505-037**

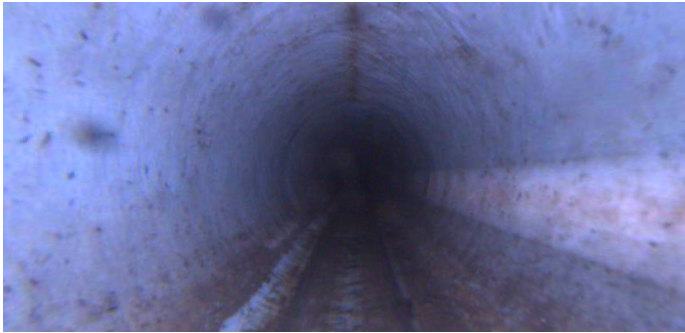
Code:	MWL
Description:	Water Level

Distance (ft):	.0
Structural Grade:	0
O&M Grade:	0
Clock Start/From:	
Clock To:	
1st Value:	
2nd Value:	
Value Percent:	5.000
Continuous Index:	
Within 8" of Joint:	NO
Remarks:

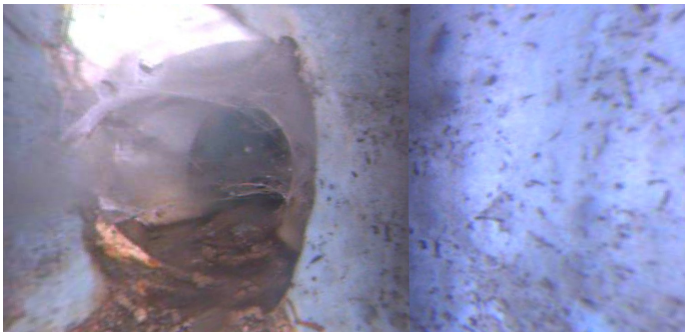
Code:	TB
Description:	Tap Break-in

Distance (ft):	19.8
Structural Grade:	0
O&M Grade:	0
Clock Start/From:	9
Clock To:	
1st Value:	4.000
2nd Value:	
Value Percent:	
Continuous Index:	
Within 8" of Joint:	
Remarks:

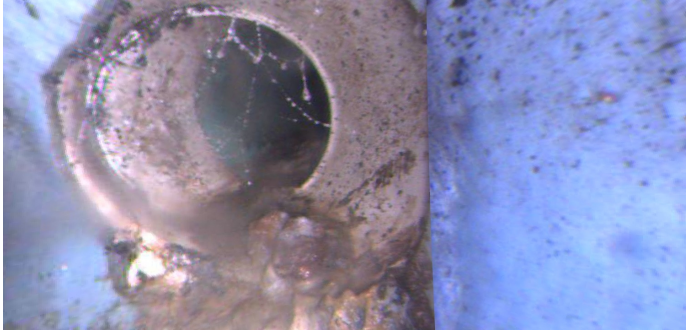
Code: **TB**
Description: **Tap Break-in**

Distance (ft): **57.4**
Structural Grade: **0**
O&M Grade: **0**
Clock Start/From: **9**
Clock To:
1st Value: **4.000**
2nd Value:
Value Percent:
Continuous Index:
Within 8" of Joint:
Remarks:

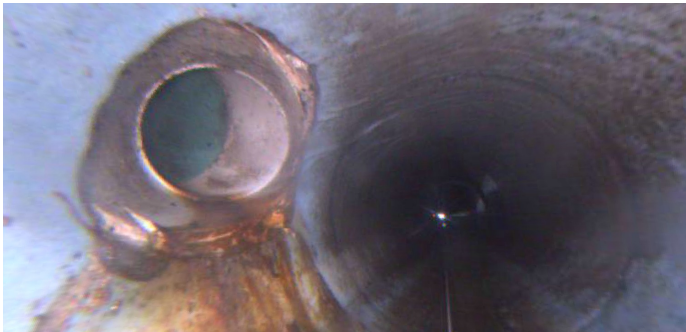
Code: **TBA**
Description: **Tap Break-in Active**

Distance (ft): **72.6**
Structural Grade: **0**
O&M Grade: **0**
Clock Start/From: **3**
Clock To:
1st Value: **4.000**
2nd Value:
Value Percent:
Continuous Index:
Within 8" of Joint:
Remarks:

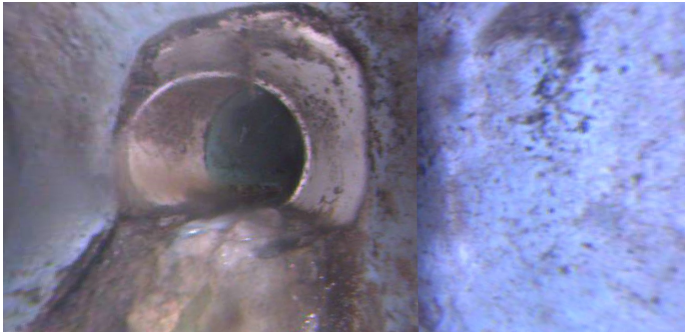
Code: **TBA**
Description: **Tap Break-in Active**

Distance (ft): **94.8**
Structural Grade: **0**
O&M Grade: **0**
Clock Start/From: **9**
Clock To:
1st Value: **4.000**
2nd Value:
Value Percent:
Continuous Index:
Within 8" of Joint:
Remarks:

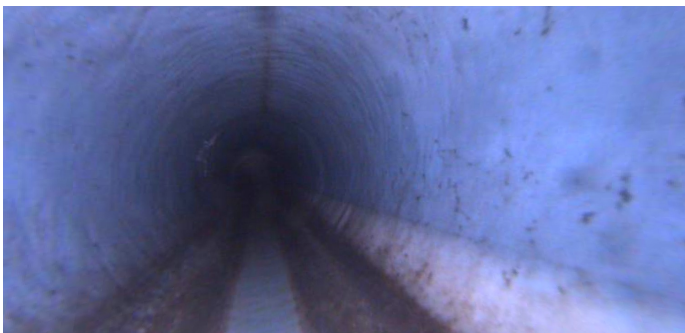
Code: **LFAC**
Description: **Lining Failure Abandoned Connection**

Distance (ft): **120.6**
Structural Grade: **0**
O&M Grade: **0**
Clock Start/From: **2**
Clock To:
1st Value:
2nd Value:
Value Percent:
Continuous Index:
Within 8" of Joint: **NO**
Remarks:

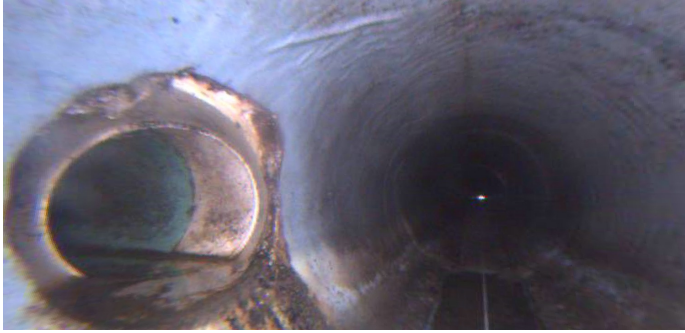
Code: **TB**
Description: **Tap Break-in**

Distance (ft): **128.6**
Structural Grade: **0**
O&M Grade: **0**
Clock Start/From: **3**
Clock To:
1st Value: **4.000**
2nd Value:
Value Percent:
Continuous Index:
Within 8" of Joint:
Remarks:

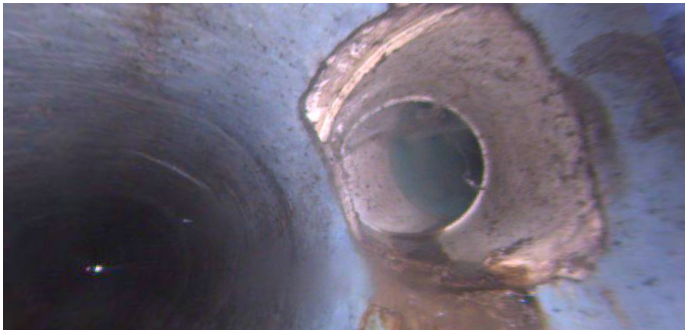
Code: **TBA**
Description: **Tap Break-in Active**

Distance (ft): **130.9**
Structural Grade: **0**
O&M Grade: **0**
Clock Start/From: **10**
Clock To:
1st Value: **4.000**
2nd Value:
Value Percent:
Continuous Index:
Within 8" of Joint:
Remarks:

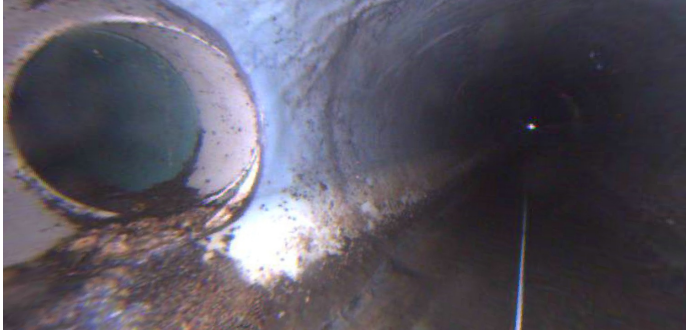
Code: **TB**
Description: **Tap Break-in**

Distance (ft): **135.3**
Structural Grade: **0**
O&M Grade: **0**
Clock Start/From: **3**
Clock To:
1st Value: **4.000**
2nd Value:
Value Percent:
Continuous Index:
Within 8" of Joint:
Remarks:

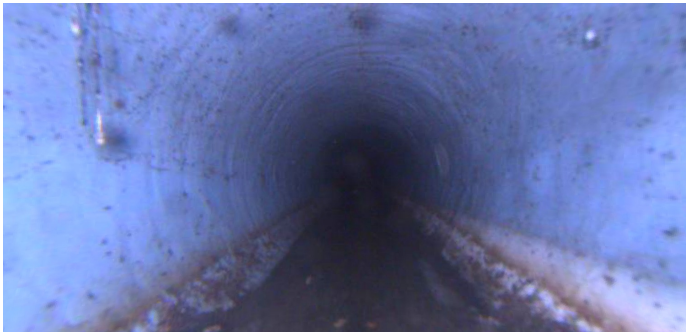
Code: **LFAC**
Description: **Lining Failure Abandoned Connection**

Distance (ft): **152.4**
Structural Grade: **0**
O&M Grade: **0**
Clock Start/From: **2**
Clock To:
1st Value:
2nd Value:
Value Percent:
Continuous Index:
Within 8" of Joint: **NO**
Remarks:

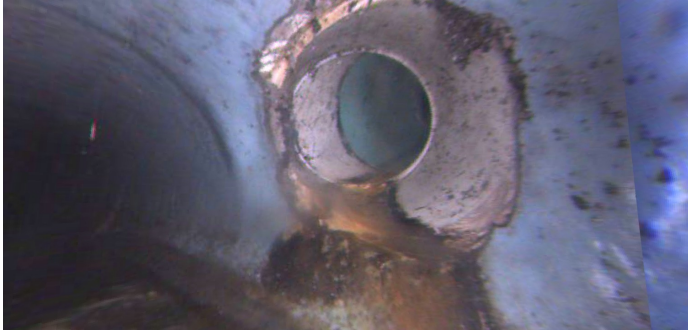
Code: **TBA**
Description: **Tap Break-in Active**

Distance (ft): **172.6**
Structural Grade: **0**
O&M Grade: **0**
Clock Start/From: **9**
Clock To:
1st Value: **4.000**
2nd Value:
Value Percent:
Continuous Index:
Within 8" of Joint:
Remarks:

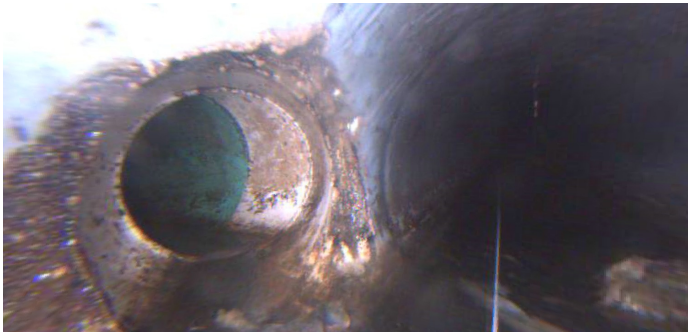
Code: **TBA**
Description: **Tap Break-in Active**

Distance (ft): **179.1**
Structural Grade: **0**
O&M Grade: **0**
Clock Start/From: **3**
Clock To:
1st Value: **4.000**
2nd Value:
Value Percent:
Continuous Index:
Within 8" of Joint:
Remarks:

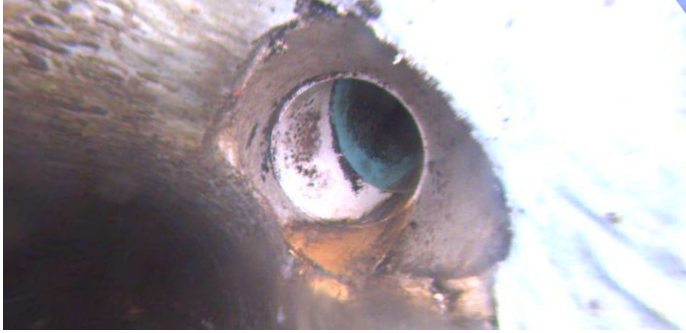
Code: **TF**
Description: **Tap Factory**

Distance (ft): **207.9**
Structural Grade: **0**
O&M Grade: **0**
Clock Start/From: **10**
Clock To:
1st Value: **4.000**
2nd Value:
Value Percent:
Continuous Index:
Within 8" of Joint:
Remarks:

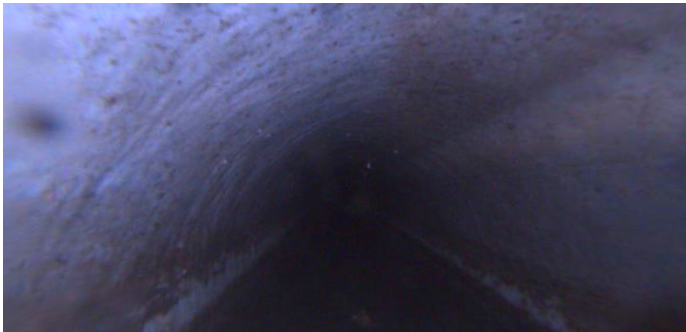
Code: **MSA**
Description: **Abandoned Survey**

Distance (ft): **240.8**
Structural Grade: **0**
O&M Grade: **0**
Clock Start/From:
Clock To:
1st Value:
2nd Value:
Value Percent:
Continuous Index:
Within 8" of Joint: **NO**
Remarks: **DSF**
