## Profile/Photo Observation Report

Street:	<b>S CALIFORNIA ST</b>	Flow Control:	<b>Not Controlled</b>
City:	<b>Hobart, IN</b>	Year Renewed:	
Location:	<b>Light Highway</b>	Tape/Media #:	
Purpose:	<b>Not Known</b>	Dia/Height:	<b>12"</b>
Use:	<b>Sanitary</b>	Material:	<b>PVC</b>
Drain Area:	<b>NA</b>	Lining:	<b>Cured in Place</b>
Category:	<b>NA</b>

US MH:	<b>M-505-038</b>	DS MH:	<b>M-505-039</b>	Total Length Surveyed (ft):	<b>219.1</b>
--------	------------------	--------	------------------	-----------------------------	--------------

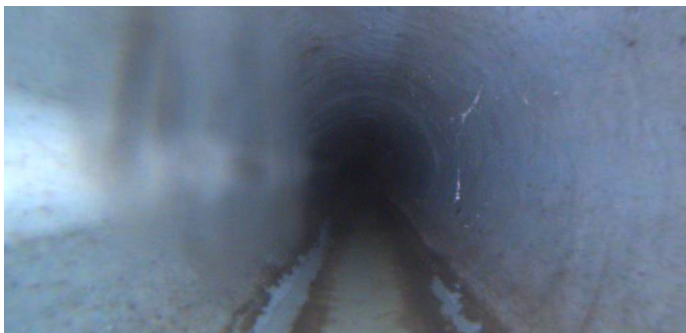
Code: **AMH**  
Description: **Manhole**

Distance (ft): **.0**  
Structural Grade: **0**  
O&M Grade: **0**  
Clock Start/From:  
Clock To:  
1st Value:  
2nd Value:  
Value Percent:  
Continuous Index:  
Within 8" of Joint: **NO**  
Remarks: **M-505-038**

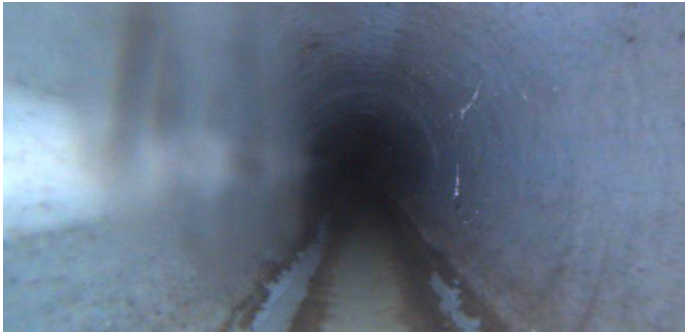
Code:	<b>MWL</b>
Description:	<b>Water Level</b>

Distance (ft):	<b>.0</b>
Structural Grade:	<b>0</b>
O&M Grade:	<b>0</b>
Clock Start/From:	
Clock To:	
1st Value:	
2nd Value:	
Value Percent:	<b>5.000</b>
Continuous Index:	
Within 8" of Joint:	<b>NO</b>
Remarks:

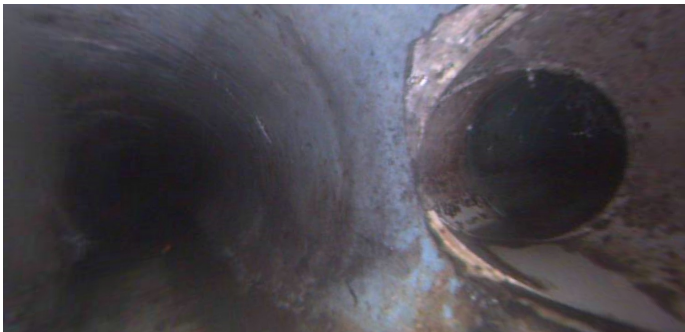
Code:	<b>TB</b>
Description:	<b>Tap Break-in</b>

Distance (ft):	<b>22.0</b>
Structural Grade:	<b>0</b>
O&M Grade:	<b>0</b>
Clock Start/From:	<b>3</b>
Clock To:	
1st Value:	<b>4.000</b>
2nd Value:	
Value Percent:	
Continuous Index:	
Within 8" of Joint:	
Remarks:

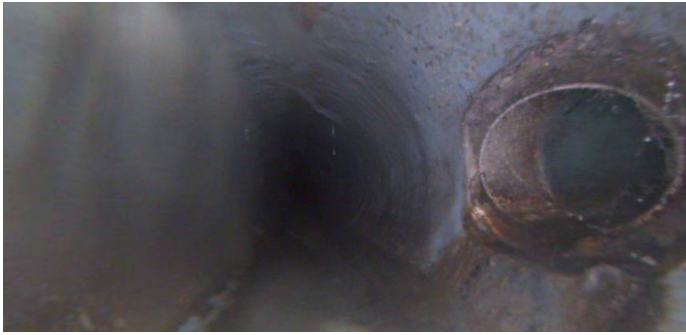
Code: **TB**  
Description: **Tap Break-in**

Distance (ft): **56.3**  
Structural Grade: **0**  
O&M Grade: **0**  
Clock Start/From: **3**  
Clock To:  
1st Value: **4.000**  
2nd Value:  
Value Percent:  
Continuous Index:  
Within 8" of Joint:  
Remarks:

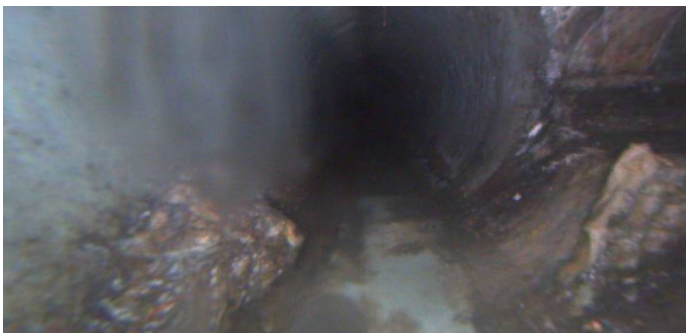
Code: **DAGS**  
Description: **Deposits Attached Grease**

Distance (ft): **94.7**  
Structural Grade: **0**  
O&M Grade: **2**  
Clock Start/From: **7**  
Clock To: **9**  
1st Value:  
2nd Value:  
Value Percent: **5.000**  
Continuous Index:  
Within 8" of Joint: **NO**  
Remarks:

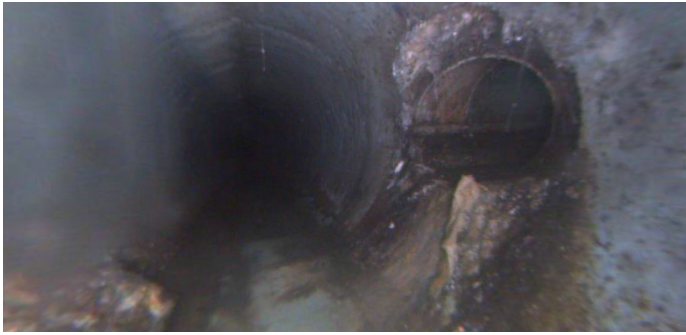
Code: **TBA**  
Description: **Tap Break-in Active**

Distance (ft): **94.7**  
Structural Grade: **0**  
O&M Grade: **0**  
Clock Start/From: **3**  
Clock To:  
1st Value: **4.000**  
2nd Value:  
Value Percent:  
Continuous Index:  
Within 8" of Joint:  
Remarks:

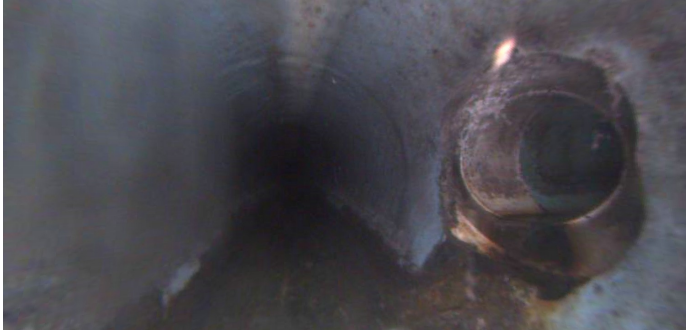
Code: **TBA**  
Description: **Tap Break-in Active**

Distance (ft): **135.1**  
Structural Grade: **0**  
O&M Grade: **0**  
Clock Start/From: **3**  
Clock To:  
1st Value: **4.000**  
2nd Value:  
Value Percent:  
Continuous Index:  
Within 8" of Joint:  
Remarks:

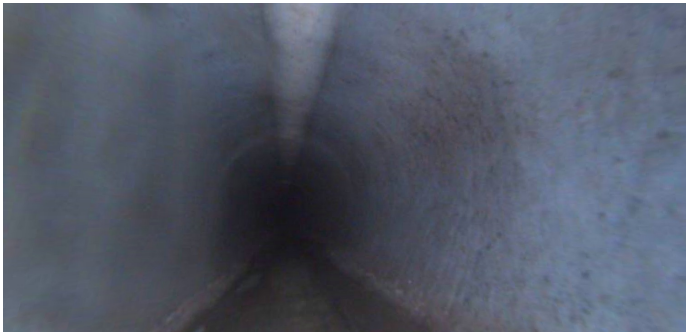
Code: **LFAC**  
Description: **Lining Failure Abandoned Connection**

Distance (ft): **138.4**  
Structural Grade: **0**  
O&M Grade: **0**  
Clock Start/From: **3**  
Clock To:  
1st Value:  
2nd Value:  
Value Percent:  
Continuous Index:  
Within 8" of Joint: **NO**  
Remarks:

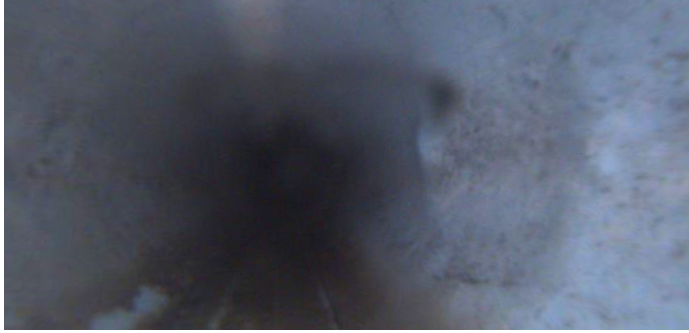
Code:	<b>LFAC</b>
Description:	<b>Lining Failure Abandoned Connection</b>
Distance (ft):	<b>161.8</b>
Structural Grade:	<b>0</b>
O&M Grade:	<b>0</b>
Clock Start/From:	<b>9</b>
Clock To:	
1st Value:	
2nd Value:	
Value Percent:	
Continuous Index:	
Within 8" of Joint:	<b>NO</b>
Remarks:

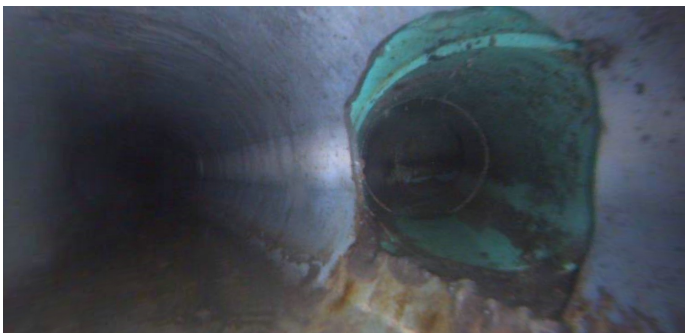
Code: **TB**  
Description: **Tap Break-in**

Distance (ft): **214.6**  
Structural Grade: **0**  
O&M Grade: **0**  
Clock Start/From: **3**  
Clock To:  
1st Value: **4.000**  
2nd Value:  
Value Percent:  
Continuous Index:  
Within 8" of Joint:  
Remarks:

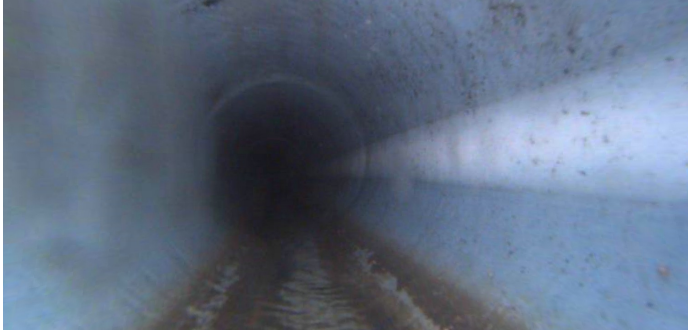
Code: **MSA**  
Description: **Abandoned Survey**

Distance (ft): **219.1**  
Structural Grade: **0**  
O&M Grade: **0**  
Clock Start/From:  
Clock To:  
1st Value:  
2nd Value:  
Value Percent:  
Continuous Index:  
Within 8" of Joint: **NO**  
Remarks: **unknown**
