Profile/Photo Observation Report

Street:	Summerlin	Flow Control:	Not Controlled
City:	Hobart, IN	Year Renewed:	
Location:	Light Highway	Tape/Media #:	
Purpose:	Not Known	Dia/Height:	12"
Use:	Sanitary	Material:	PVC
Drain Area:	NA	Lining:	Cured in Place
Category:	NA		
Comment:

Location Details:		Direction of Survey:	Upstream
US MH:	M-505-038	DS MH:	M-505-039
		Total Length Surveyed (ft):	10.8

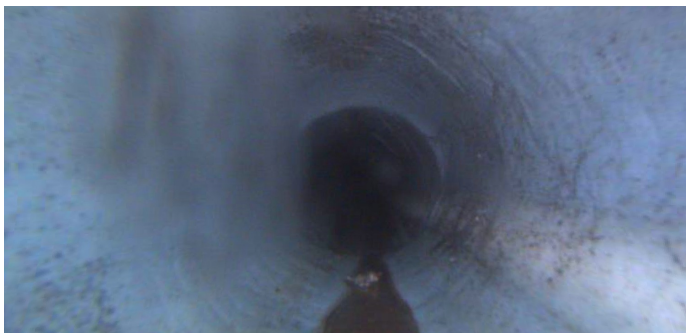
Code: **AMH**
Description: **Manhole**

Distance (ft): **.0**
Structural Grade: **0**
O&M Grade: **0**
Clock Start/From:
Clock To:
1st Value:
2nd Value:
Value Percent:
Continuous Index:
Within 8" of Joint: **NO**
Remarks: **M-505-038**

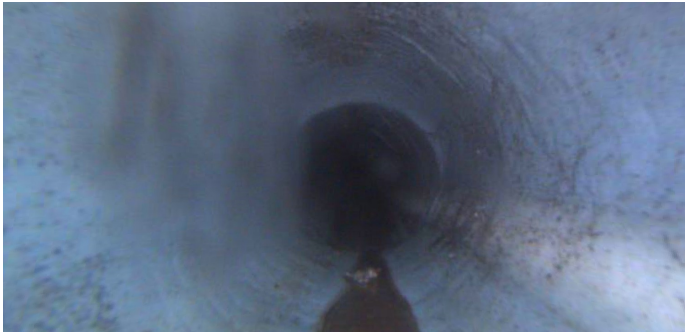
Code:	MWL
Description:	Water Level

Distance (ft):	.0
Structural Grade:	0
O&M Grade:	0
Clock Start/From:	
Clock To:	
1st Value:	
2nd Value:	
Value Percent:	5.000
Continuous Index:	
Within 8" of Joint:	NO
Remarks:

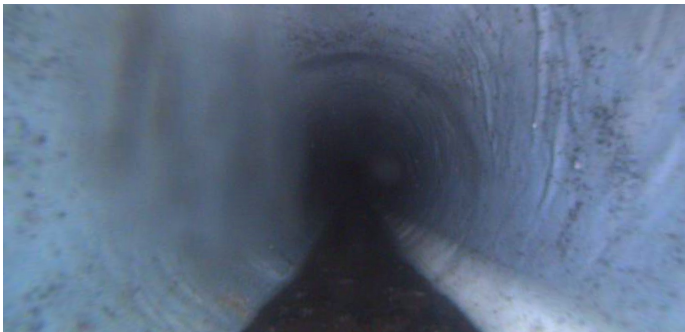
Code:	MSA
Description:	Abandoned Survey

Distance (ft):	10.8
Structural Grade:	0
O&M Grade:	0
Clock Start/From:	
Clock To:	
1st Value:	
2nd Value:	
Value Percent:	
Continuous Index:	
Within 8" of Joint:	NO
Remarks:	unknown
