Profile/Photo Observation Report

Date:	04/21/2018	Weather:		Coding:	PACP 6.0
Pipe Length (ft):	278.0	Owner:	NA	Pre Clean:	No Pre-Cleaning
P.O.#:		Surveyor:	Mark Ruby	PSR:	P-505-041-042
Customer:		Clean Date:	01/01/1900	Shape:	C

Street:	S VIRGINIA ST	Flow Control:	Not Controlled
City:	Hobart, IN	Year Renewed:	
Location:	Light Highway	Tape/Media #:	
Purpose:	Routine Assessment	Dia/Height:	12"
Use:	Sanitary	Material:	PVC
Drain Area:	NA	Lining:	
Category:	NA		
Comment:	P_C at O_C at 273 ft . Flow direction wrong		
Location Details:		Direction of Survey:	Downstream
US MH:	M-505-042	DS MH:	M-505-041
		Total Length Surveyed (ft):	274.3

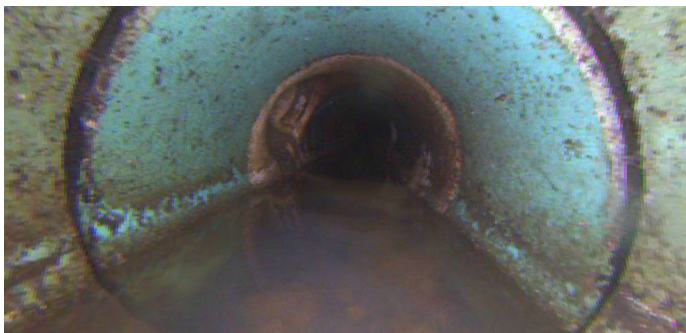
Code: **AMH**
Description: **Manhole**

Distance (ft): **.0**
Structural Grade: **0**
O&M Grade: **0**
Clock Start/From:
Clock To:
1st Value:
2nd Value:
Value Percent:
Continuous Index:
Within 8" of Joint: **NO**
Remarks: **M-505-042**

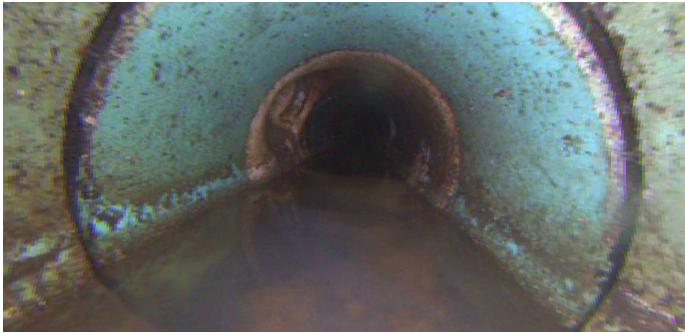
Code:	MWL
Description:	Water Level

Distance (ft):	.0
Structural Grade:	0
O&M Grade:	0
Clock Start/From:	
Clock To:	
1st Value:	
2nd Value:	
Value Percent:	5.000
Continuous Index:	
Within 8" of Joint:	NO
Remarks:

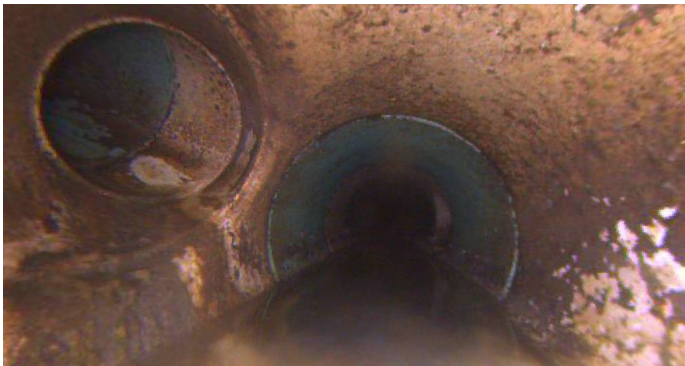
Code:	TF
Description:	Tap Factory

Distance (ft):	2.2
Structural Grade:	0
O&M Grade:	0
Clock Start/From:	9
Clock To:	
1st Value:	4.000
2nd Value:	
Value Percent:	
Continuous Index:	
Within 8" of Joint:	
Remarks:

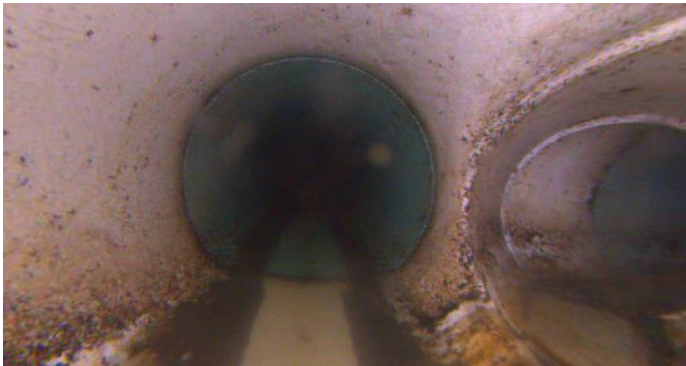
Code: **TF**
Description: **Tap Factory**

Distance (ft): **46.2**
Structural Grade: **0**
O&M Grade: **0**
Clock Start/From: **4**
Clock To:
1st Value: **4.000**
2nd Value:
Value Percent:
Continuous Index:
Within 8" of Joint:
Remarks:
