## Profile/Photo Observation Report

Street:	<b>S VIRGINIA ST &amp; W 2ND ST</b>	Flow Control:	<b>Not Controlled</b>
City:	<b>Hobart, IN</b>	Year Renewed:	
Location:	<b>Light Highway</b>	Tape/Media #:	
Purpose:	<b>Routine Assessment</b>	Dia/Height:	<b>12"</b>
Use:	<b>Sanitary</b>	Material:	<b>PVC</b>
Drain Area:	<b>NA</b>	Lining:	
Category:	<b>NA</b>		
Comment:	<b>Flow direction wrong</b>

Location Details:		Direction of Survey:	<b>Upstream</b>
US MH:	<b>M-505-043</b>	DS MH:	<b>M-505-042</b>
		Total Length Surveyed (ft):	<b>271.6</b>

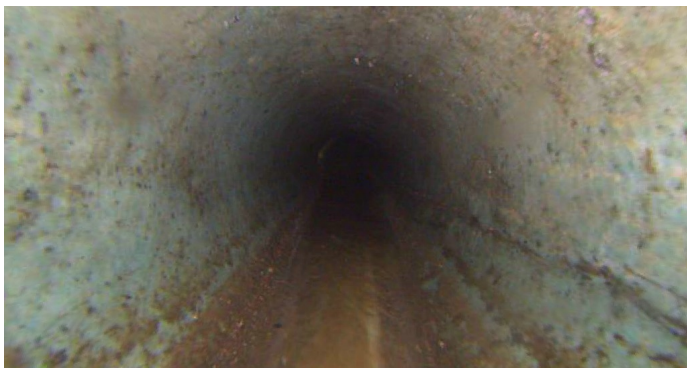
Position	Code	Observation	Video (sec)	Grade
M-505-042				
.0	AMH	Manhole	10	NA
.0	MWL	Water Level	21	NA
5.2	TF	Tap Factory	45	NA
52.1	TF	Tap Factory	151	NA
55.3	TF	Tap Factory	169	NA
65.0	TF	Tap Factory	200	NA
104.9	TF	Tap Factory	291	NA
106.8	TF	Tap Factory	307	NA
140.1	TF	Tap Factory	385	NA
169.0	TF	Tap Factory	454	NA
192.4	TF	Tap Factory	513	NA
224.9	TF	Tap Factory	590	NA
227.0	TF	Tap Factory	606	NA
271.6	AMH	Manhole	709	NA
M-505-043

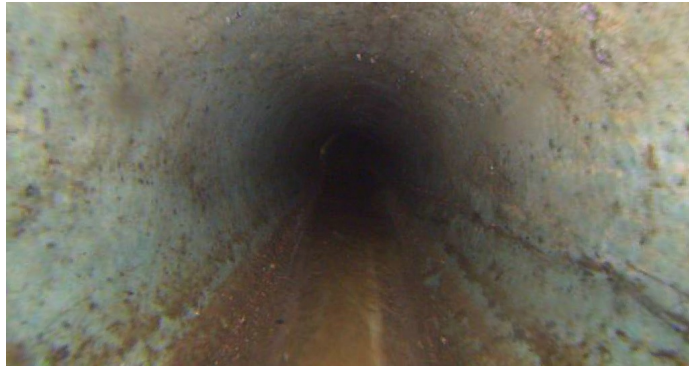
Code:	<b>MWL</b>
Description:	<b>Water Level</b>
Distance (ft):	<b>.0</b>
Structural Grade:	<b>0</b>
O&M Grade:	<b>0</b>
Clock Start/From:	
Clock To:	
1st Value:	
2nd Value:	
Value Percent:	<b>10.000</b>
Continuous Index:	
Within 8" of Joint:	<b>NO</b>
Remarks:

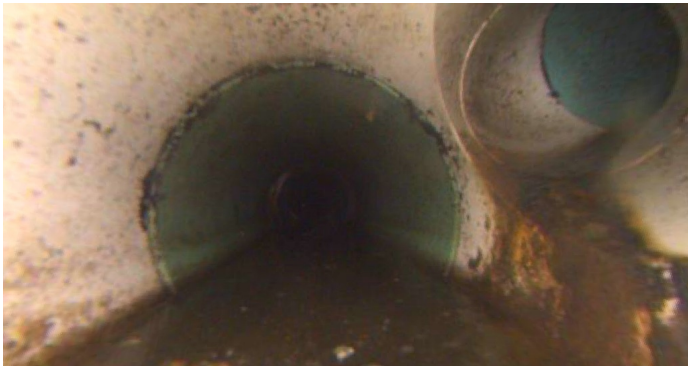
Code: **TF**  
Description: **Tap Factory**

Distance (ft): **55.3**  
Structural Grade: **0**  
O&M Grade: **0**  
Clock Start/From: **9**  
Clock To:  
1st Value: **4.000**  
2nd Value:  
Value Percent:  
Continuous Index:  
Within 8" of Joint:  
Remarks:

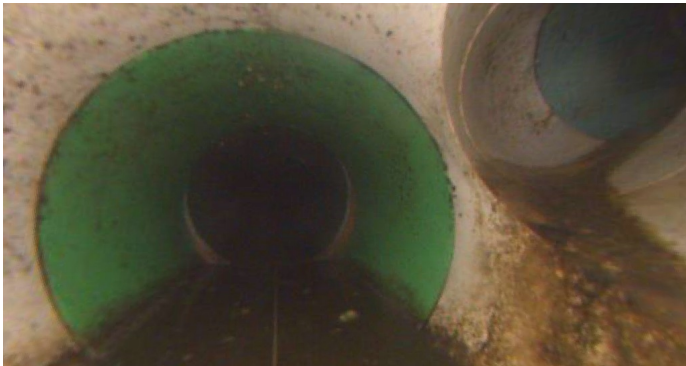
Code: **TF**  
Description: **Tap Factory**

Distance (ft): **104.9**  
Structural Grade: **0**  
O&M Grade: **0**  
Clock Start/From: **10**  
Clock To:  
1st Value: **4.000**  
2nd Value:  
Value Percent:  
Continuous Index:  
Within 8" of Joint:  
Remarks:

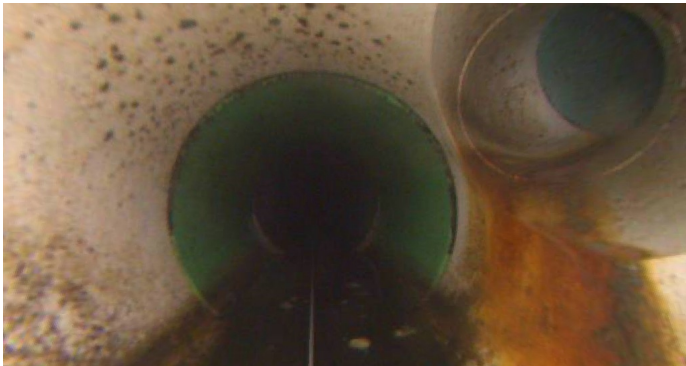
Code: **TF**  
Description: **Tap Factory**

Distance (ft): **192.4**  
Structural Grade: **0**  
O&M Grade: **0**  
Clock Start/From: **10**  
Clock To:  
1st Value: **4.000**  
2nd Value:  
Value Percent:  
Continuous Index:  
Within 8" of Joint:  
Remarks:

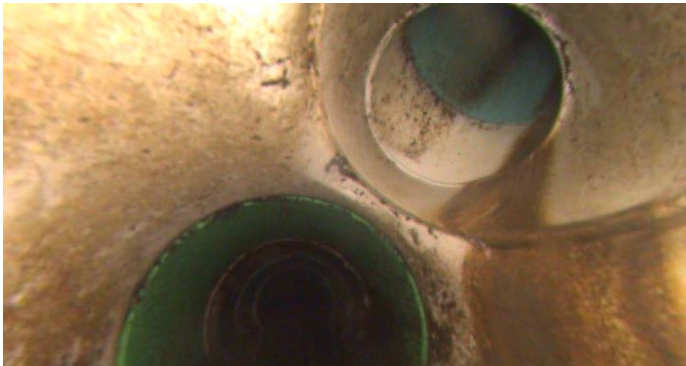
Code: **TF**  
Description: **Tap Factory**

Distance (ft): **227.0**  
Structural Grade: **0**  
O&M Grade: **0**  
Clock Start/From: **10**  
Clock To:  
1st Value: **4.000**  
2nd Value:  
Value Percent:  
Continuous Index:  
Within 8" of Joint:  
Remarks:

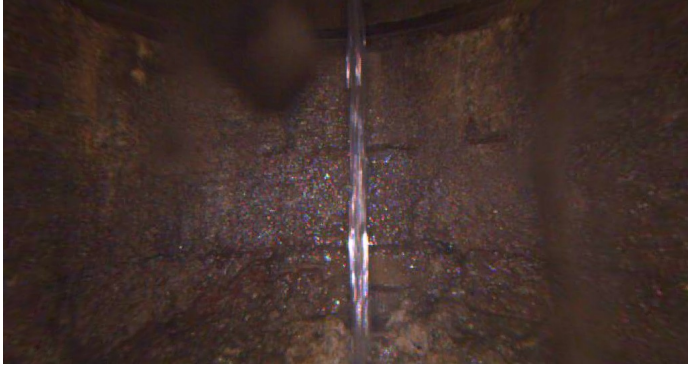
Code:	AMH
Description:	Manhole
Distance (ft):	271.6
Structural Grade:	0
O&M Grade:	0
Clock Start/From:	
Clock To:	
1st Value:	
2nd Value:	
Value Percent:	
Continuous Index:	
Within 8" of Joint:	NO
Remarks:	M-505-043
