Profile/Photo Observation Report

Street:	FOXCROFT STREET	Flow Control:	Not Controlled
City:	Hobart, IN	Year Renewed:	
Location:	Light Highway	Tape/Media #:	
Purpose:	Routine Assessment	Dia/Height:	12"
Use:	Sanitary	Material:	PVC
Drain Area:	NA	Lining:	
Category:	NA		
Comment:	Flow direction wrong

Location Details:		Direction of Survey:	Upstream
US MH:	M-505-043	DS MH:	M-505-042
		Total Length Surveyed (ft):	271.6

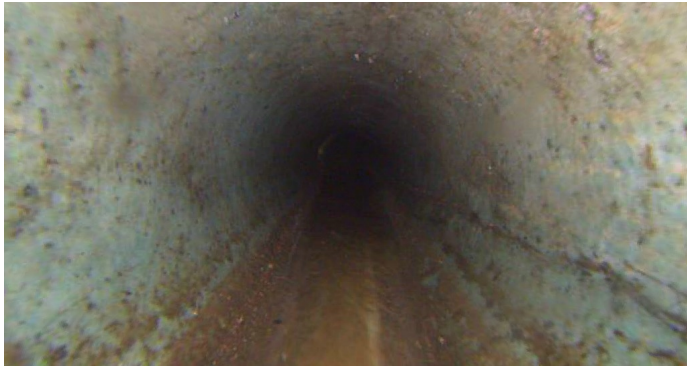
Code: **MWL**
Description: **Water Level**

Distance (ft): **.0**
Structural Grade: **0**
O&M Grade: **0**
Clock Start/From:
Clock To:
1st Value:
2nd Value:
Value Percent: **10.000**
Continuous Index:
Within 8" of Joint: **NO**
Remarks:

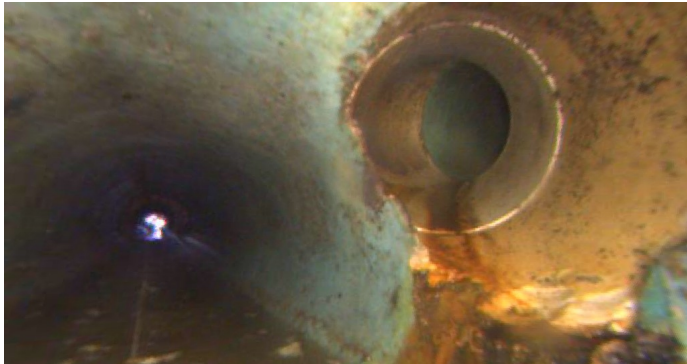
Code: **TF**
Description: **Tap Factory**

Distance (ft): **5.2**
Structural Grade: **0**
O&M Grade: **0**
Clock Start/From: **9**
Clock To:
1st Value: **4.000**
2nd Value:
Value Percent:
Continuous Index:
Within 8" of Joint:
Remarks:

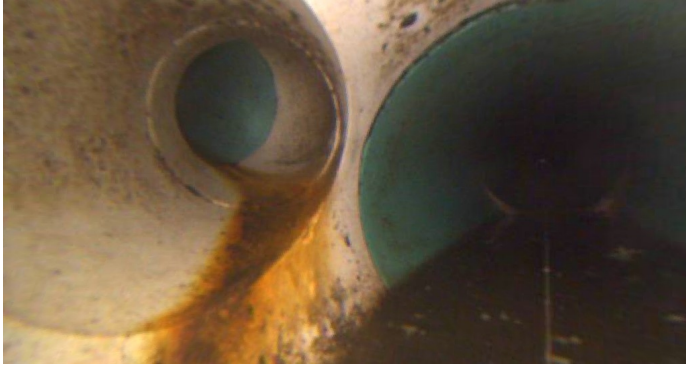
Code: **TF**
Description: **Tap Factory**

Distance (ft): **52.1**
Structural Grade: **0**
O&M Grade: **0**
Clock Start/From: **3**
Clock To:
1st Value: **4.000**
2nd Value:
Value Percent:
Continuous Index:
Within 8" of Joint:
Remarks:

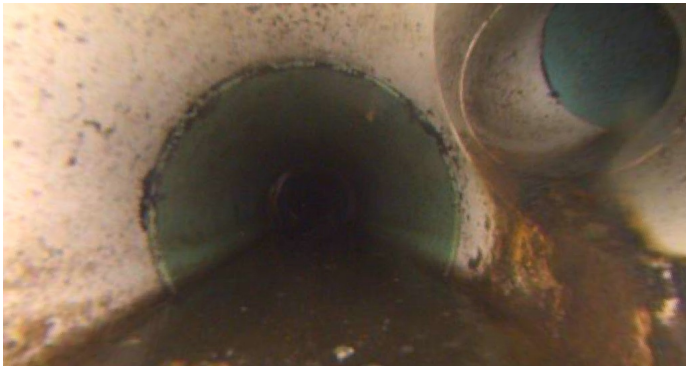
Code: **TF**
Description: **Tap Factory**

Distance (ft): **55.3**
Structural Grade: **0**
O&M Grade: **0**
Clock Start/From: **9**
Clock To:
1st Value: **4.000**
2nd Value:
Value Percent:
Continuous Index:
Within 8" of Joint:
Remarks:

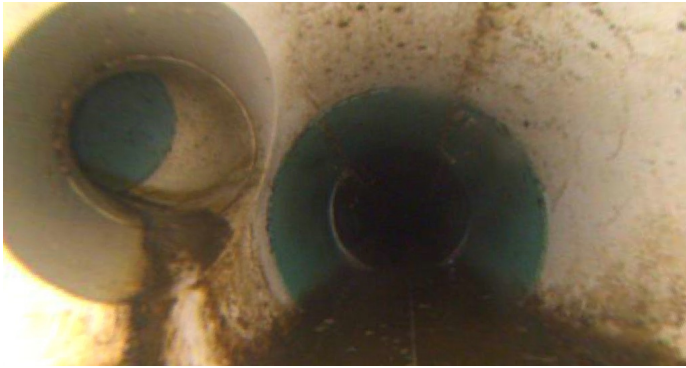
Code: **TF**
Description: **Tap Factory**

Distance (ft): **65.0**
Structural Grade: **0**
O&M Grade: **0**
Clock Start/From: **3**
Clock To:
1st Value: **4.000**
2nd Value:
Value Percent:
Continuous Index:
Within 8" of Joint:
Remarks:

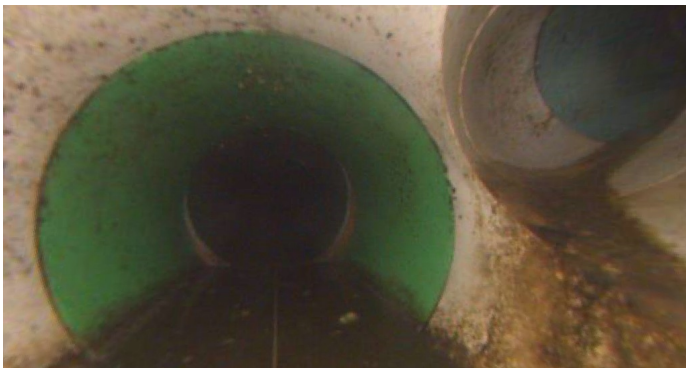
Code: **TF**
Description: **Tap Factory**

Distance (ft): **104.9**
Structural Grade: **0**
O&M Grade: **0**
Clock Start/From: **10**
Clock To:
1st Value: **4.000**
2nd Value:
Value Percent:
Continuous Index:
Within 8" of Joint:
Remarks:

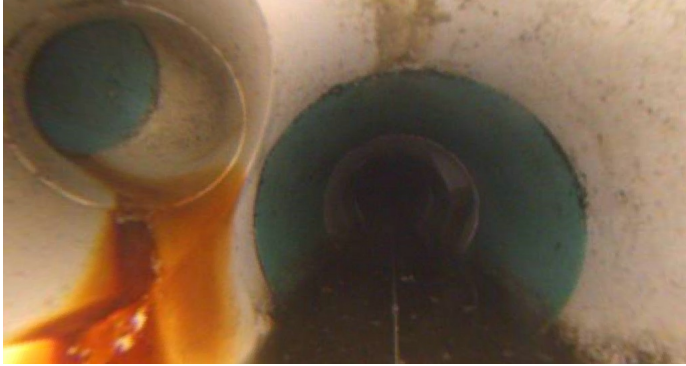
Code: **TF**
Description: **Tap Factory**

Distance (ft): **106.8**
Structural Grade: **0**
O&M Grade: **0**
Clock Start/From: **2**
Clock To:
1st Value: **4.000**
2nd Value:
Value Percent:
Continuous Index:
Within 8" of Joint:
Remarks:

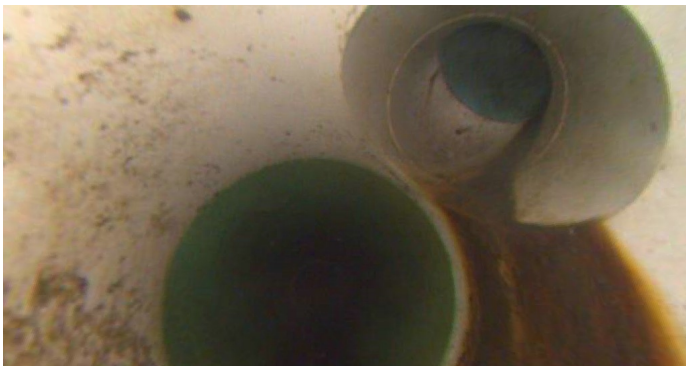
Code: **TF**
Description: **Tap Factory**

Distance (ft): **140.1**
Structural Grade: **0**
O&M Grade: **0**
Clock Start/From: **11**
Clock To:
1st Value: **4.000**
2nd Value:
Value Percent:
Continuous Index:
Within 8" of Joint:
Remarks:

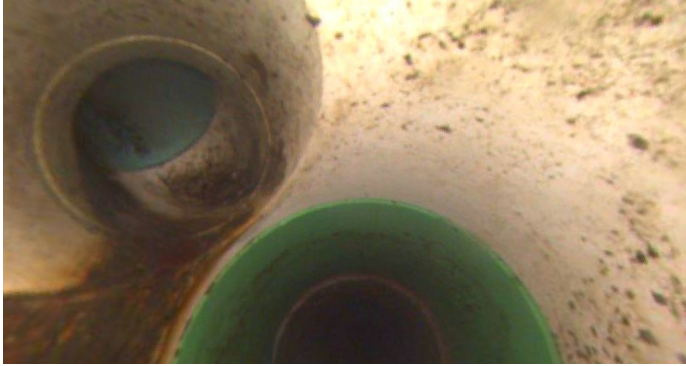
Code: **TF**
Description: **Tap Factory**

Distance (ft): **169.0**
Structural Grade: **0**
O&M Grade: **0**
Clock Start/From: **2**
Clock To:
1st Value: **4.000**
2nd Value:
Value Percent:
Continuous Index:
Within 8" of Joint:
Remarks:

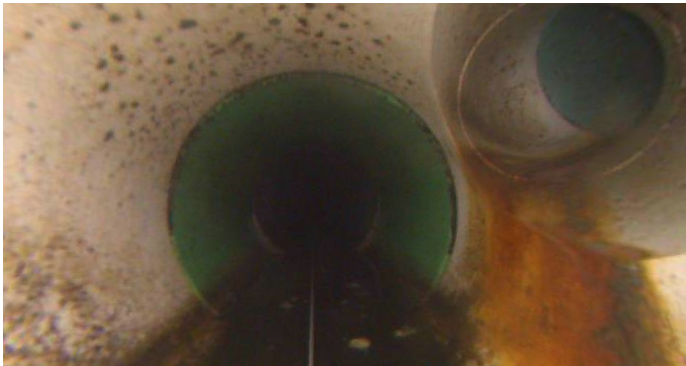
Code: **TF**
Description: **Tap Factory**

Distance (ft): **192.4**
Structural Grade: **0**
O&M Grade: **0**
Clock Start/From: **10**
Clock To:
1st Value: **4.000**
2nd Value:
Value Percent:
Continuous Index:
Within 8" of Joint:
Remarks:

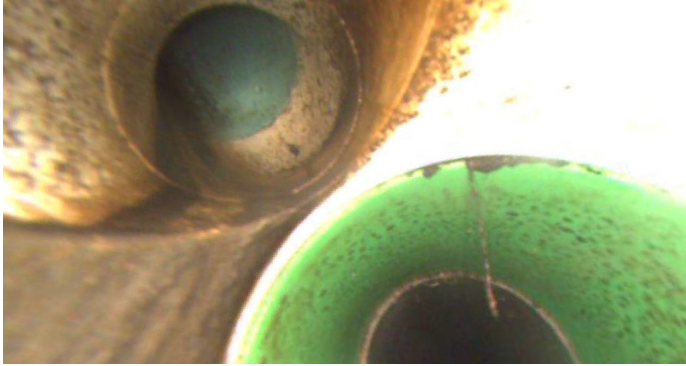
Code: **TF**
Description: **Tap Factory**

Distance (ft): **224.9**
Structural Grade: **0**
O&M Grade: **0**
Clock Start/From: **2**
Clock To:
1st Value: **4.000**
2nd Value:
Value Percent:
Continuous Index:
Within 8" of Joint:
Remarks:

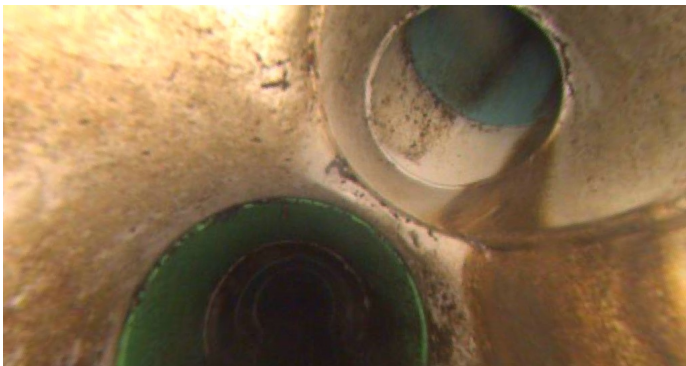
Code: **TF**
Description: **Tap Factory**

Distance (ft): **227.0**
Structural Grade: **0**
O&M Grade: **0**
Clock Start/From: **10**
Clock To:
1st Value: **4.000**
2nd Value:
Value Percent:
Continuous Index:
Within 8" of Joint:
Remarks:

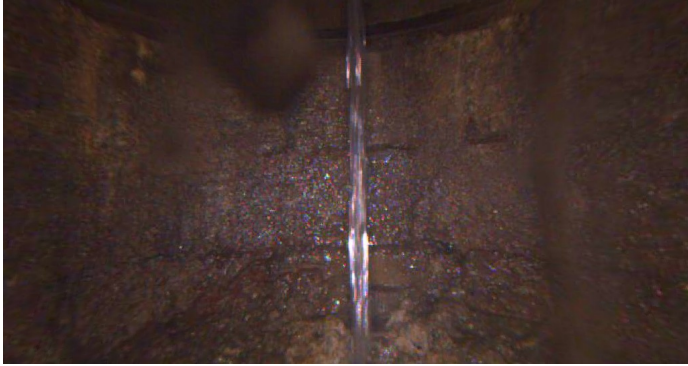
Code:	AMH
Description:	Manhole
Distance (ft):	271.6
Structural Grade:	0
O&M Grade:	0
Clock Start/From:	
Clock To:	
1st Value:	
2nd Value:	
Value Percent:	
Continuous Index:	
Within 8" of Joint:	NO
Remarks:	M-505-043
