Profile/Photo Observation Report

Date:	04/21/2018	Weather:		Coding:	PACP 6.0
Pipe Length (ft):	305.7	Owner:	NA	Pre Clean:	No Pre-Cleaning
P.O.#:		Surveyor:	Byrd Fitzgerald	PSR:	P-505-044-043
Customer:		Clean Date:	01/01/1900	Shape:	C

Street:	S VIRGINIA ST & W 2ND ST	Flow Control:	Not Controlled
City:	Hobart, IN	Year Renewed:	
Location:	Light Highway	Tape/Media #:	
Purpose:	Routine Assessment	Dia/Height:	12"
Use:	Sanitary	Material:	PVC
Drain Area:	NA	Lining:	
Category:	NA		
Comment:	Flow direction wrong		
Location Details:		Direction of Survey:	Upstream
US MH:	M-505-043	DS MH:	M-505-044
		Total Length Surveyed (ft):	300.2

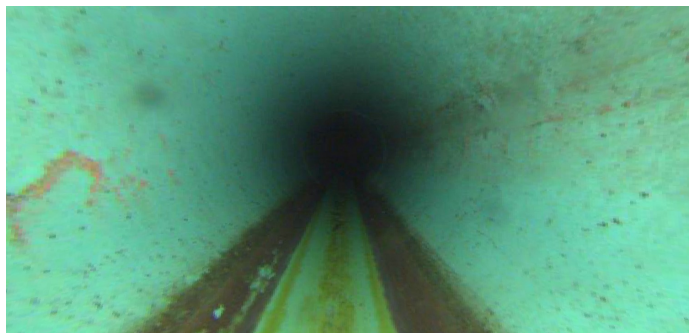
Code: **AMH**
 Description: **Manhole**
 Distance (ft): **.0**
 Structural Grade: **0**
 O&M Grade: **0**
 Clock Start/From:
 Clock To:
 1st Value:
 2nd Value:
 Value Percent:
 Continuous Index:
 Within 8" of Joint: **NO**
 Remarks: **M-505-044**

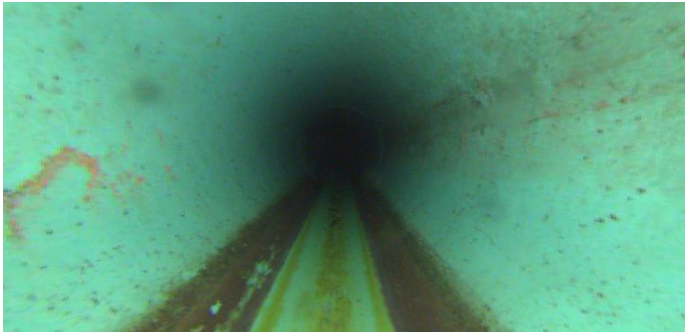
Code:	MWL
Description:	Water Level

Distance (ft):	.0
Structural Grade:	0
O&M Grade:	0
Clock Start/From:	
Clock To:	
1st Value:	
2nd Value:	
Value Percent:	5.000
Continuous Index:	
Within 8" of Joint:	NO
Remarks:

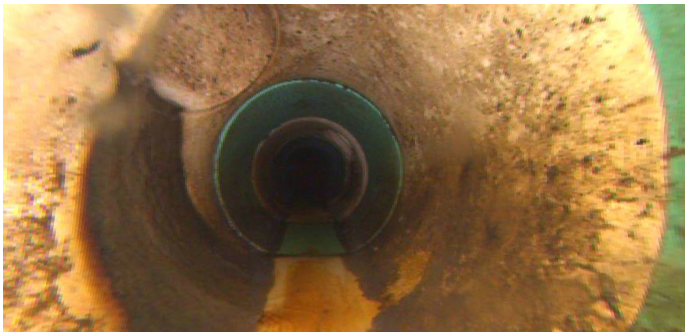
Code:	TF
Description:	Tap Factory

Distance (ft):	27.9
Structural Grade:	0
O&M Grade:	0
Clock Start/From:	11
Clock To:	
1st Value:	4.000
2nd Value:	
Value Percent:	
Continuous Index:	
Within 8" of Joint:	YES
Remarks:

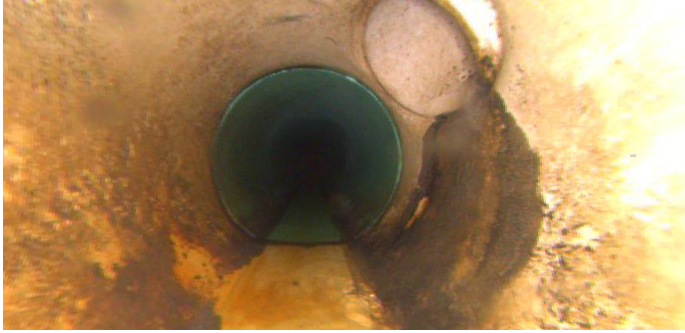
Code: **TF**
Description: **Tap Factory**

Distance (ft): **30.1**
Structural Grade: **0**
O&M Grade: **0**
Clock Start/From: **1**
Clock To:
1st Value: **4.000**
2nd Value:
Value Percent:
Continuous Index:
Within 8" of Joint: **YES**
Remarks:

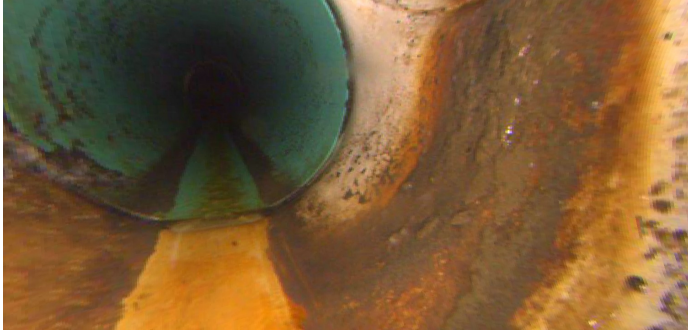
Code:	DAZ
Description:	Deposits Attached Other
Distance (ft):	64.4
Structural Grade:	0
O&M Grade:	2
Clock Start/From:	2
Clock To:	5
1st Value:	
2nd Value:	
Value Percent:	5.000
Continuous Index:	
Within 8" of Joint:	YES
Remarks:

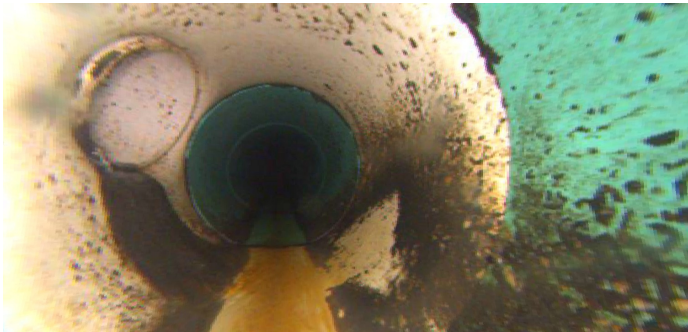
Code:	TF
Description:	Tap Factory
Distance (ft):	69.8
Structural Grade:	0
O&M Grade:	0
Clock Start/From:	10
Clock To:	
1st Value:	4.000
2nd Value:	
Value Percent:	
Continuous Index:	
Within 8" of Joint:	YES
Remarks:

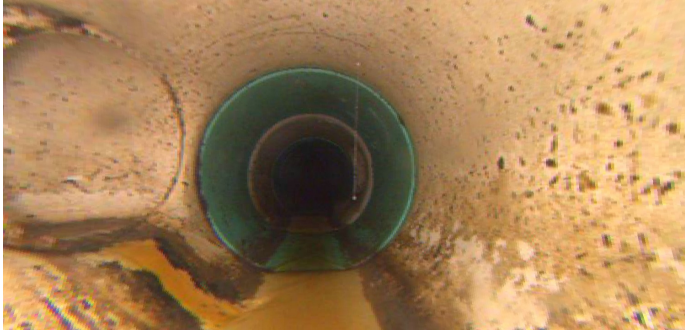
Code: **TF**
Description: **Tap Factory**

Distance (ft): **234.6**
Structural Grade: **0**
O&M Grade: **0**
Clock Start/From: **9**
Clock To:
1st Value: **4.000**
2nd Value:
Value Percent:
Continuous Index:
Within 8" of Joint: **YES**
Remarks:

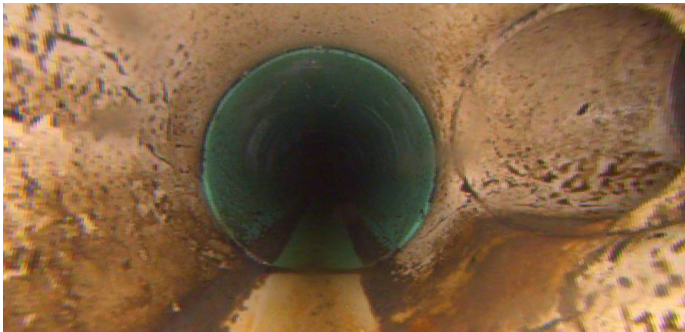
Code: **TF**
Description: **Tap Factory**

Distance (ft): **236.8**
Structural Grade: **0**
O&M Grade: **0**
Clock Start/From: **3**
Clock To:
1st Value: **4.000**
2nd Value:
Value Percent:
Continuous Index:
Within 8" of Joint: **YES**
Remarks:

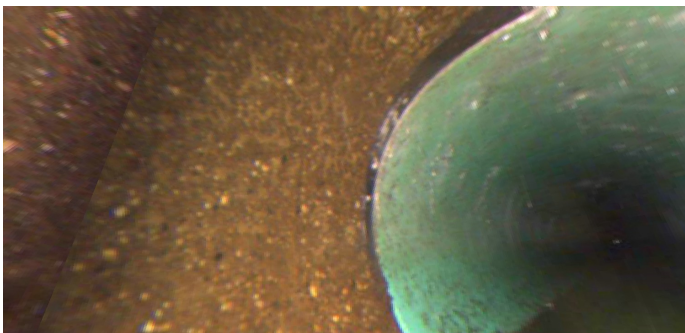
Code: **SAV**
Description: **Surface Aggregate Visible**

Distance (ft): **274.6**
Structural Grade: **3**
O&M Grade: **0**
Clock Start/From: **7**
Clock To: **5**
1st Value:
2nd Value:
Value Percent:
Continuous Index: **S01**
Within 8" of Joint:
Remarks:

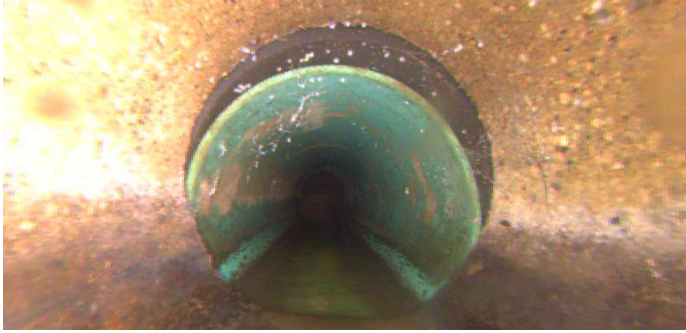
Code: **MMC**
Description: **Material Change**

Distance (ft): **292.5**
Structural Grade: **0**
O&M Grade: **0**
Clock Start/From:
Clock To:
1st Value:
2nd Value:
Value Percent:
Continuous Index:
Within 8" of Joint: **NO**
Remarks: **pvc**

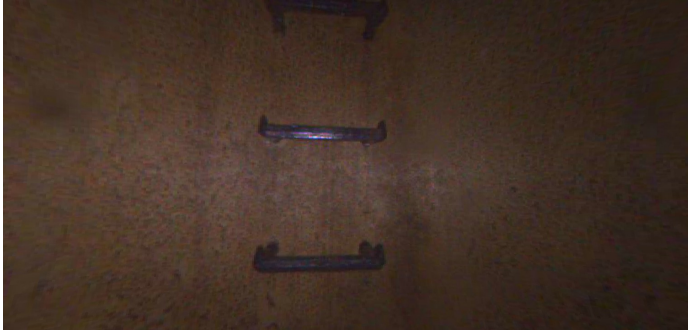
Code:	AMH
Description:	Manhole
Distance (ft):	300.2
Structural Grade:	0
O&M Grade:	0
Clock Start/From:	
Clock To:	
1st Value:	
2nd Value:	
Value Percent:	
Continuous Index:	
Within 8" of Joint:	NO
Remarks:	M-505-043
