Profile/Photo Observation Report

| Street: | FOXCROFT STREET | Flow Control: | Not Controlled |
| Purpose: | Routine Assessment | Dia/Height: | 12" |
| US MH: | M-505-044 | DS MH: | M-505-045 |

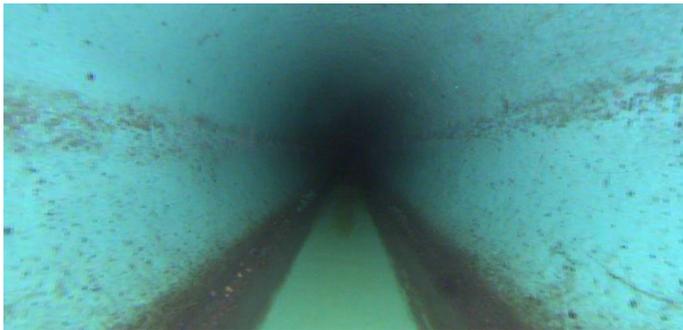
Code: **AMH**
Description: **Manhole**

Distance (ft): **.0**
Structural Grade: **0**
O&M Grade: **0**
Clock Start/From:
Clock To:
1st Value:
2nd Value:
Value Percent:
Continuous Index:
Within 8" of Joint: **NO**
Remarks: **M-505-044**

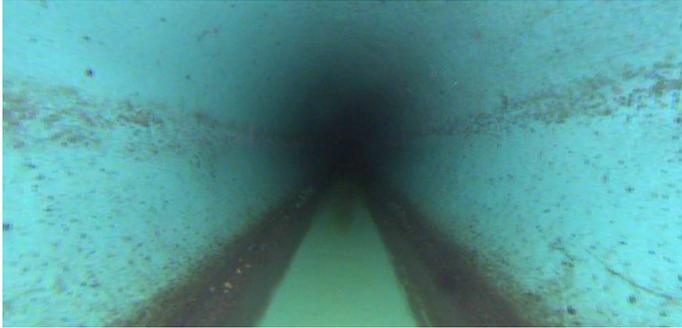
Code: **MWL**
Description: **Water Level**

Distance (ft): **.0**
Structural Grade: **0**
O&M Grade: **0**
Clock Start/From:
Clock To:
1st Value:
2nd Value:
Value Percent: **5.000**
Continuous Index:
Within 8" of Joint: **NO**
Remarks:

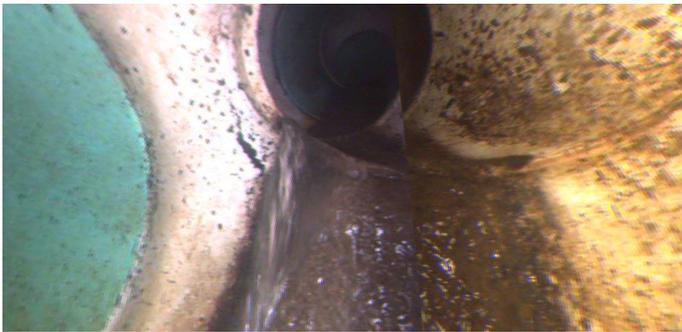
Code: **TFA**
Description: **Tap Factory Active**

Distance (ft): **10.6**
Structural Grade: **0**
O&M Grade: **0**
Clock Start/From: **2**
Clock To:
1st Value: **4.000**
2nd Value:
Value Percent:
Continuous Index:
Within 8" of Joint: **YES**
Remarks:

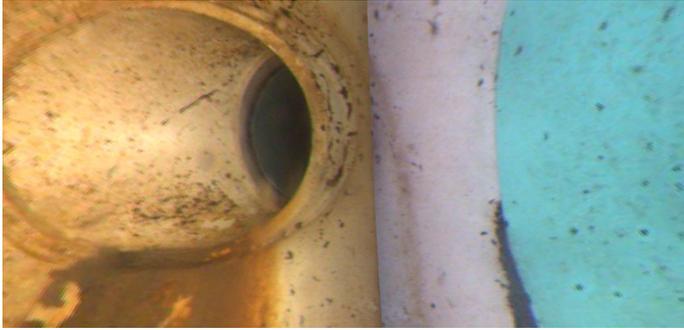
Code: **TF**
Description: **Tap Factory**

Distance (ft): **13.1**
Structural Grade: **0**
O&M Grade: **0**
Clock Start/From: **10**
Clock To:
1st Value: **4.000**
2nd Value:
Value Percent:
Continuous Index:
Within 8" of Joint: **YES**
Remarks:

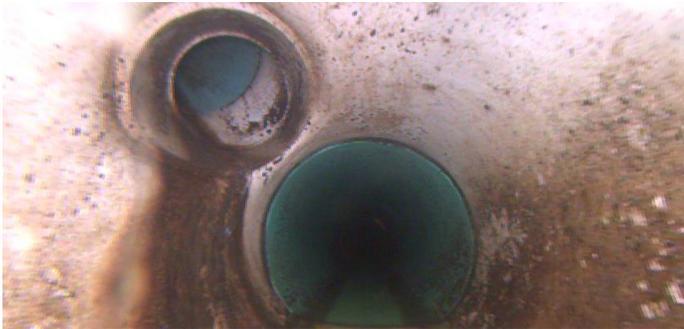
Code: **TF**
Description: **Tap Factory**

Distance (ft): **55.4**
Structural Grade: **0**
O&M Grade: **0**
Clock Start/From: **11**
Clock To:
1st Value: **4.000**
2nd Value:
Value Percent:
Continuous Index:
Within 8" of Joint: **YES**
Remarks:

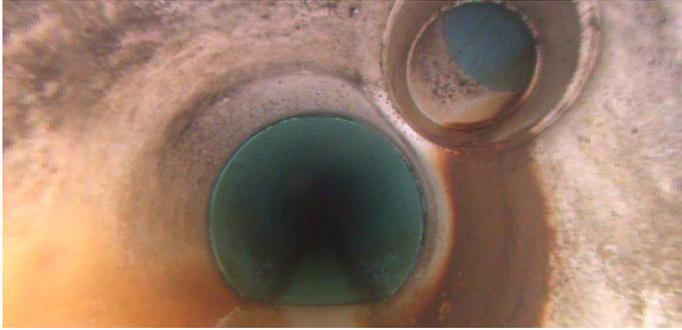
Code: **TF**
Description: **Tap Factory**

Distance (ft): **61.1**
Structural Grade: **0**
O&M Grade: **0**
Clock Start/From: **1**
Clock To:
1st Value: **4.000**
2nd Value:
Value Percent:
Continuous Index:
Within 8" of Joint: **YES**
Remarks:

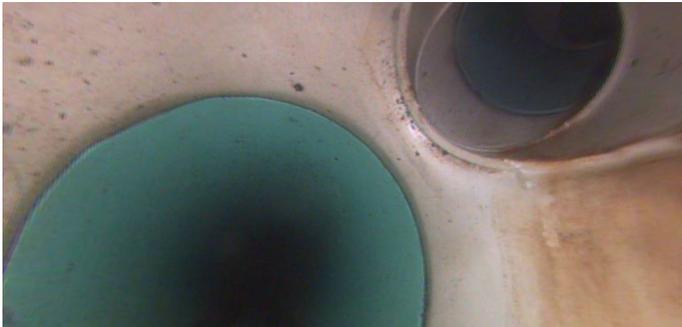
Code: **TF**
Description: **Tap Factory**

Distance (ft): **102.1**
Structural Grade: **0**
O&M Grade: **0**
Clock Start/From: **1**
Clock To:
1st Value: **4.000**
2nd Value:
Value Percent:
Continuous Index:
Within 8" of Joint: **YES**
Remarks:

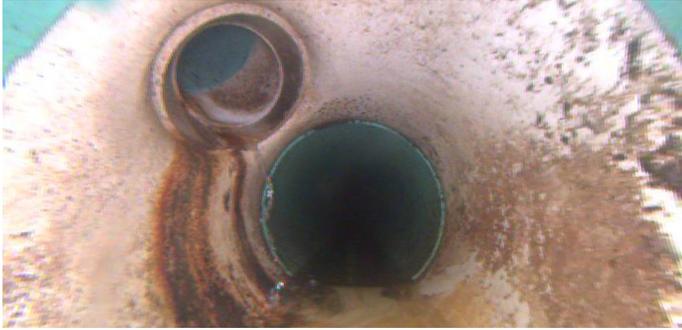
Code: **TFA**
Description: **Tap Factory Active**

Distance (ft): **111.0**
Structural Grade: **0**
O&M Grade: **0**
Clock Start/From: **11**
Clock To:
1st Value: **4.000**
2nd Value:
Value Percent:
Continuous Index:
Within 8" of Joint: **YES**
Remarks:

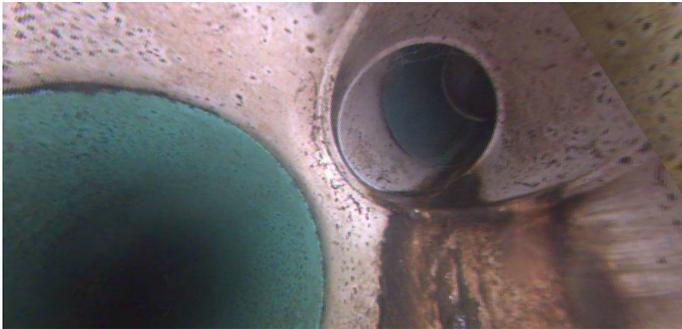
Code: **TF**
Description: **Tap Factory**

Distance (ft): **136.1**
Structural Grade: **0**
O&M Grade: **0**
Clock Start/From: **1**
Clock To:
1st Value: **4.000**
2nd Value:
Value Percent:
Continuous Index:
Within 8" of Joint: **YES**
Remarks:

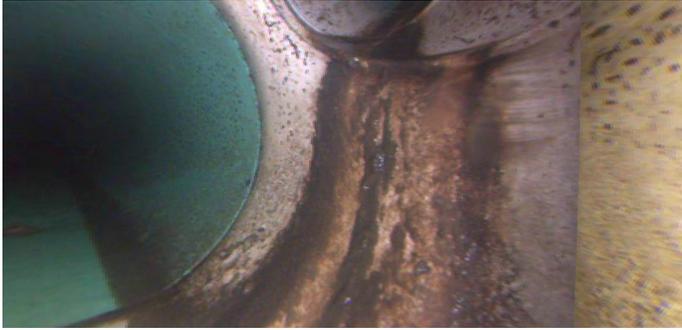
| Position | Code | Observation | Video (sec) | Grade |
|---|---|---|---|---|
| 136.1 | DAGS | Deposits Attached Grease | 390 | M 2 |

Code: **DAGS**
Description: **Deposits Attached Grease**

Distance (ft): **136.1**
Structural Grade: **0**
O&M Grade: **2**
Clock Start/From: **2**
Clock To: **5**
1st Value:
2nd Value:
Value Percent: **5.000**
Continuous Index:
Within 8" of Joint: **YES**
Remarks:

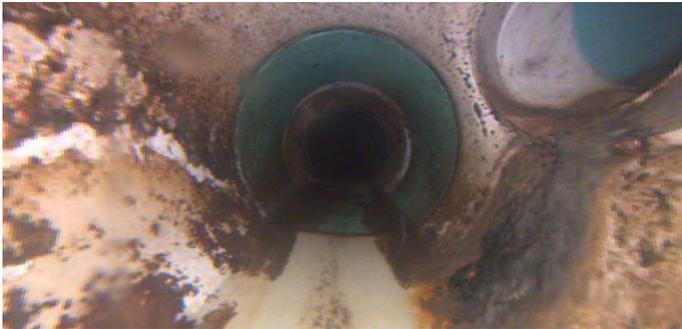
Code: **TF**
Description: **Tap Factory**

Distance (ft): **195.4**
Structural Grade: **0**
O&M Grade: **0**
Clock Start/From: **1**
Clock To:
1st Value: **4.000**
2nd Value:
Value Percent:
Continuous Index:
Within 8" of Joint: **YES**
Remarks:

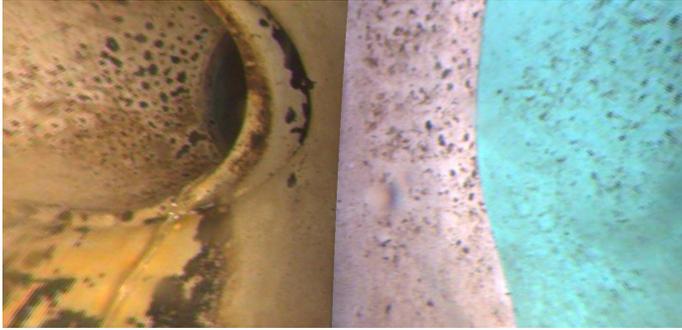
Code: **TFA**
Description: **Tap Factory Active**

Distance (ft): **198.7**
Structural Grade: **0**
O&M Grade: **0**
Clock Start/From: **10**
Clock To:
1st Value: **4.000**
2nd Value:
Value Percent:
Continuous Index:
Within 8" of Joint: **YES**
Remarks:

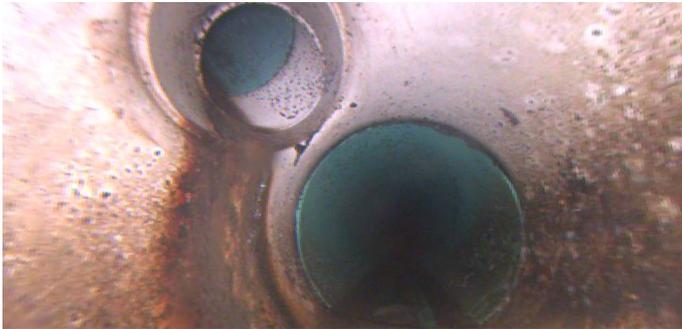
Code: **TF**
Description: **Tap Factory**

Distance (ft): **235.8**
Structural Grade: **0**
O&M Grade: **0**
Clock Start/From: **11**
Clock To:
1st Value: **4.000**
2nd Value:
Value Percent:
Continuous Index:
Within 8" of Joint: **YES**
Remarks:

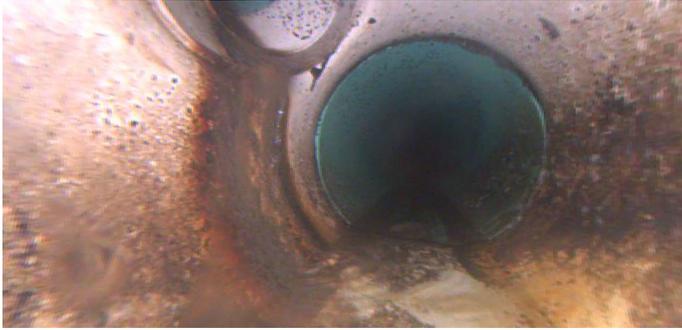
| Position | Code | Observation | Video (sec) | Grade |
|---|---|---|---|---|
| 235.8 | DAZ | Deposits Attached Other | 638 | M 2 |

Code: **DAZ**
Description: **Deposits Attached Other**

Distance (ft): **235.8**
Structural Grade: **0**
O&M Grade: **2**
Clock Start/From: **7**
Clock To: **5**
1st Value:
2nd Value:
Value Percent: **5.000**
Continuous Index:
Within 8" of Joint: **NO**
Remarks:

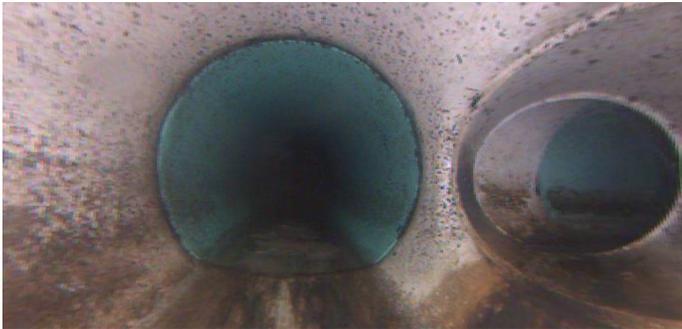
Code: **TF**
Description: **Tap Factory**

Distance (ft): **267.6**
Structural Grade: **0**
O&M Grade: **0**
Clock Start/From: **3**
Clock To:
1st Value: **4.000**
2nd Value:
Value Percent:
Continuous Index:
Within 8" of Joint: **YES**
Remarks:

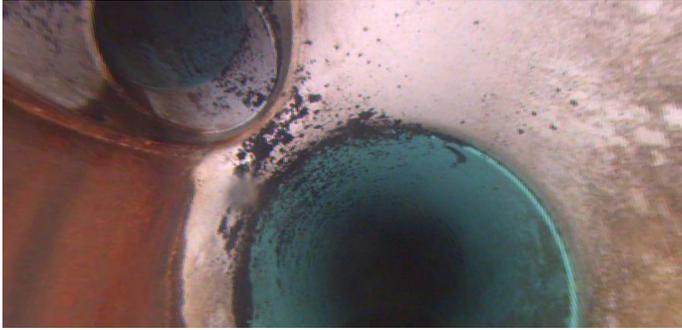
Code: **TF**
Description: **Tap Factory**

Distance (ft): **273.6**
Structural Grade: **0**
O&M Grade: **0**
Clock Start/From: **11**
Clock To:
1st Value: **4.000**
2nd Value:
Value Percent:
Continuous Index:
Within 8" of Joint: **YES**
Remarks:

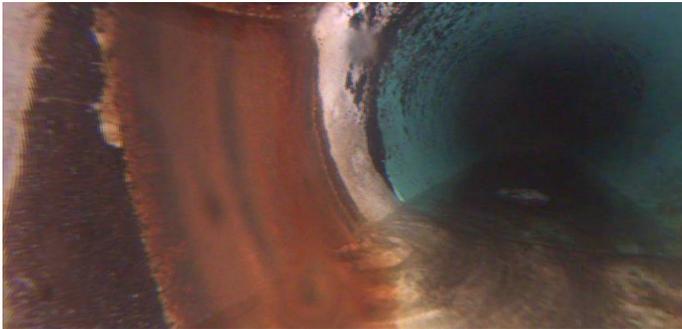
| Position | Code | Observation | Video (sec) | Grade |
|---|---|---|---|---|
| 273.6 | IS | Infil Stain | 748 | NA |

Code: **IS**
Description: **Infil Stain**

Distance (ft): **273.6**
Structural Grade: **0**
O&M Grade: **0**
Clock Start/From: **7**
Clock To: **10**
1st Value:
2nd Value:
Value Percent:
Continuous Index:
Within 8" of Joint:
Remarks:

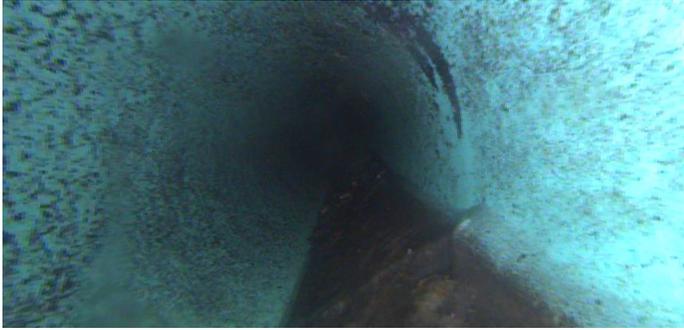
| Comment: | R_M at 274 ft nothing visible .Flow direction wrong | | |

Code: **MSA**
Description: **Abandoned Survey**

Distance (ft): **276.1**
Structural Grade: **0**
O&M Grade: **0**
Clock Start/From:
Clock To:
1st Value:
2nd Value:
Value Percent:
Continuous Index:
Within 8" of Joint: **NO**
Remarks: **camera flipped**
