Profile/Photo Observation Report

Date:	11/08/2021	Weather:		Coding:	PACP 7.0
Pipe Length (ft):	294.2	Owner:	City of Hobart	Pre Clean:	Heavy Cleaning
P.O.#:	YES502259	Surveyor:	Steven Bucklin	PSR:	P-505-045-044
Customer:	City of Hobart, IN (Red	Clean Date:	11/08/2021	Shape:	C

Street:	South Virginia Street	Flow Control:	Not Controlled
City:	City of Hobart	Year Renewed:	
Location:	Local rural streets with light traffic, t	Tape/Media #:	
Purpose:	Routine Assessment	Dia/Height:	12"
Use:	Sanitary Sewage Pipe	Material:	PVC
Drain Area:		Lining:	None
Category:	NA		
Comment:			
Location Details:		Direction of Survey:	Downstream
US MH:	M-505-044	DS MH:	M-505-045
		Total Length Surveyed (ft):	294.2

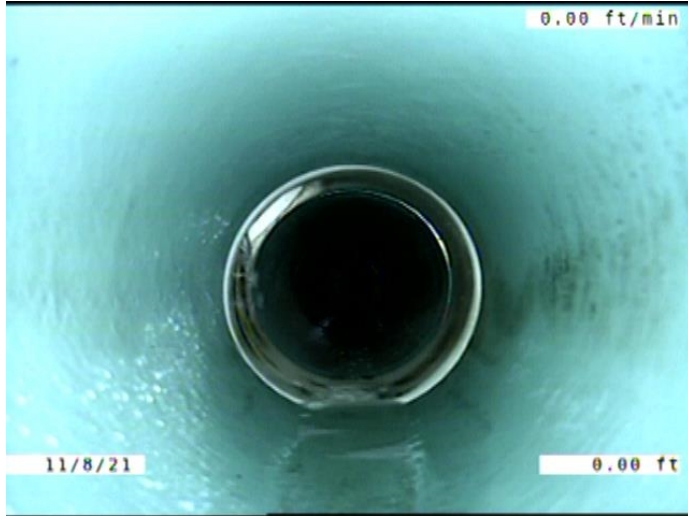
Code: **MWL**
Description: **Miscellaneous Water Level**

Distance (ft): **.0**
Structural Grade: **0**
O&M Grade: **0**
Clock Start/From:
Clock To:
1st Value:
2nd Value:
Value Percent: **5.000**
Continuous Index:
Within 8" of Joint: **NO**
Remarks:

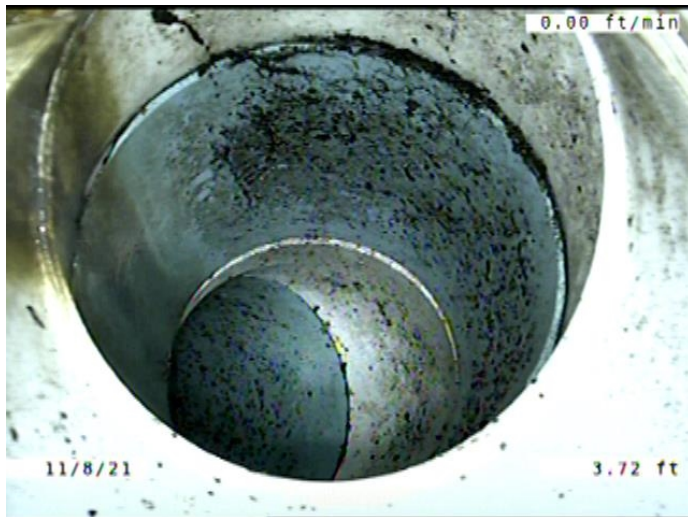
Code: **TFA**
Description: **Tap Factory Activity**

Distance (ft): **3.7**
Structural Grade: **0**
O&M Grade: **0**
Clock Start/From: **11**
Clock To:
1st Value: **4.000**
2nd Value:
Value Percent:
Continuous Index:
Within 8" of Joint: **YES**
Remarks:

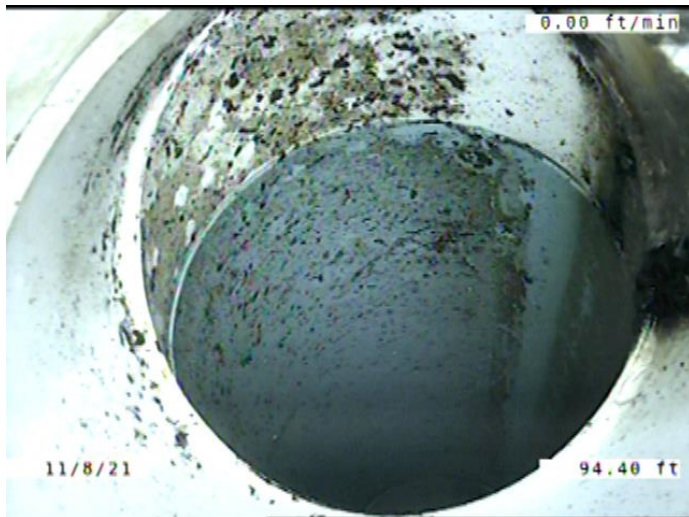
Code: **TFA**
 Description: **Tap Factory Activity**

Distance (ft): **94.4**
 Structural Grade: **0**
 O&M Grade: **0**
 Clock Start/From: **1**
 Clock To:
 1st Value: **4.000**
 2nd Value:
 Value Percent:
 Continuous Index:
 Within 8" of Joint: **YES**
 Remarks:

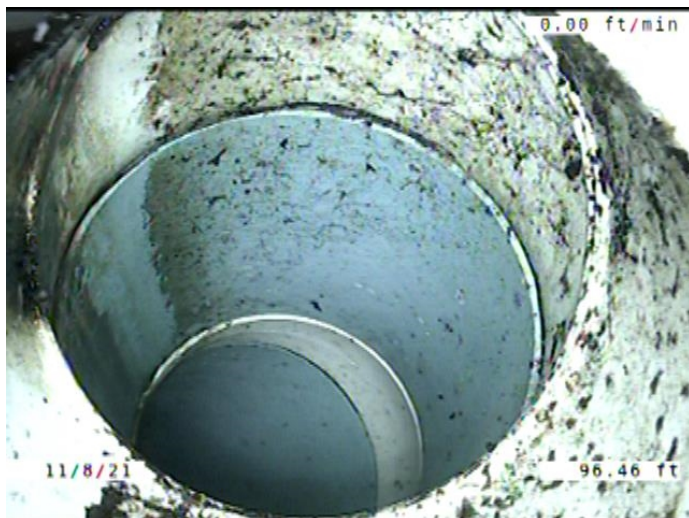
Code: **TFA**
 Description: **Tap Factory Activity**

Distance (ft): **96.5**
 Structural Grade: **0**
 O&M Grade: **0**
 Clock Start/From: **10**
 Clock To:
 1st Value: **4.000**
 2nd Value:
 Value Percent:
 Continuous Index:
 Within 8" of Joint: **YES**
 Remarks:

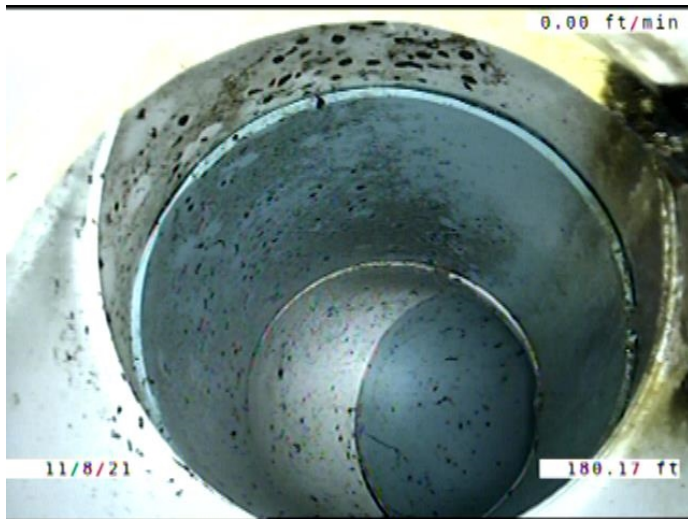
Code: **TF**
Description: **Tap Factory**

Distance (ft): **180.2**
Structural Grade: **0**
O&M Grade: **0**
Clock Start/From: **1**
Clock To:
1st Value: **4.000**
2nd Value:
Value Percent:
Continuous Index:
Within 8" of Joint: **YES**
Remarks: **CONSTANTLY RUNNING WATER.**

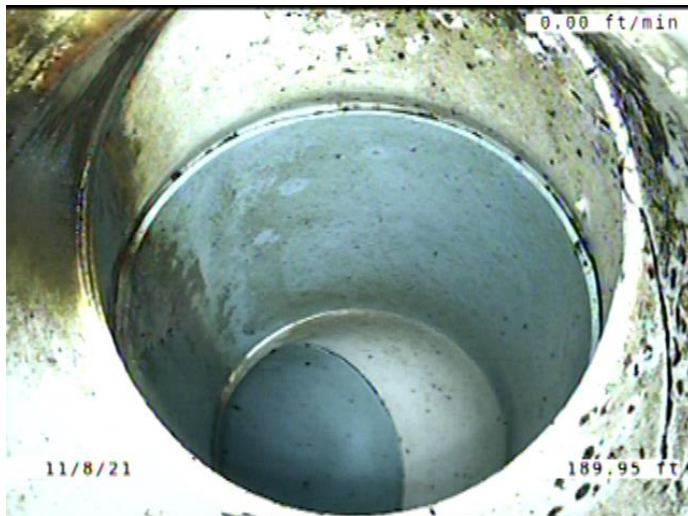
Code: **TF**
Description: **Tap Factory**

Distance (ft): **190.0**
Structural Grade: **0**
O&M Grade: **0**
Clock Start/From: **11**
Clock To:
1st Value: **4.000**
2nd Value:
Value Percent:
Continuous Index:
Within 8" of Joint: **YES**
Remarks:

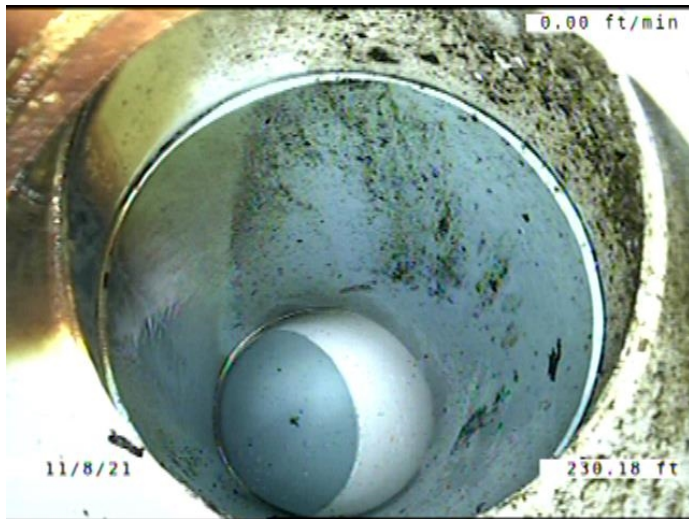
Code: **TF**
Description: **Tap Factory**

Distance (ft): **230.2**
Structural Grade: **0**
O&M Grade: **0**
Clock Start/From: **11**
Clock To:
1st Value: **4.000**
2nd Value:
Value Percent:
Continuous Index:
Within 8" of Joint: **YES**
Remarks:

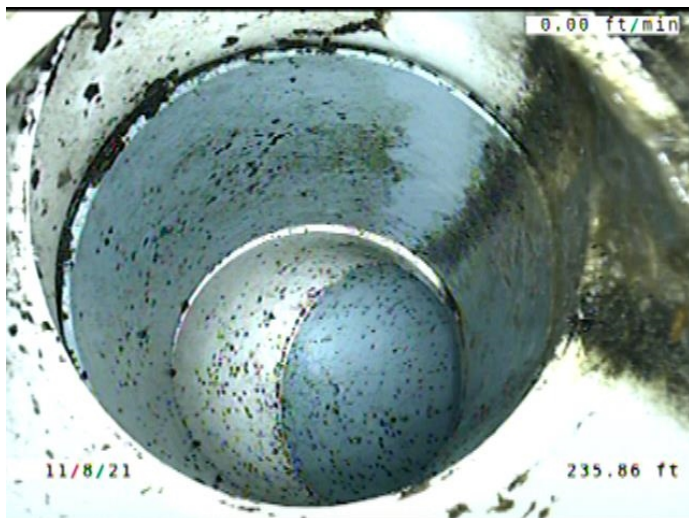
Code: **TF**
Description: **Tap Factory**

Distance (ft): **235.9**
Structural Grade: **0**
O&M Grade: **0**
Clock Start/From: **1**
Clock To:
1st Value: **4.000**
2nd Value:
Value Percent:
Continuous Index:
Within 8" of Joint: **YES**
Remarks:

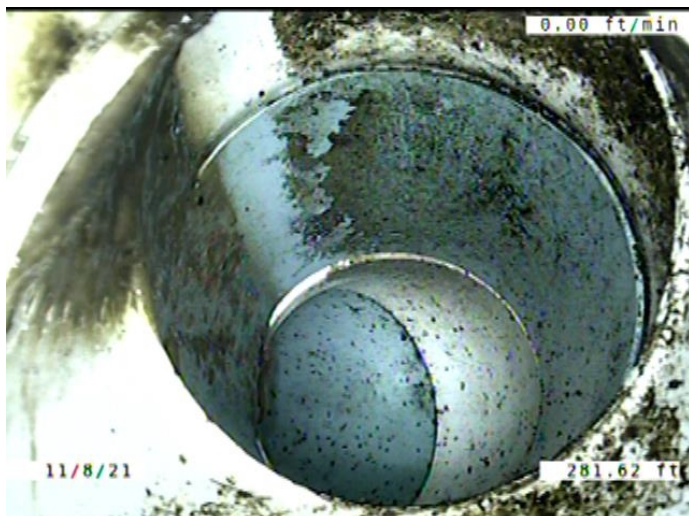
Code: **TF**
 Description: **Tap Factory**

Distance (ft): **281.6**
 Structural Grade: **0**
 O&M Grade: **0**
 Clock Start/From: **11**
 Clock To:
 1st Value: **4.000**
 2nd Value:
 Value Percent:
 Continuous Index:
 Within 8" of Joint: **YES**
 Remarks:
