Profile/Photo Observation Report

Date:	11/08/2021	Weather:		Coding:	PACP 7.0
Pipe Length (ft):	294.2	Owner:	City of Hobart	Pre Clean:	Heavy Cleaning
P.O.#:	YES502259	Surveyor:	Steven Bucklin	PSR:	P-505-045-044
Customer:	City of Hobart, IN (Red	Clean Date:	11/08/2021	Shape:	C

Street:	South Virginia Street	Flow Control:	Not Controlled
City:	City of Hobart	Year Renewed:	
Location:	Local rural streets with light traffic, t	Tape/Media #:	
Purpose:	Routine Assessment	Dia/Height:	12"
Use:	Sanitary Sewage Pipe	Material:	PVC
Drain Area:		Lining:	None
Category:	NA		
Comment:			
Location Details:		Direction of Survey:	Downstream
US MH:	M-505-044	DS MH:	M-505-045
		Total Length Surveyed (ft):	294.2

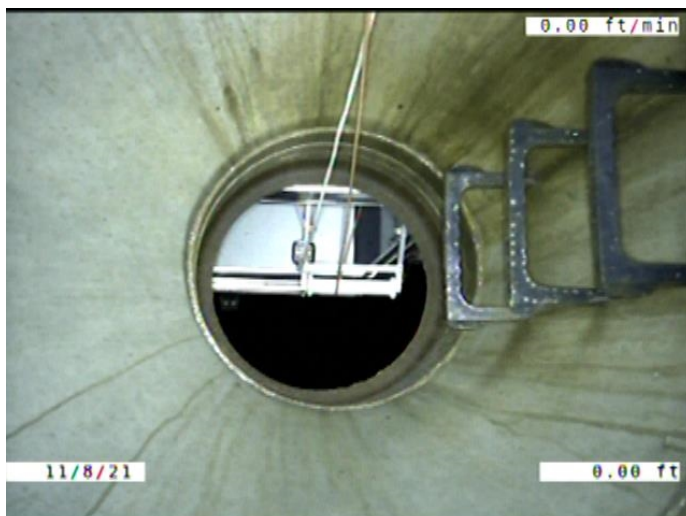
Code: **AMH**
 Description: **Manhole**

Distance (ft): **.0**
 Structural Grade: **0**
 O&M Grade: **0**
 Clock Start/From:
 Clock To:
 1st Value:
 2nd Value:
 Value Percent:
 Continuous Index:
 Within 8" of Joint: **NO**
 Remarks: **M-505-044**

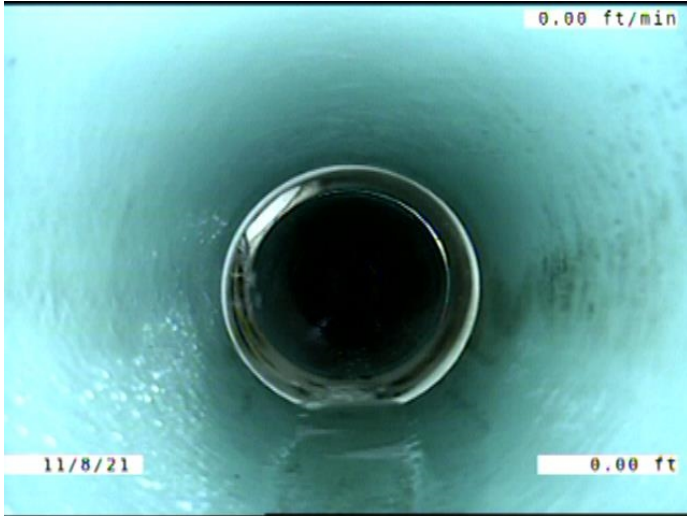
Code: **MWL**
Description: **Miscellaneous Water Level**

Distance (ft): **.0**
Structural Grade: **0**
O&M Grade: **0**
Clock Start/From:
Clock To:
1st Value:
2nd Value:
Value Percent: **5.000**
Continuous Index:
Within 8" of Joint: **NO**
Remarks:

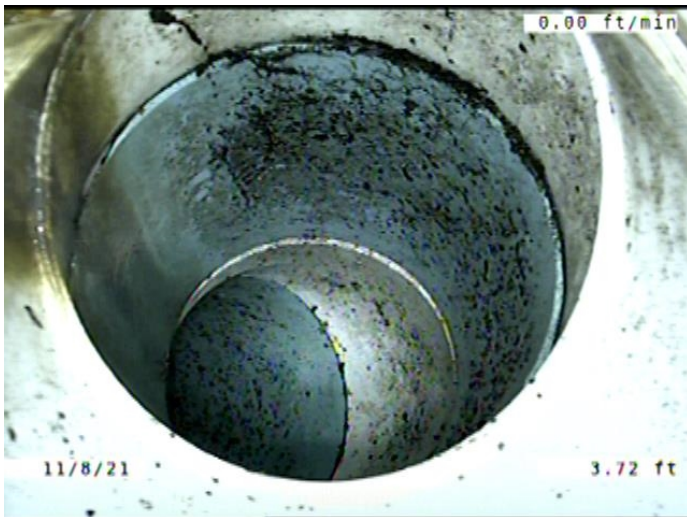
Code: **TFA**
Description: **Tap Factory Activity**

Distance (ft): **3.7**
Structural Grade: **0**
O&M Grade: **0**
Clock Start/From: **11**
Clock To:
1st Value: **4.000**
2nd Value:
Value Percent:
Continuous Index:
Within 8" of Joint: **YES**
Remarks:

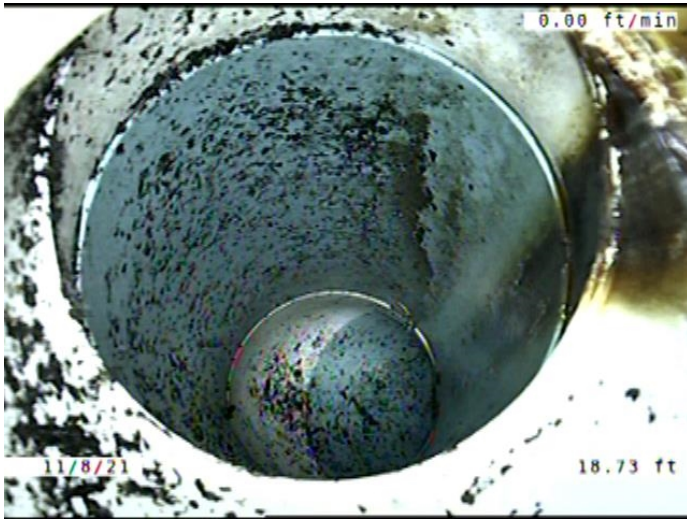
Code: **TF**
Description: **Tap Factory**

Distance (ft): **18.7**
Structural Grade: **0**
O&M Grade: **0**
Clock Start/From: **2**
Clock To:
1st Value: **4.000**
2nd Value:
Value Percent:
Continuous Index:
Within 8" of Joint: **YES**
Remarks: **CONSTANTLY RUNNING WATER.**

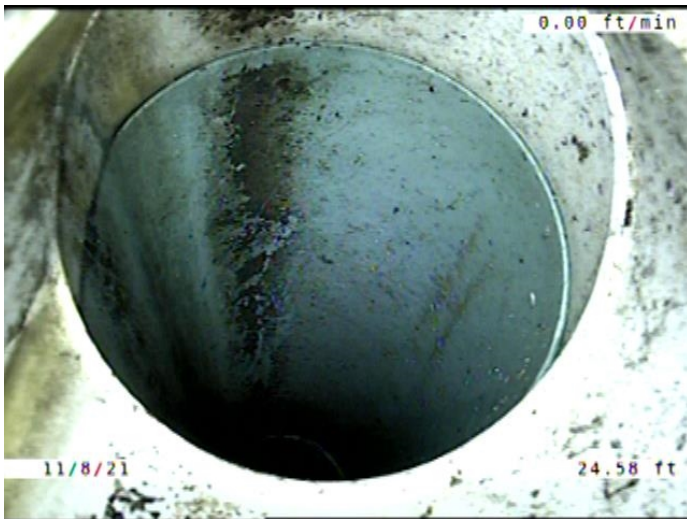
Code: **TF**
Description: **Tap Factory**

Distance (ft): **24.6**
Structural Grade: **0**
O&M Grade: **0**
Clock Start/From: **9**
Clock To:
1st Value: **4.000**
2nd Value:
Value Percent:
Continuous Index:
Within 8" of Joint: **YES**
Remarks:

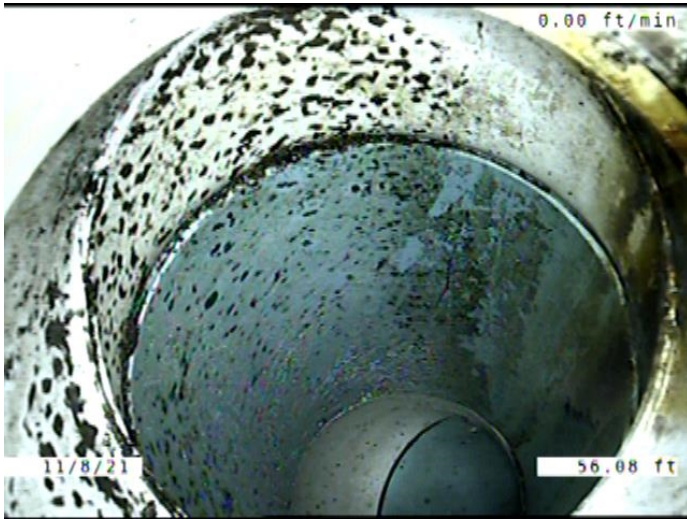
Code: **TF**
Description: **Tap Factory**

Distance (ft): **56.1**
Structural Grade: **0**
O&M Grade: **0**
Clock Start/From: **1**
Clock To:
1st Value: **4.000**
2nd Value:
Value Percent:
Continuous Index:
Within 8" of Joint: **YES**
Remarks: **CONSTANTLY RUNNING WATER.**

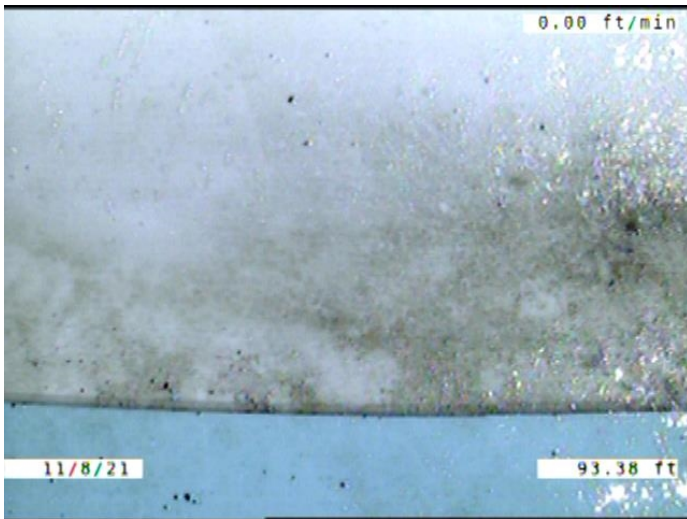
Code: **JAM**
Description: **Joint Angular Medium**

Distance (ft): **93.4**
Structural Grade: **3**
O&M Grade: **0**
Clock Start/From:
Clock To:
1st Value:
2nd Value:
Value Percent:
Continuous Index:
Within 8" of Joint: **NO**
Remarks:

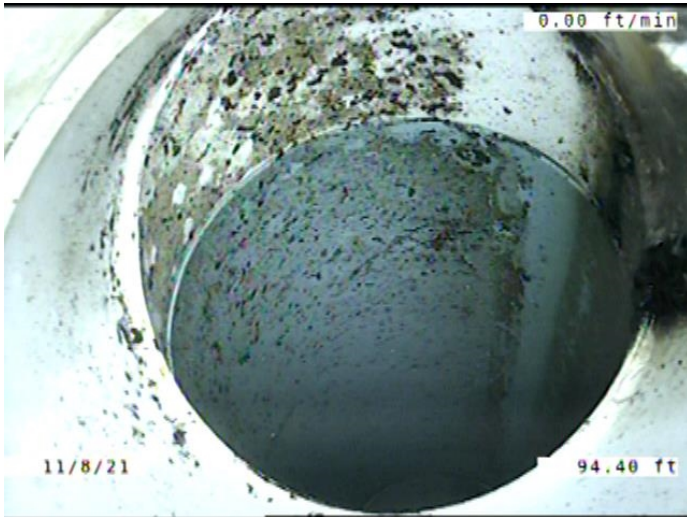
Code: **TFA**
 Description: **Tap Factory Activity**

Distance (ft): **94.4**
 Structural Grade: **0**
 O&M Grade: **0**
 Clock Start/From: **1**
 Clock To:
 1st Value: **4.000**
 2nd Value:
 Value Percent:
 Continuous Index:
 Within 8" of Joint: **YES**
 Remarks:

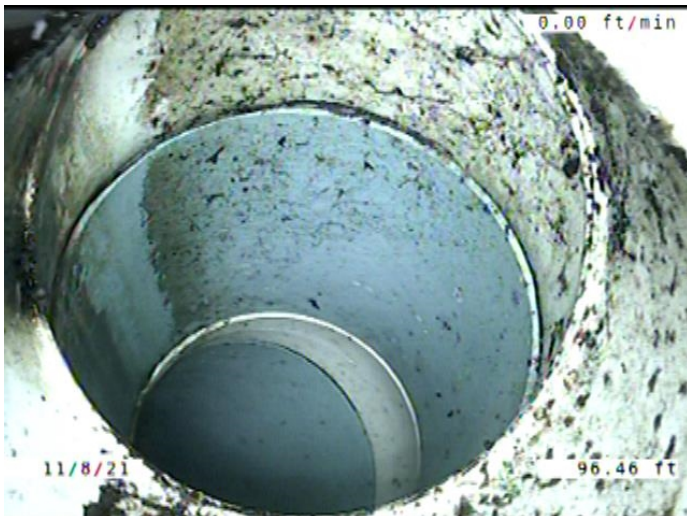
Code: **TFA**
 Description: **Tap Factory Activity**

Distance (ft): **96.5**
 Structural Grade: **0**
 O&M Grade: **0**
 Clock Start/From: **10**
 Clock To:
 1st Value: **4.000**
 2nd Value:
 Value Percent:
 Continuous Index:
 Within 8" of Joint: **YES**
 Remarks:

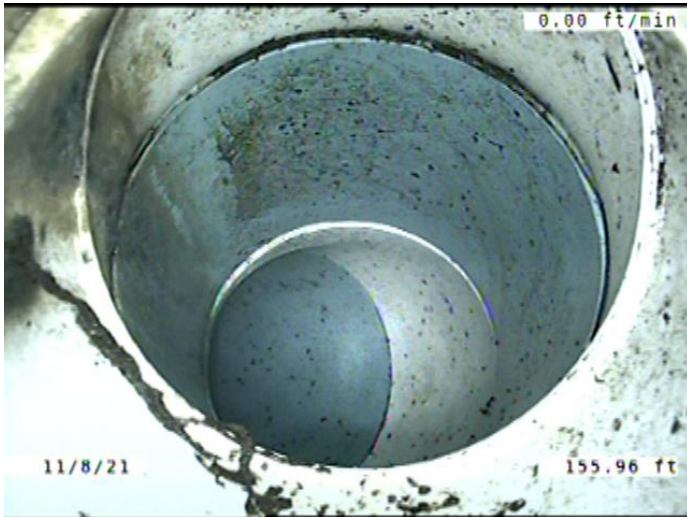
Code: **TFA**
 Description: **Tap Factory Activity**

Distance (ft): **156.0**
 Structural Grade: **0**
 O&M Grade: **0**
 Clock Start/From: **10**
 Clock To:
 1st Value: **4.000**
 2nd Value:
 Value Percent:
 Continuous Index:
 Within 8" of Joint: **YES**
 Remarks:

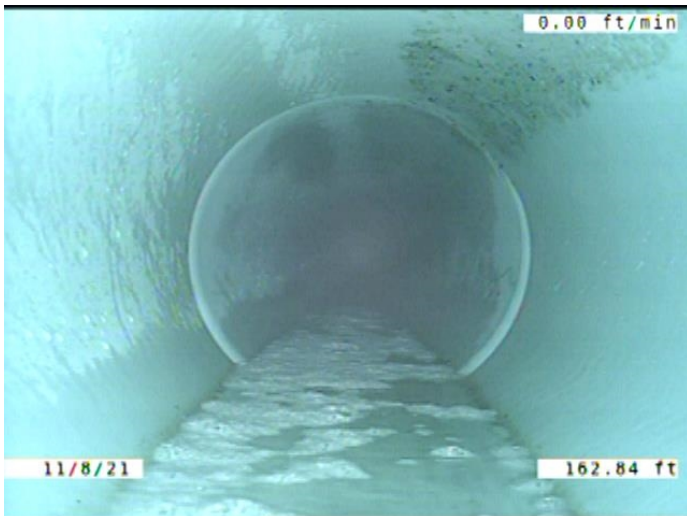
Code: **MWLS**
 Description: **Miscellaneous Water Level Sag**

Distance (ft): **162.8**
 Structural Grade: **2**
 O&M Grade: **0**
 Clock Start/From:
 Clock To:
 1st Value:
 2nd Value:
 Value Percent: **5.000**
 Continuous Index:
 Within 8" of Joint: **NO**
 Remarks:

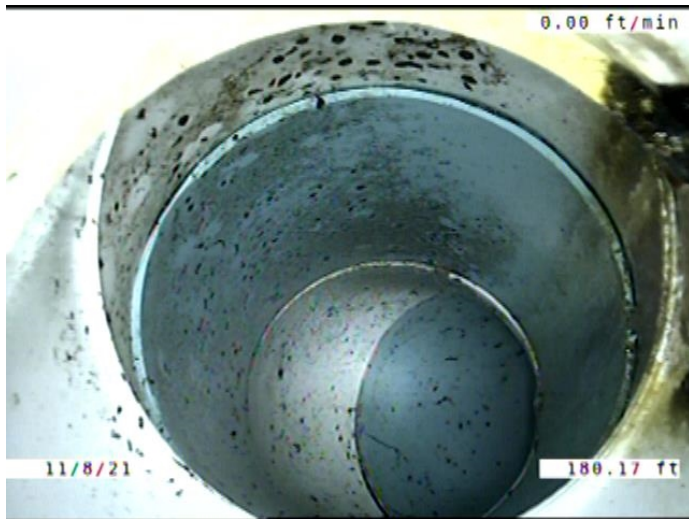
Code: **TF**
Description: **Tap Factory**

Distance (ft): **180.2**
Structural Grade: **0**
O&M Grade: **0**
Clock Start/From: **1**
Clock To:
1st Value: **4.000**
2nd Value:
Value Percent:
Continuous Index:
Within 8" of Joint: **YES**
Remarks: **CONSTANTLY RUNNING WATER.**

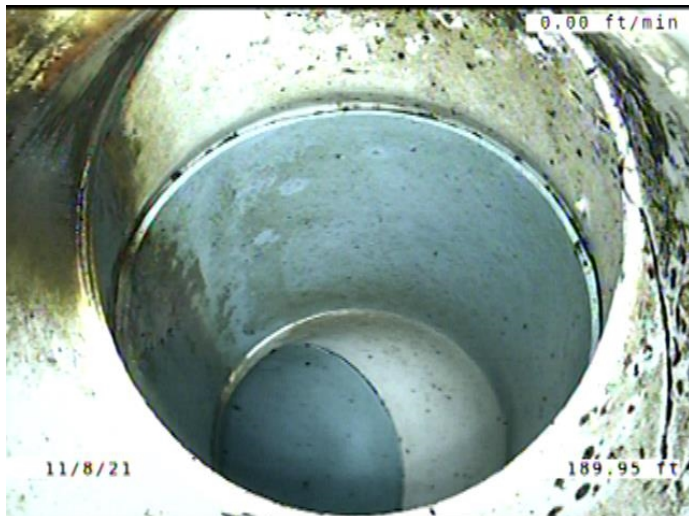
Code: **TF**
Description: **Tap Factory**

Distance (ft): **190.0**
Structural Grade: **0**
O&M Grade: **0**
Clock Start/From: **11**
Clock To:
1st Value: **4.000**
2nd Value:
Value Percent:
Continuous Index:
Within 8" of Joint: **YES**
Remarks:

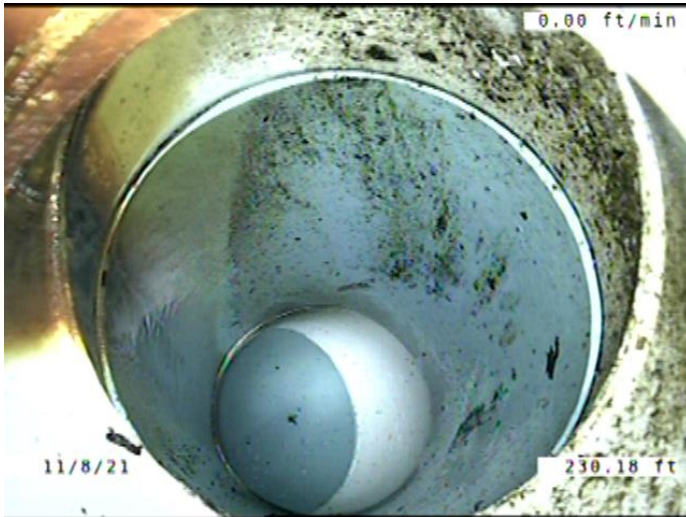
Code: **TF**
Description: **Tap Factory**

Distance (ft): **230.2**
Structural Grade: **0**
O&M Grade: **0**
Clock Start/From: **11**
Clock To:
1st Value: **4.000**
2nd Value:
Value Percent:
Continuous Index:
Within 8" of Joint: **YES**
Remarks:

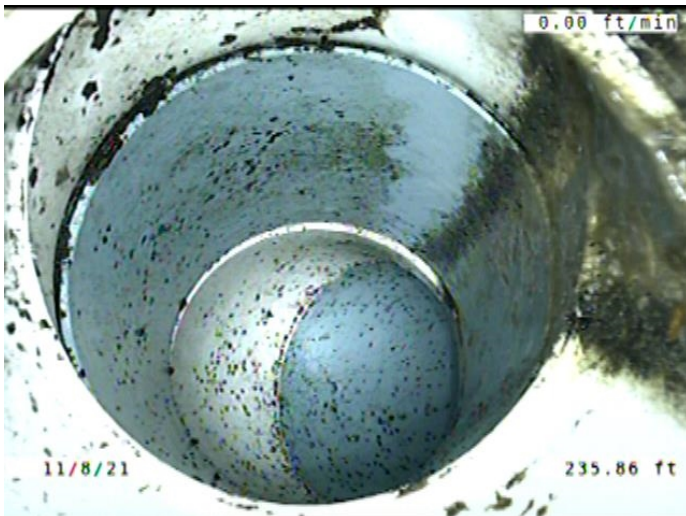
Code: **TF**
Description: **Tap Factory**

Distance (ft): **235.9**
Structural Grade: **0**
O&M Grade: **0**
Clock Start/From: **1**
Clock To:
1st Value: **4.000**
2nd Value:
Value Percent:
Continuous Index:
Within 8" of Joint: **YES**
Remarks:

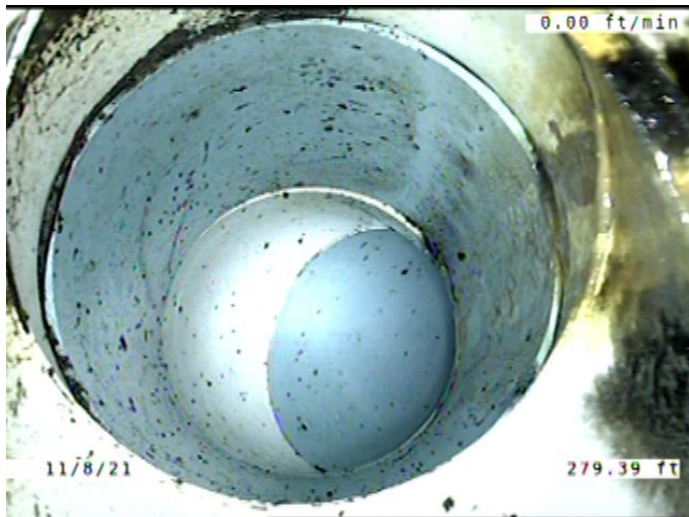
Code: **TF**
 Description: **Tap Factory**

Distance (ft): **279.4**
 Structural Grade: **0**
 O&M Grade: **0**
 Clock Start/From: **2**
 Clock To:
 1st Value: **4.000**
 2nd Value:
 Value Percent:
 Continuous Index:
 Within 8" of Joint: **YES**
 Remarks: **CONSTANTLY RUNNING WATER.**

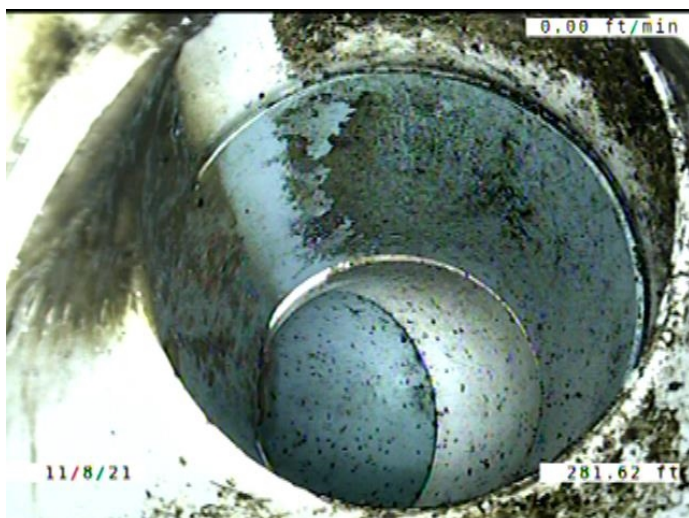
Code: **TF**
 Description: **Tap Factory**

Distance (ft): **281.6**
 Structural Grade: **0**
 O&M Grade: **0**
 Clock Start/From: **11**
 Clock To:
 1st Value: **4.000**
 2nd Value:
 Value Percent:
 Continuous Index:
 Within 8" of Joint: **YES**
 Remarks:

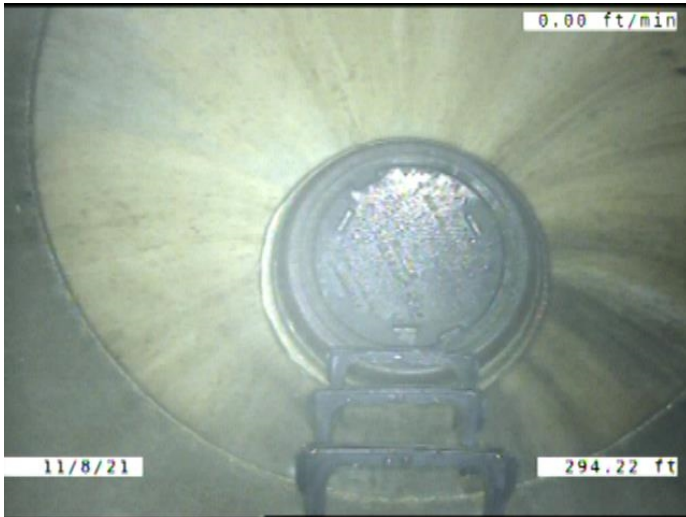
Code:	AMH
Description:	Manhole
Distance (ft):	294.2
Structural Grade:	0
O&M Grade:	0
Clock Start/From:	
Clock To:	
1st Value:	
2nd Value:	
Value Percent:	
Continuous Index:	
Within 8" of Joint:	NO
Remarks:	M-505-045
