Profile/Photo Observation Report

Date:	04/16/2018	Weather:		Coding:	PACP 6.0
Pipe Length (ft):		Owner:	City of Hobart	Pre Clean:	No Pre-Cleaning
P.O.#:	54-4	Surveyor:	M. Pielacha	PSR:	M-505-046-M-505-043
Customer:	City of Hobart	Clean Date:		Shape:	C

Street:	Colorado Street	Flow Control:	Not Controlled
City:	Hobart, IN	Year Renewed:	
Location:	Light Highway	Tape/Media #:	DEP 54
Purpose:	Routine Assessment	Dia/Height:	18"
Use:	Sanitary	Material:	VCP
Drain Area:		Lining:

US MH: **M-505-046** DS MH: **M-505-043** Total Length Surveyed (ft): **163.9**

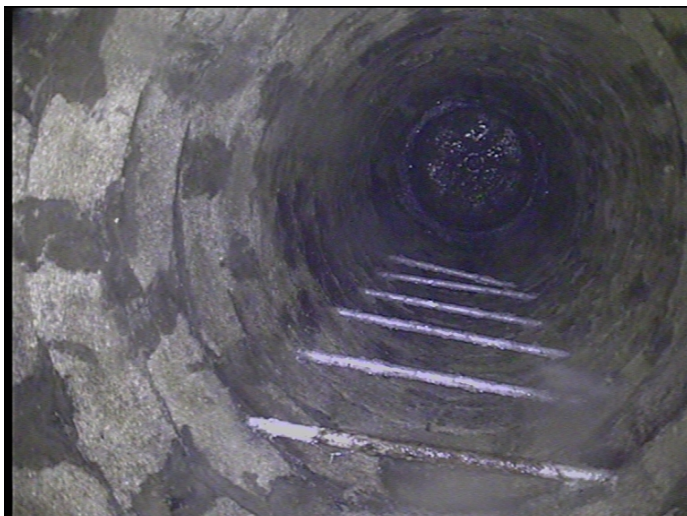
Code: **AMH**
 Description: **Manhole**

Distance (ft): **.0**
 Structural Grade: **0**
 O&M Grade: **0**
 Clock Start/From:
 Clock To:
 1st Value:
 2nd Value:
 Value Percent:
 Continuous Index:
 Within 8" of Joint: **NO**
 Remarks: **M-505-046**

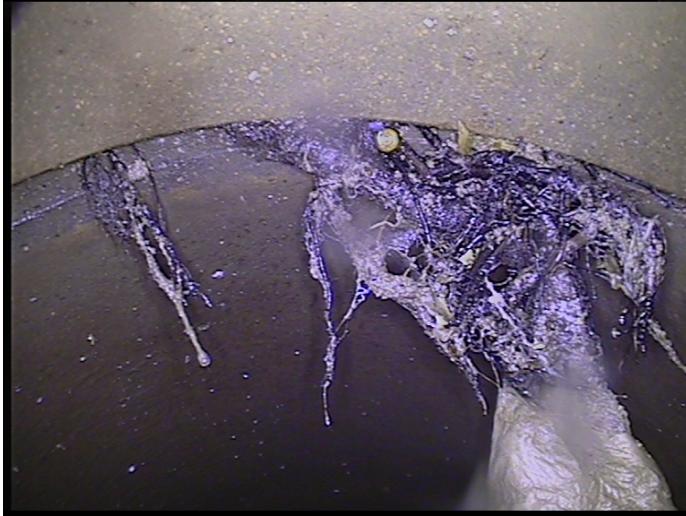
Code: **RMJ**
Description: **Roots Medium Joint**

Distance (ft): **56.9**
Structural Grade: **0**
O&M Grade: **3**
Clock Start/From: **10**
Clock To: **2**
1st Value:
2nd Value:
Value Percent: **10.000**
Continuous Index: **S01**
Within 8" of Joint: **YES**
Remarks:

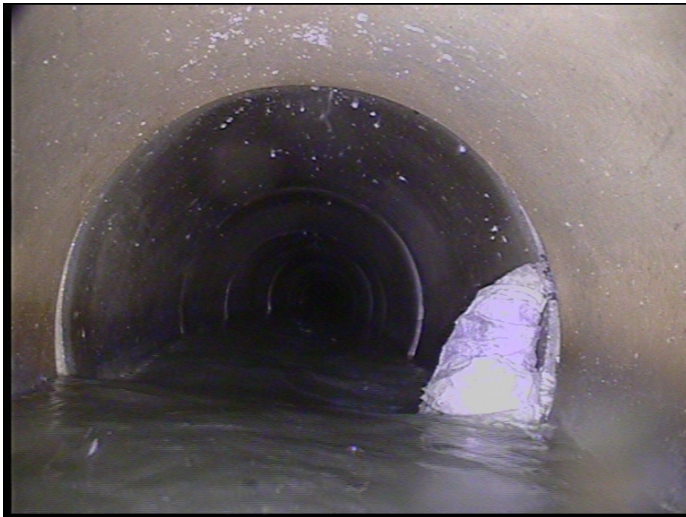
Code: **RMJ**
Description: **Roots Medium Joint**

Distance (ft): **73.5**
Structural Grade: **0**
O&M Grade: **3**
Clock Start/From: **10**
Clock To: **2**
1st Value:
2nd Value:
Value Percent: **10.000**
Continuous Index: **F01**
Within 8" of Joint: **YES**
Remarks:
