Profile/Photo Observation Report

Street:	Colorado Street	Flow Control:	Not Controlled
City:	Hobart, IN	Year Renewed:	
Location:	Light Highway	Tape/Media #:	DEP 54
Purpose:	Routine Assessment	Dia/Height:	18"
Use:	Sanitary	Material:	VCP
Drain Area:		Lining:	
Category:	NA		
Comment:

Location Details:		Direction of Survey:	Downstream
US MH:	M-505-046	DS MH:	M-505-043
		Total Length Surveyed (ft):	163.9

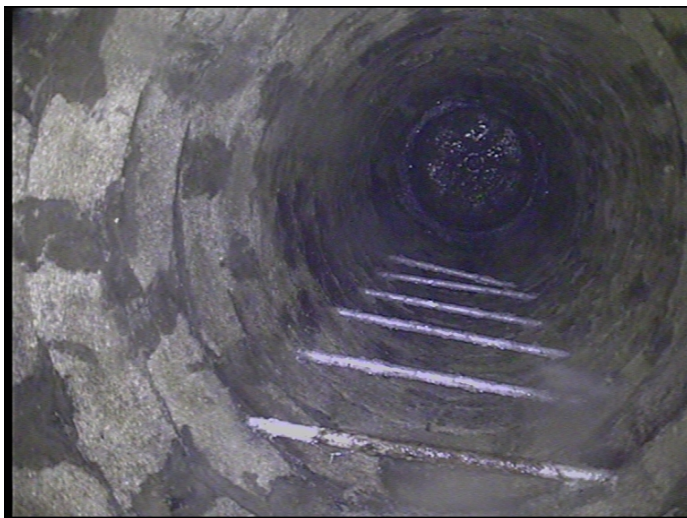
Code: **AMH**
 Description: **Manhole**

Distance (ft): **.0**
 Structural Grade: **0**
 O&M Grade: **0**
 Clock Start/From:
 Clock To:
 1st Value:
 2nd Value:
 Value Percent:
 Continuous Index:
 Within 8" of Joint: **NO**
 Remarks: **M-505-046**

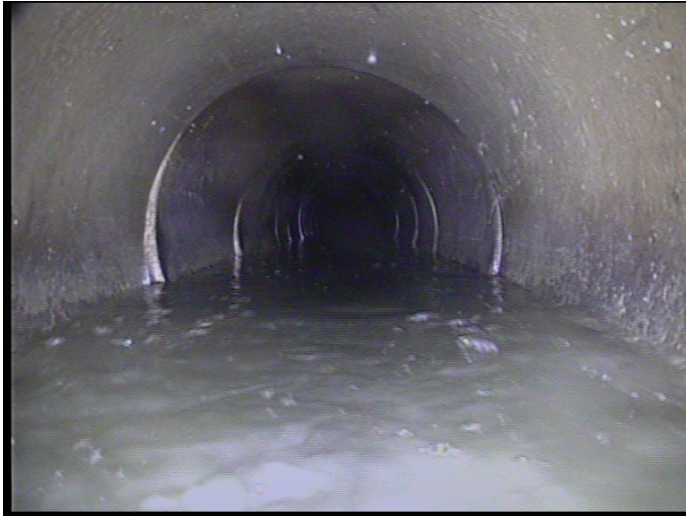
Code: **MWL**
Description: **Water Level**

Distance (ft): **.0**
Structural Grade: **0**
O&M Grade: **0**
Clock Start/From:
Clock To:
1st Value:
2nd Value:
Value Percent: **20.000**
Continuous Index:
Within 8" of Joint: **NO**
Remarks:

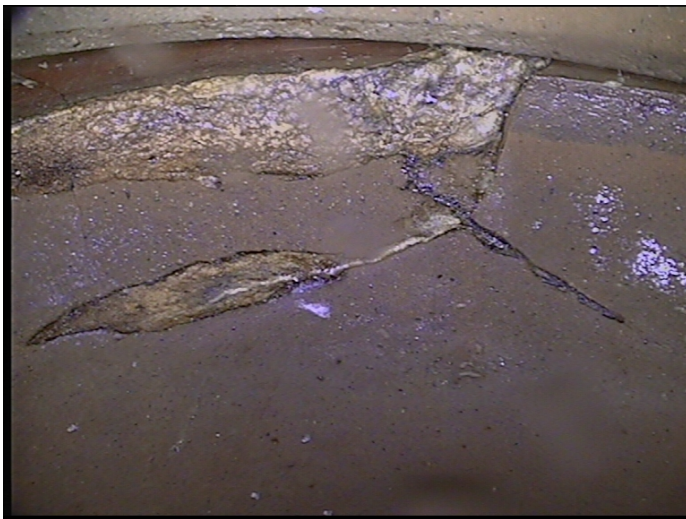
Code: **CC**
Description: **Crack Circumferential**

Distance (ft): **10.7**
Structural Grade: **1**
O&M Grade: **0**
Clock Start/From: **9**
Clock To: **11**
1st Value:
2nd Value:
Value Percent:
Continuous Index:
Within 8" of Joint: **YES**
Remarks:

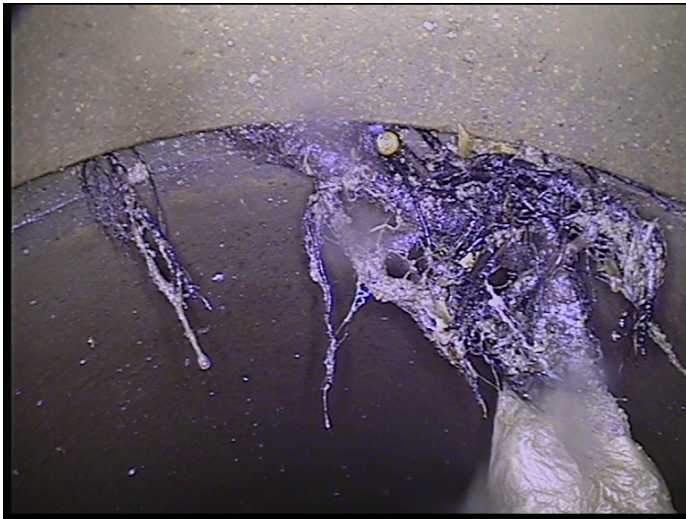
Code: **RMJ**
Description: **Roots Medium Joint**

Distance (ft): **56.9**
Structural Grade: **0**
O&M Grade: **3**
Clock Start/From: **10**
Clock To: **2**
1st Value:
2nd Value:
Value Percent: **10.000**
Continuous Index: **S01**
Within 8" of Joint: **YES**
Remarks:

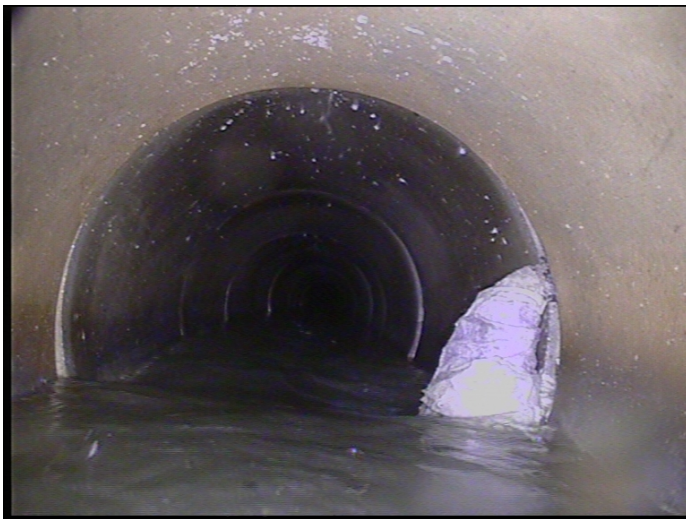
Code: **RMJ**
Description: **Roots Medium Joint**

Distance (ft): **73.5**
Structural Grade: **0**
O&M Grade: **3**
Clock Start/From: **10**
Clock To: **2**
1st Value:
2nd Value:
Value Percent: **10.000**
Continuous Index: **F01**
Within 8" of Joint: **YES**
Remarks:

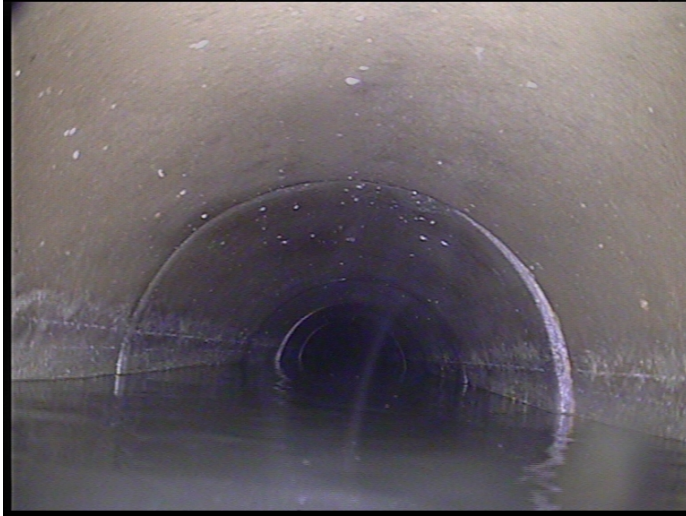
Code:	MWL
Description:	Water Level
Distance (ft):	120.2
Structural Grade:	0
O&M Grade:	0
Clock Start/From:	
Clock To:	
1st Value:	
2nd Value:	
Value Percent:	45.000
Continuous Index:	
Within 8" of Joint:	NO
Remarks:

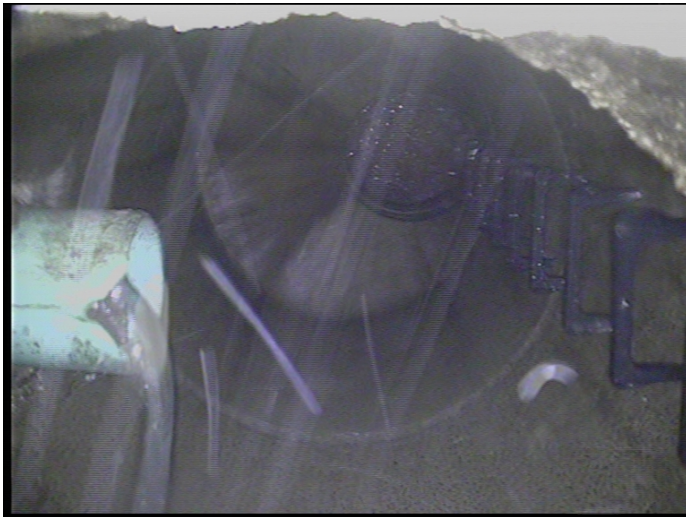
Code:	AMH
Description:	Manhole
Distance (ft):	163.9
Structural Grade:	0
O&M Grade:	0
Clock Start/From:	
Clock To:	
1st Value:	
2nd Value:	
Value Percent:	
Continuous Index:	
Within 8" of Joint:	NO
Remarks:	M-505-043
