Profile/Photo Observation Report

Street:	S DELAWARE ST	Flow Control:	Not Controlled
City:	Hobart, IN	Year Renewed:	
Location:	Light Highway	Tape/Media #:	
Purpose:	Routine Assessment	Dia/Height:	12"
Use:	Sanitary	Material:	PVC
Drain Area:	NA	Lining:	
Category:	NA		
Comment:	Flow direction wrong

Location Details:		Direction of Survey:	Downstream
US MH:	M-505-048	DS MH:	M-505-047
		Total Length Surveyed (ft):	248.7

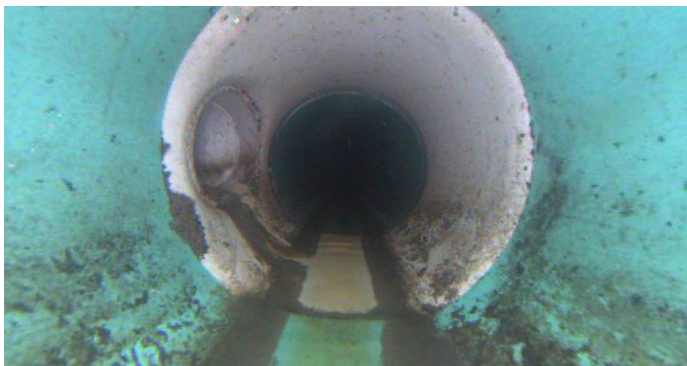
Code: **AMH**
 Description: **Manhole**
 Distance (ft): **.0**
 Structural Grade: **0**
 O&M Grade: **0**
 Clock Start/From:
 Clock To:
 1st Value:
 2nd Value:
 Value Percent:
 Continuous Index:
 Within 8" of Joint: **NO**
 Remarks: **M-505-048**

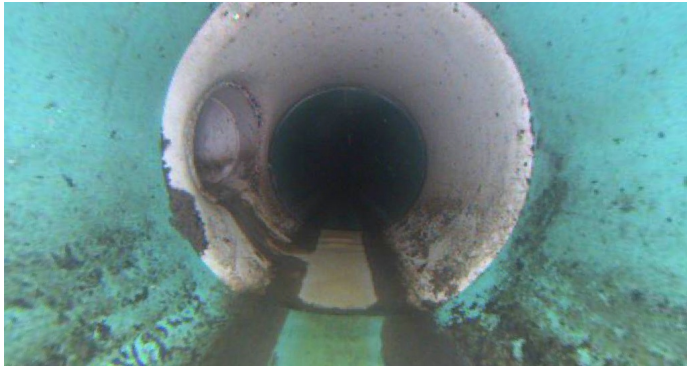
Code: **MWL**
Description: **Water Level**

Distance (ft): **.0**
Structural Grade: **0**
O&M Grade: **0**
Clock Start/From:
Clock To:
1st Value:
2nd Value:
Value Percent: **10.000**
Continuous Index:
Within 8" of Joint: **NO**
Remarks:

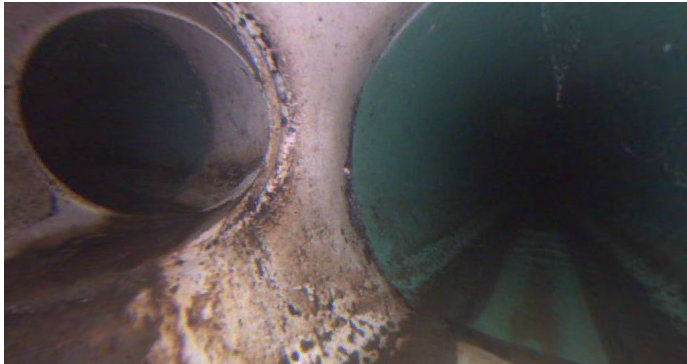
Code: **TF**
Description: **Tap Factory**

Distance (ft): **2.5**
Structural Grade: **0**
O&M Grade: **0**
Clock Start/From: **9**
Clock To:
1st Value: **4.000**
2nd Value:
Value Percent:
Continuous Index:
Within 8" of Joint:
Remarks:

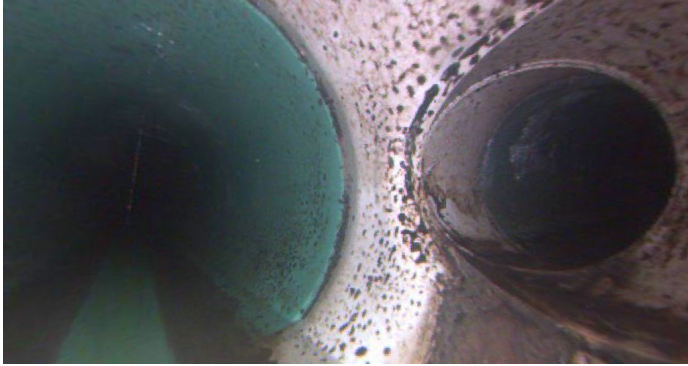
Code: **TF**
Description: **Tap Factory**

Distance (ft): **13.7**
Structural Grade: **0**
O&M Grade: **0**
Clock Start/From: **4**
Clock To:
1st Value: **4.000**
2nd Value:
Value Percent:
Continuous Index:
Within 8" of Joint:
Remarks:

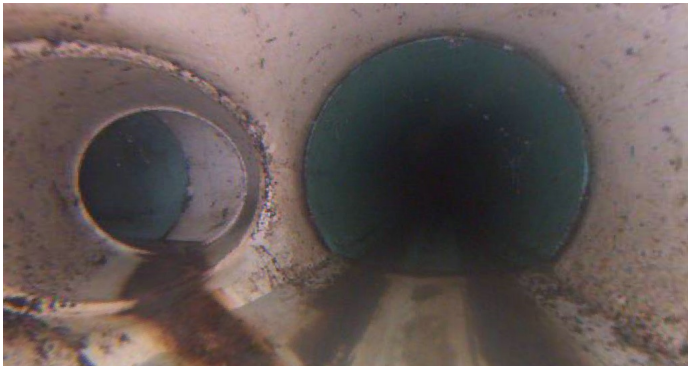
Code: **TF**
Description: **Tap Factory**

Distance (ft): **49.5**
Structural Grade: **0**
O&M Grade: **0**
Clock Start/From: **8**
Clock To:
1st Value: **4.000**
2nd Value:
Value Percent:
Continuous Index:
Within 8" of Joint:
Remarks:

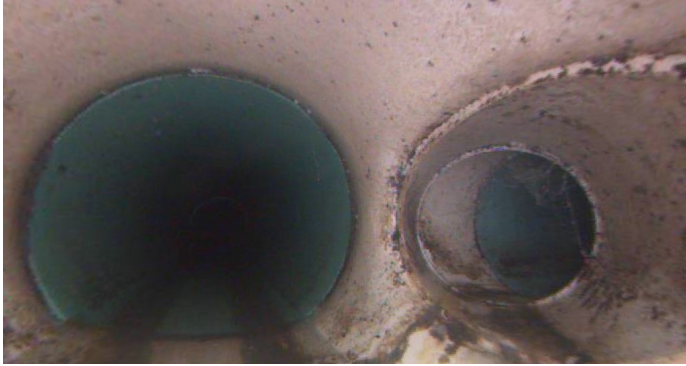
Code: **TF**
Description: **Tap Factory**

Distance (ft): **68.2**
Structural Grade: **0**
O&M Grade: **0**
Clock Start/From: **4**
Clock To:
1st Value: **4.000**
2nd Value:
Value Percent:
Continuous Index:
Within 8" of Joint:
Remarks:

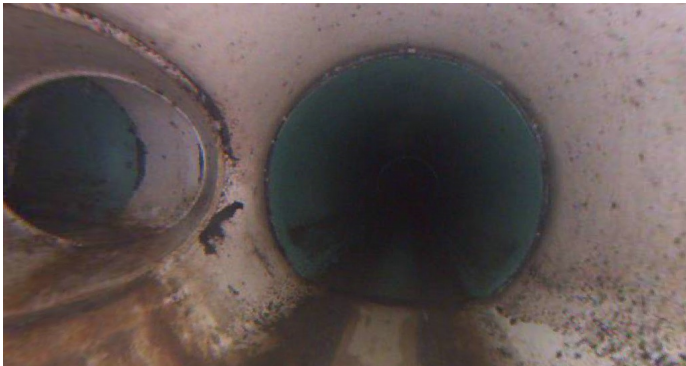
Code: **TF**
Description: **Tap Factory**

Distance (ft): **102.4**
Structural Grade: **0**
O&M Grade: **0**
Clock Start/From: **8**
Clock To:
1st Value: **4.000**
2nd Value:
Value Percent:
Continuous Index:
Within 8" of Joint:
Remarks:

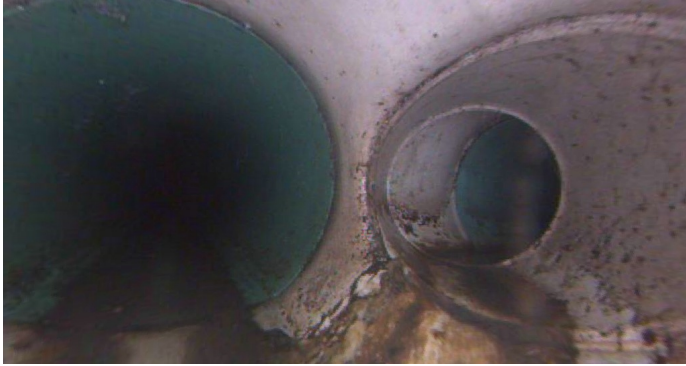
Code: **TF**
Description: **Tap Factory**

Distance (ft): **113.9**
Structural Grade: **0**
O&M Grade: **0**
Clock Start/From: **4**
Clock To:
1st Value: **4.000**
2nd Value:
Value Percent:
Continuous Index:
Within 8" of Joint:
Remarks:

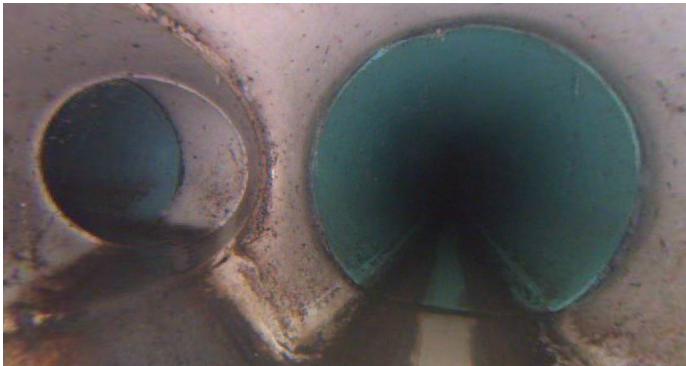
Code: **TF**
Description: **Tap Factory**

Distance (ft): **154.2**
Structural Grade: **0**
O&M Grade: **0**
Clock Start/From: **8**
Clock To:
1st Value: **4.000**
2nd Value:
Value Percent:
Continuous Index:
Within 8" of Joint:
Remarks:

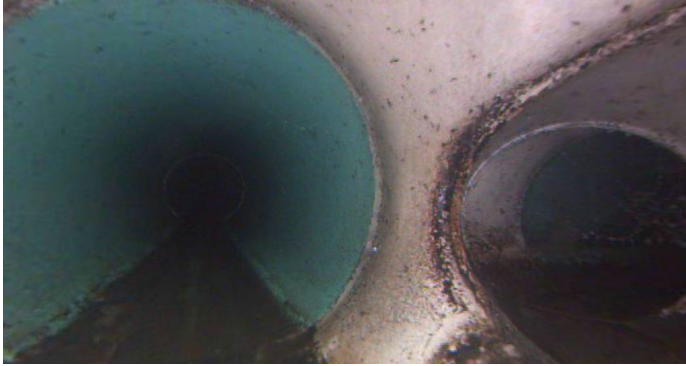
Code: **TF**
Description: **Tap Factory**

Distance (ft): **163.0**
Structural Grade: **0**
O&M Grade: **0**
Clock Start/From: **4**
Clock To:
1st Value: **4.000**
2nd Value:
Value Percent:
Continuous Index:
Within 8" of Joint:
Remarks:

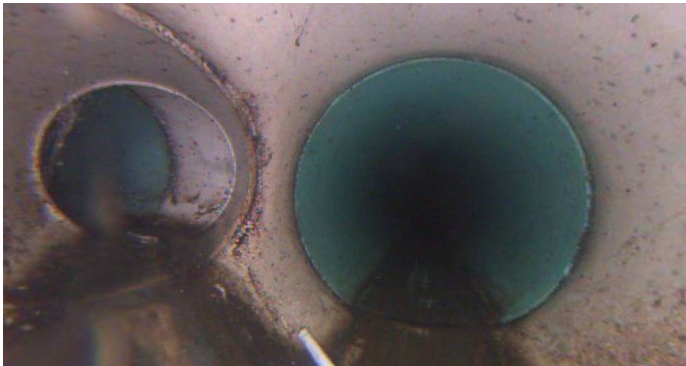
Code: **TF**
Description: **Tap Factory**

Distance (ft): **204.7**
Structural Grade: **0**
O&M Grade: **0**
Clock Start/From: **8**
Clock To:
1st Value: **4.000**
2nd Value:
Value Percent:
Continuous Index:
Within 8" of Joint:
Remarks:

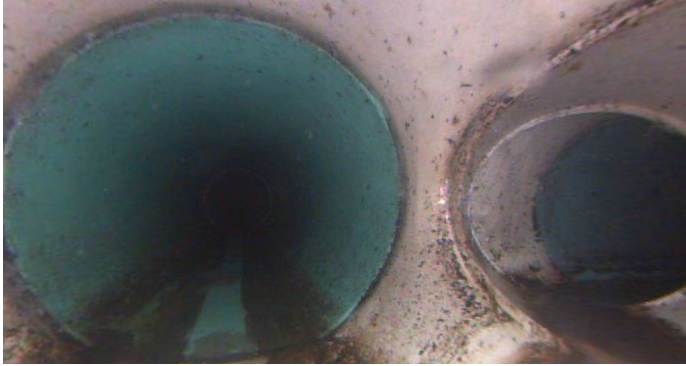
Code: **TF**
Description: **Tap Factory**

Distance (ft): **214.5**
Structural Grade: **0**
O&M Grade: **0**
Clock Start/From: **4**
Clock To:
1st Value: **4.000**
2nd Value:
Value Percent:
Continuous Index:
Within 8" of Joint:
Remarks:

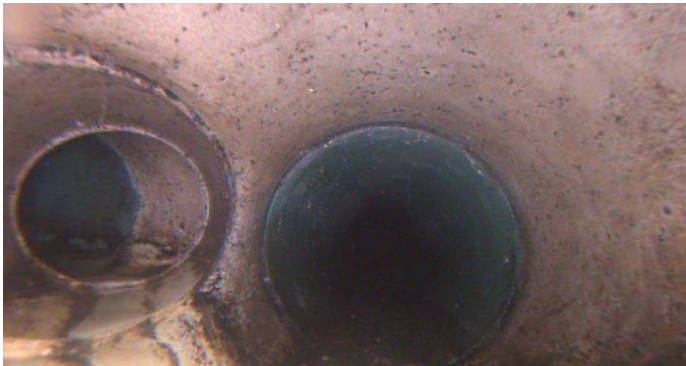
Code: **TF**
Description: **Tap Factory**

Distance (ft): **241.9**
Structural Grade: **0**
O&M Grade: **0**
Clock Start/From: **8**
Clock To:
1st Value: **4.000**
2nd Value:
Value Percent:
Continuous Index:
Within 8" of Joint:
Remarks:

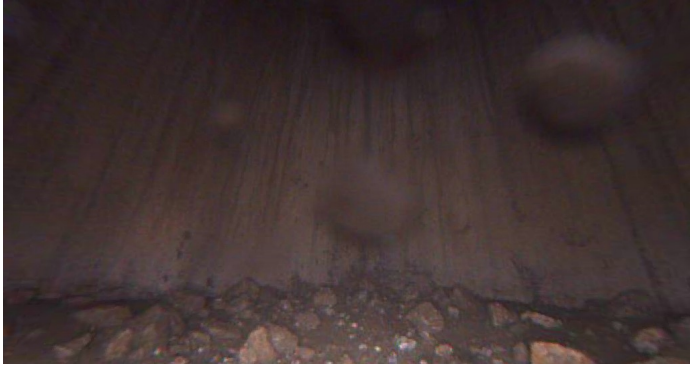
Code:	AMH
Description:	Manhole
Distance (ft):	248.7
Structural Grade:	0
O&M Grade:	0
Clock Start/From:	
Clock To:	
1st Value:	
2nd Value:	
Value Percent:	
Continuous Index:	
Within 8" of Joint:	NO
Remarks:	M-505-047
