Profile/Photo Observation Report

Street:	FOXCROFT STREET	Flow Control:	Not Controlled
City:	Hobart, IN	Year Renewed:	
Location:	Light Highway	Tape/Media #:	
Purpose:	Routine Assessment	Dia/Height:	12"
Use:	Sanitary	Material:	PVC
Drain Area:	NA	Lining:	
Category:	NA		
Comment:	Flow direction wrong

Location Details:		Direction of Survey:	Downstream
US MH:	M-505-048	DS MH:	M-505-047
		Total Length Surveyed (ft):	248.7

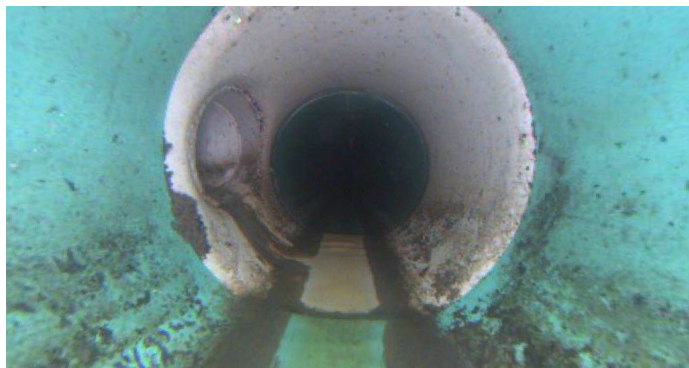
Code: **AMH**
Description: **Manhole**

Distance (ft): **.0**
Structural Grade: **0**
O&M Grade: **0**
Clock Start/From:
Clock To:
1st Value:
2nd Value:
Value Percent:
Continuous Index:
Within 8" of Joint: **NO**
Remarks: **M-505-048**

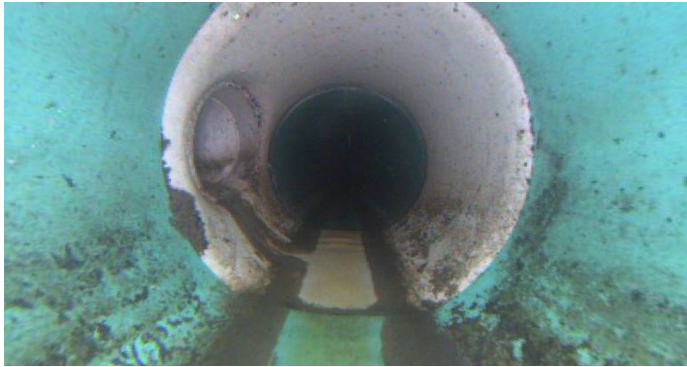
Code: **MWL**
Description: **Water Level**

Distance (ft): **.0**
Structural Grade: **0**
O&M Grade: **0**
Clock Start/From:
Clock To:
1st Value:
2nd Value:
Value Percent: **10.000**
Continuous Index:
Within 8" of Joint: **NO**
Remarks:

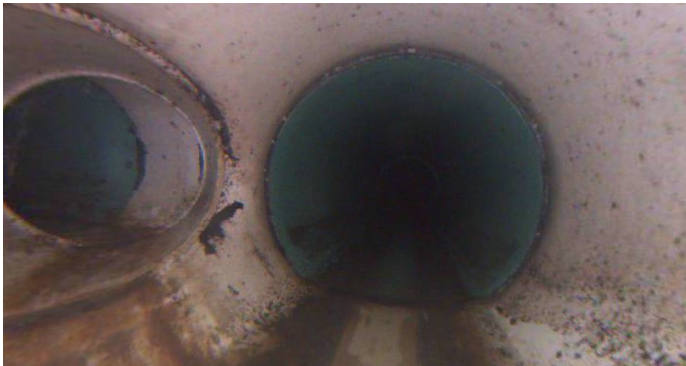
Code: **TF**
Description: **Tap Factory**

Distance (ft): **102.4**
Structural Grade: **0**
O&M Grade: **0**
Clock Start/From: **8**
Clock To:
1st Value: **4.000**
2nd Value:
Value Percent:
Continuous Index:
Within 8" of Joint:
Remarks:

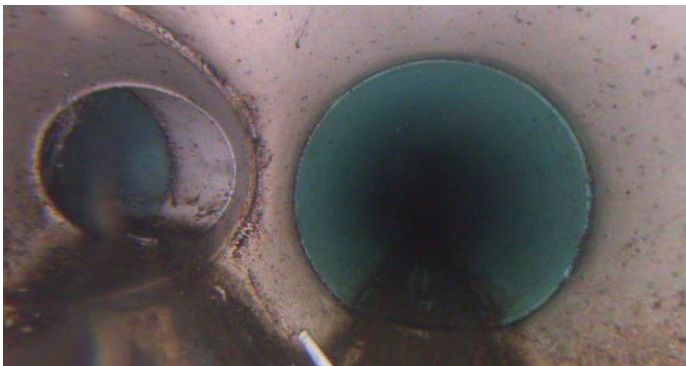
Code: **TF**
Description: **Tap Factory**

Distance (ft): **204.7**
Structural Grade: **0**
O&M Grade: **0**
Clock Start/From: **8**
Clock To:
1st Value: **4.000**
2nd Value:
Value Percent:
Continuous Index:
Within 8" of Joint:
Remarks:

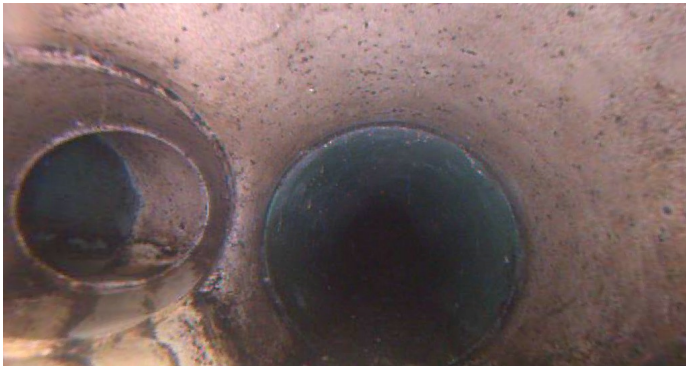
Code: **TF**
Description: **Tap Factory**

Distance (ft): **241.9**
Structural Grade: **0**
O&M Grade: **0**
Clock Start/From: **8**
Clock To:
1st Value: **4.000**
2nd Value:
Value Percent:
Continuous Index:
Within 8" of Joint:
Remarks:

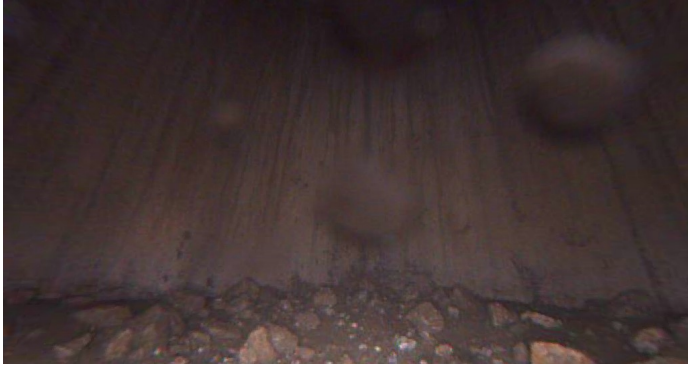
Code:	AMH
Description:	Manhole
Distance (ft):	248.7
Structural Grade:	0
O&M Grade:	0
Clock Start/From:	
Clock To:	
1st Value:	
2nd Value:	
Value Percent:	
Continuous Index:	
Within 8" of Joint:	NO
Remarks:	M-505-047
