## Profile/Photo Observation Report

Date:	<b>04/21/2018</b>	Weather:		Coding:	<b>PACP 6.0</b>
Pipe Length (ft):	<b>236.3</b>	Owner:	<b>NA</b>	Pre Clean:	<b>No Pre-Cleaning</b>
P.O.#:		Surveyor:	<b>Mark Ruby</b>	PSR:	<b>P-505-048-049</b>
Customer:		Clean Date:	<b>01/01/1900</b>	Shape:	<b>C</b>

Street:	<b>S DELAWARE ST</b>	Flow Control:	<b>Not Controlled</b>
City:	<b>Hobart, IN</b>	Year Renewed:	
Location:	<b>Light Highway</b>	Tape/Media #:	
Purpose:	<b>Routine Assessment</b>	Dia/Height:	<b>12"</b>
Use:	<b>Sanitary</b>	Material:	<b>PVC</b>
Drain Area:	<b>NA</b>	Lining:	
Category:	<b>NA</b>		
Comment:	<b>Flow direction wrong</b>		
Location Details:		Direction of Survey:	<b>Upstream</b>
US MH:	<b>M-505-049</b>	DS MH:	<b>M-505-048</b>
		Total Length Surveyed (ft):	<b>220.9</b>

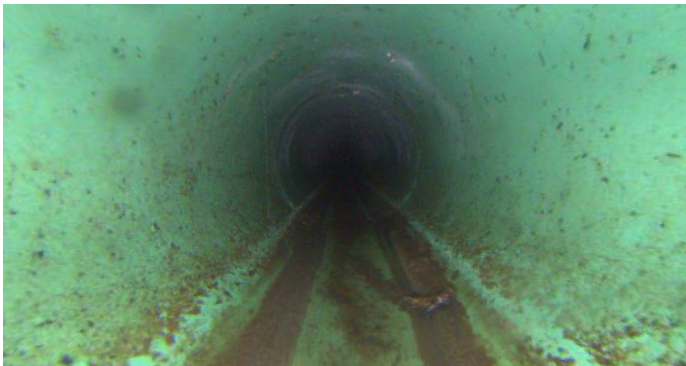
Position	Code	Observation	Video (sec)	Grade
M-505-048				
.0	AMH	Manhole	10	NA
.0	MWL	Water Level	21	NA
31.2	TF	Tap Factory	97	NA
42.2	TF	Tap Factory	132	NA
79.8	TF	Tap Factory	221	NA
91.2	TF	Tap Factory	256	NA
134.5	TF	Tap Factory	355	NA
142.7	TF	Tap Factory	383	NA
179.0	TF	Tap Factory	468	NA
181.4	TF	Tap Factory	485	NA
220.9	AMH	Manhole	577	NA
M-505-049

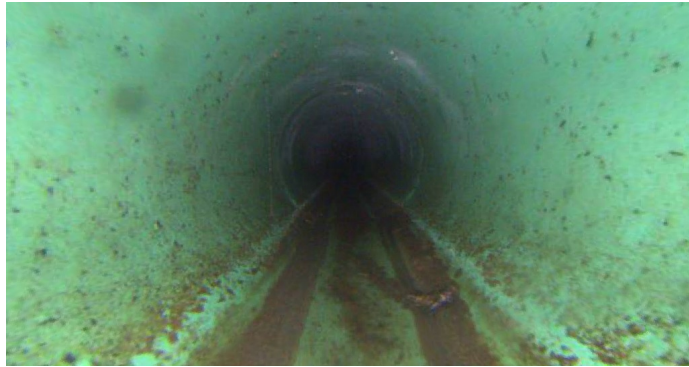
Code:	<b>MWL</b>
Description:	<b>Water Level</b>
Distance (ft):	<b>.0</b>
Structural Grade:	<b>0</b>
O&M Grade:	<b>0</b>
Clock Start/From:	
Clock To:	
1st Value:	
2nd Value:	
Value Percent:	<b>10.000</b>
Continuous Index:	
Within 8" of Joint:	<b>NO</b>
Remarks:

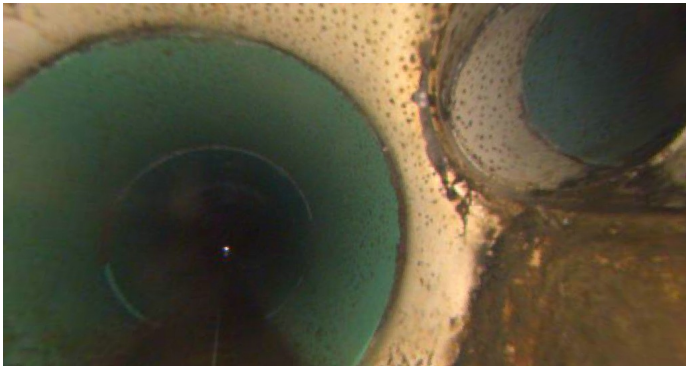
Code: **TF**  
Description: **Tap Factory**

Distance (ft): **134.5**  
Structural Grade: **0**  
O&M Grade: **0**  
Clock Start/From: **10**  
Clock To:  
1st Value: **4.000**  
2nd Value:  
Value Percent:  
Continuous Index:  
Within 8" of Joint:  
Remarks:

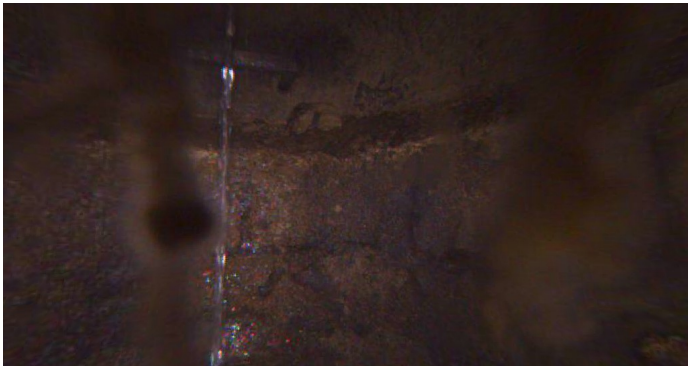
Code: **AMH**  
Description: **Manhole**

Distance (ft): **220.9**  
Structural Grade: **0**  
O&M Grade: **0**  
Clock Start/From:  
Clock To:  
1st Value:  
2nd Value:  
Value Percent:  
Continuous Index:  
Within 8" of Joint: **NO**  
Remarks: **M-505-049**
