## Profile/Photo Observation Report

Street:	<b>FOXCROFT STREET</b>	Flow Control:	<b>Not Controlled</b>
City:	<b>Hobart, IN</b>	Year Renewed:	
Location:	<b>Light Highway</b>	Tape/Media #:	
Purpose:	<b>Routine Assessment</b>	Dia/Height:	<b>12"</b>
Use:	<b>Sanitary</b>	Material:	<b>PVC</b>
Drain Area:	<b>NA</b>	Lining:	
Category:	<b>NA</b>		
Comment:	<b>Flow direction wrong</b>

Location Details:		Direction of Survey:	<b>Upstream</b>
US MH:	<b>M-505-049</b>	DS MH:	<b>M-505-048</b>
		Total Length Surveyed (ft):	<b>220.9</b>

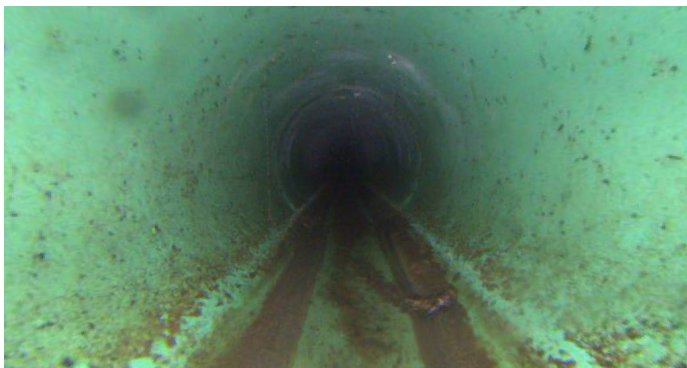
Code: **AMH**  
 Description: **Manhole**

Distance (ft): **.0**  
 Structural Grade: **0**  
 O&M Grade: **0**  
 Clock Start/From:  
 Clock To:  
 1st Value:  
 2nd Value:  
 Value Percent:  
 Continuous Index:  
 Within 8" of Joint: **NO**  
 Remarks: **M-505-048**

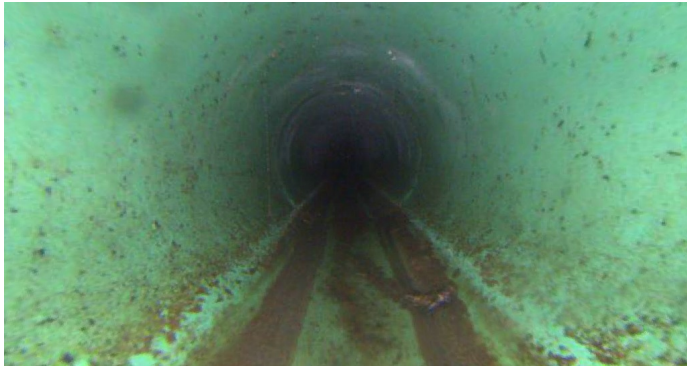
Code: **MWL**  
Description: **Water Level**

Distance (ft): **.0**  
Structural Grade: **0**  
O&M Grade: **0**  
Clock Start/From:  
Clock To:  
1st Value:  
2nd Value:  
Value Percent: **10.000**  
Continuous Index:  
Within 8" of Joint: **NO**  
Remarks:

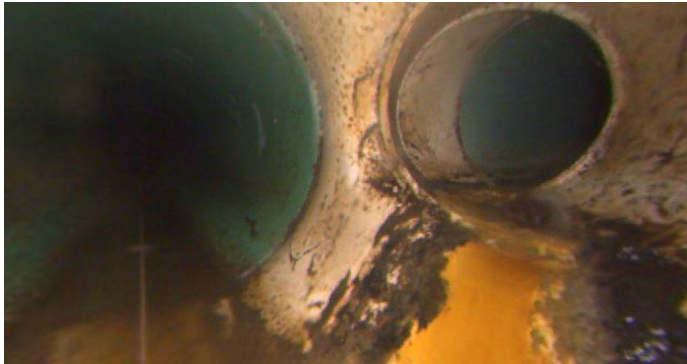
Code: **TF**  
Description: **Tap Factory**

Distance (ft): **31.2**  
Structural Grade: **0**  
O&M Grade: **0**  
Clock Start/From: **8**  
Clock To:  
1st Value: **4.000**  
2nd Value:  
Value Percent:  
Continuous Index:  
Within 8" of Joint:  
Remarks:

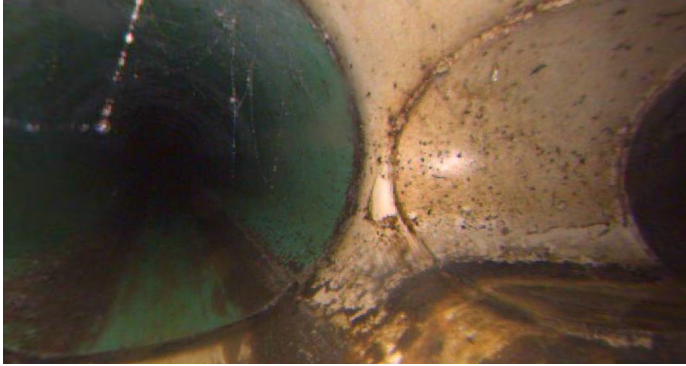
Code: **TF**  
Description: **Tap Factory**

Distance (ft): **42.2**  
Structural Grade: **0**  
O&M Grade: **0**  
Clock Start/From: **4**  
Clock To:  
1st Value: **4.000**  
2nd Value:  
Value Percent:  
Continuous Index:  
Within 8" of Joint:  
Remarks:

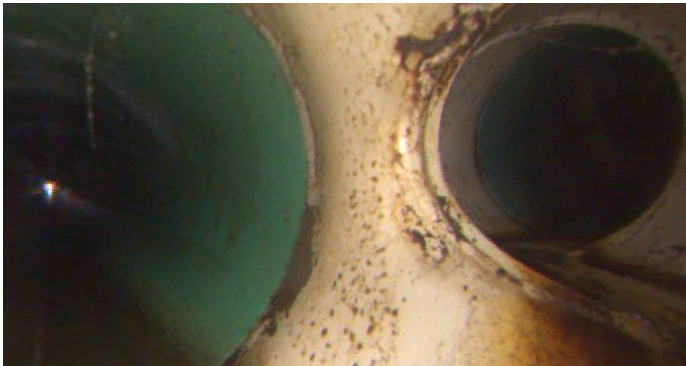
Code: **TF**  
Description: **Tap Factory**

Distance (ft): **79.8**  
Structural Grade: **0**  
O&M Grade: **0**  
Clock Start/From: **9**  
Clock To:  
1st Value: **4.000**  
2nd Value:  
Value Percent:  
Continuous Index:  
Within 8" of Joint:  
Remarks:

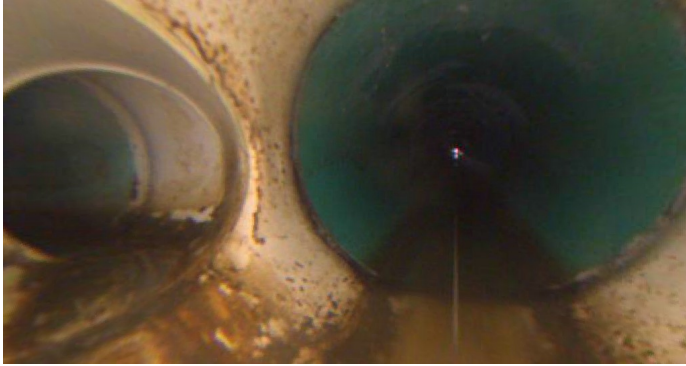
Code: **TF**  
Description: **Tap Factory**

Distance (ft): **91.2**  
Structural Grade: **0**  
O&M Grade: **0**  
Clock Start/From: **4**  
Clock To:  
1st Value: **4.000**  
2nd Value:  
Value Percent:  
Continuous Index:  
Within 8" of Joint:  
Remarks:

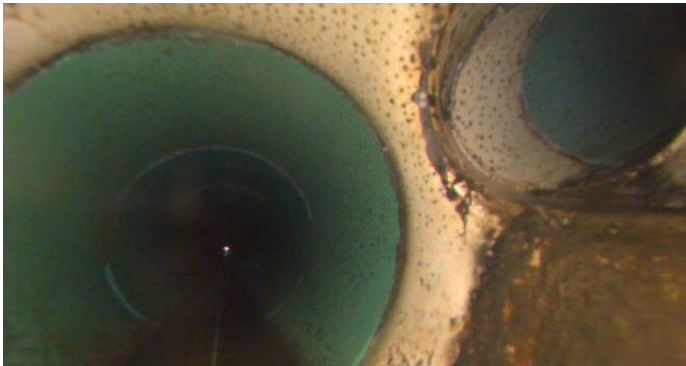
Code: **TF**  
Description: **Tap Factory**

Distance (ft): **134.5**  
Structural Grade: **0**  
O&M Grade: **0**  
Clock Start/From: **10**  
Clock To:  
1st Value: **4.000**  
2nd Value:  
Value Percent:  
Continuous Index:  
Within 8" of Joint:  
Remarks:

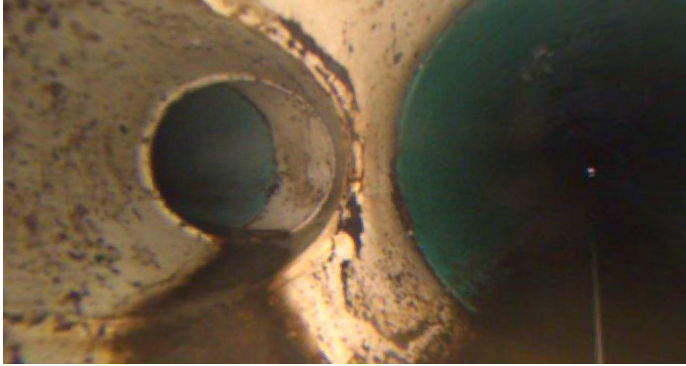
Code: **TF**  
Description: **Tap Factory**

Distance (ft): **142.7**  
Structural Grade: **0**  
O&M Grade: **0**  
Clock Start/From: **4**  
Clock To:  
1st Value: **4.000**  
2nd Value:  
Value Percent:  
Continuous Index:  
Within 8" of Joint:  
Remarks:

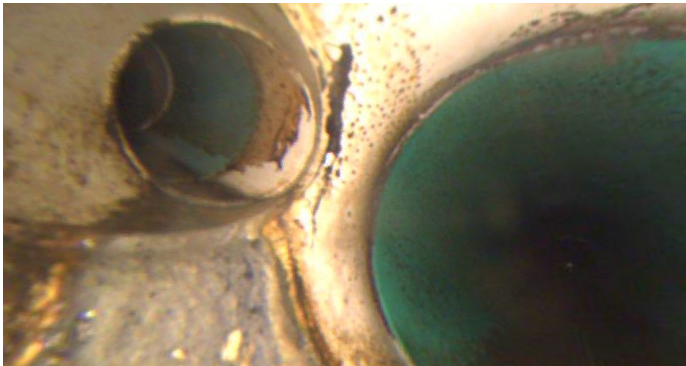
Code: **TF**  
Description: **Tap Factory**

Distance (ft): **179.0**  
Structural Grade: **0**  
O&M Grade: **0**  
Clock Start/From: **2**  
Clock To:  
1st Value: **4.000**  
2nd Value:  
Value Percent:  
Continuous Index:  
Within 8" of Joint:  
Remarks:

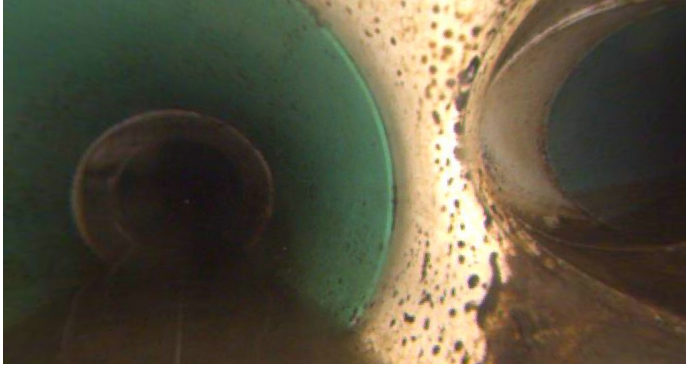
Code: **TF**  
Description: **Tap Factory**

Distance (ft): **181.4**  
Structural Grade: **0**  
O&M Grade: **0**  
Clock Start/From: **8**  
Clock To:  
1st Value: **4.000**  
2nd Value:  
Value Percent:  
Continuous Index:  
Within 8" of Joint:  
Remarks:

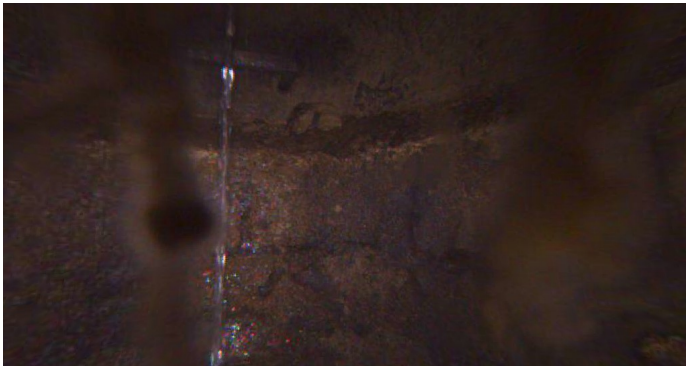
Code: **AMH**  
Description: **Manhole**

Distance (ft): **220.9**  
Structural Grade: **0**  
O&M Grade: **0**  
Clock Start/From:  
Clock To:  
1st Value:  
2nd Value:  
Value Percent:  
Continuous Index:  
Within 8" of Joint: **NO**  
Remarks: **M-505-049**
