Profile/Photo Observation Report

Date:	04/21/2018	Weather:		Coding:	PACP 6.0
Pipe Length (ft):	310.1	Owner:	NA	Pre Clean:	No Pre-Cleaning
P.O.#:		Surveyor:	Byrd Fitzgerald	PSR:	P-505-050-049
Customer:		Clean Date:	01/01/1900	Shape:	C

Street:	S DELAWARE ST & W 2ND ST	Flow Control:	Not Controlled
City:	Hobart, IN	Year Renewed:	
Location:	Light Highway	Tape/Media #:	
Purpose:	Routine Assessment	Dia/Height:	10"
Use:	Sanitary	Material:	PVC
Drain Area:	NA	Lining:	
Category:	NA		
Comment:	Flow direction wrong		
Location Details:		Direction of Survey:	Upstream
US MH:	M-505-049	DS MH:	M-505-050
		Total Length Surveyed (ft):	313.9

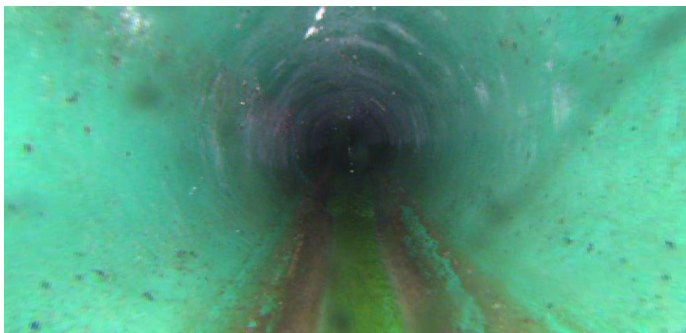
Code: **AMH**
Description: **Manhole**

Distance (ft): **.0**
Structural Grade: **0**
O&M Grade: **0**
Clock Start/From:
Clock To:
1st Value:
2nd Value:
Value Percent:
Continuous Index:
Within 8" of Joint: **NO**
Remarks: **M-505-050**

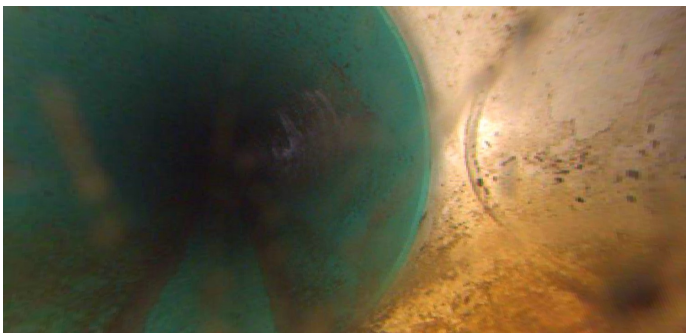
Code: **TF**
Description: **Tap Factory**

Distance (ft): **259.3**
Structural Grade: **0**
O&M Grade: **0**
Clock Start/From: **3**
Clock To:
1st Value: **4.000**
2nd Value:
Value Percent:
Continuous Index:
Within 8" of Joint: **YES**
Remarks:
