Profile/Photo Observation Report

Street:	FOXCROFT STREET	Flow Control:	Not Controlled
City:	Hobart, IN	Year Renewed:	
Location:	Light Highway	Tape/Media #:	
Purpose:	Routine Assessment	Dia/Height:	10"
Use:	Sanitary	Material:	PVC
Drain Area:	NA	Lining:	
Category:	NA		
Comment:	Flow direction wrong

Location Details:		Direction of Survey:	Upstream
US MH:	M-505-049	DS MH:	M-505-050
		Total Length Surveyed (ft):	313.9

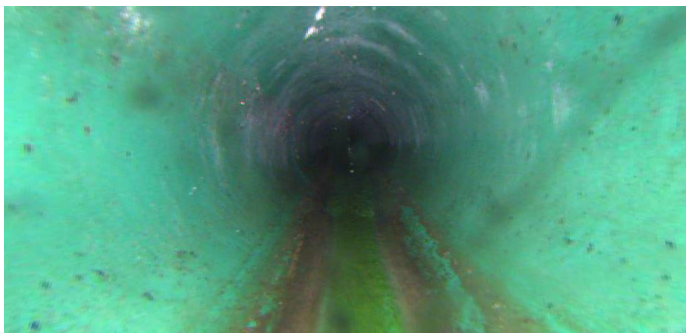
Code: **AMH**
Description: **Manhole**

Distance (ft): **.0**
Structural Grade: **0**
O&M Grade: **0**
Clock Start/From:
Clock To:
1st Value:
2nd Value:
Value Percent:
Continuous Index:
Within 8" of Joint: **NO**
Remarks: **M-505-050**

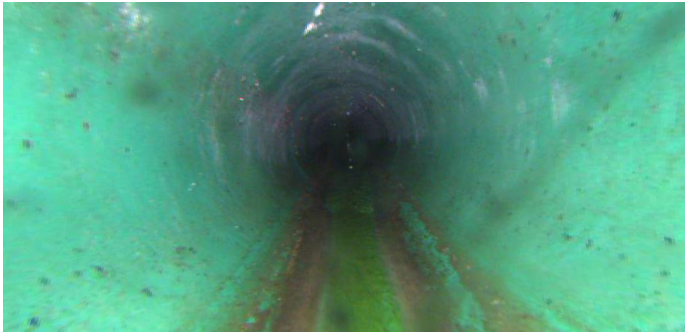
Code:	MWL
Description:	Water Level

Distance (ft):	.0
Structural Grade:	0
O&M Grade:	0
Clock Start/From:	
Clock To:	
1st Value:	
2nd Value:	
Value Percent:	5.000
Continuous Index:	
Within 8" of Joint:	NO
Remarks:

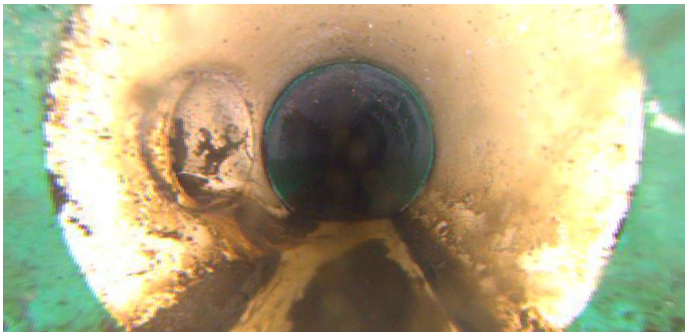
Code:	TF
Description:	Tap Factory

Distance (ft):	35.0
Structural Grade:	0
O&M Grade:	0
Clock Start/From:	9
Clock To:	
1st Value:	4.000
2nd Value:	
Value Percent:	
Continuous Index:	
Within 8" of Joint:	YES
Remarks:

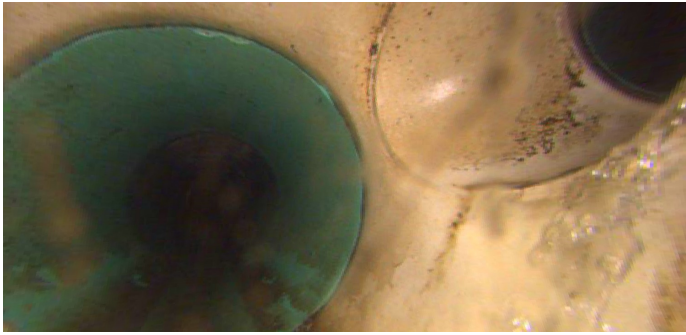
Code: **TFA**
Description: **Tap Factory Active**

Distance (ft): **77.9**
Structural Grade: **0**
O&M Grade: **0**
Clock Start/From: **2**
Clock To:
1st Value: **4.000**
2nd Value:
Value Percent:
Continuous Index:
Within 8" of Joint: **YES**
Remarks:

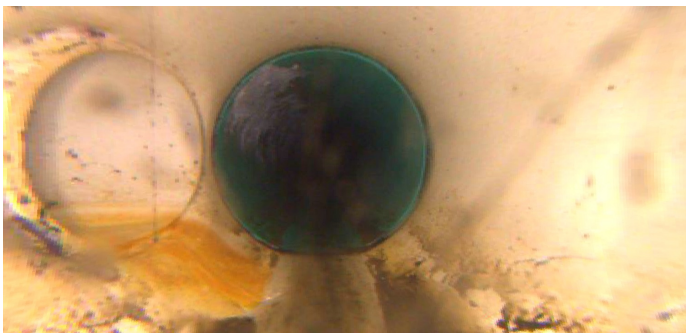
Code: **TF**
Description: **Tap Factory**

Distance (ft): **84.5**
Structural Grade: **0**
O&M Grade: **0**
Clock Start/From: **9**
Clock To:
1st Value: **4.000**
2nd Value:
Value Percent:
Continuous Index:
Within 8" of Joint: **YES**
Remarks:

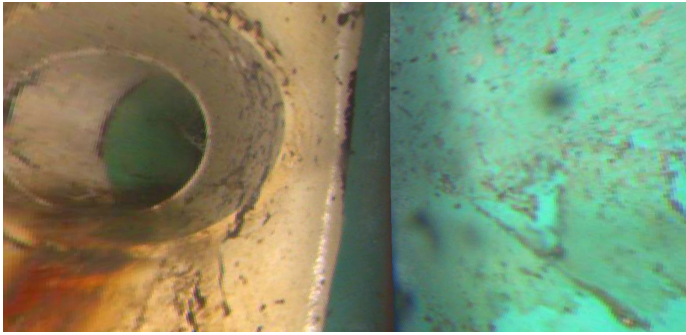
Code: **TF**
Description: **Tap Factory**

Distance (ft): **118.4**
Structural Grade: **0**
O&M Grade: **0**
Clock Start/From: **10**
Clock To:
1st Value: **4.000**
2nd Value:
Value Percent:
Continuous Index:
Within 8" of Joint: **YES**
Remarks:

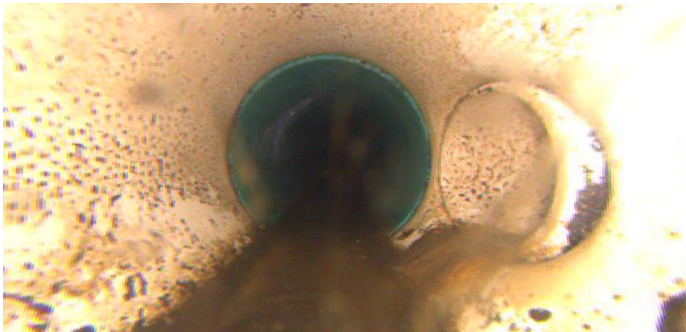
Code: **TF**
Description: **Tap Factory**

Distance (ft): **122.7**
Structural Grade: **0**
O&M Grade: **0**
Clock Start/From: **3**
Clock To:
1st Value: **4.000**
2nd Value:
Value Percent:
Continuous Index:
Within 8" of Joint: **YES**
Remarks:

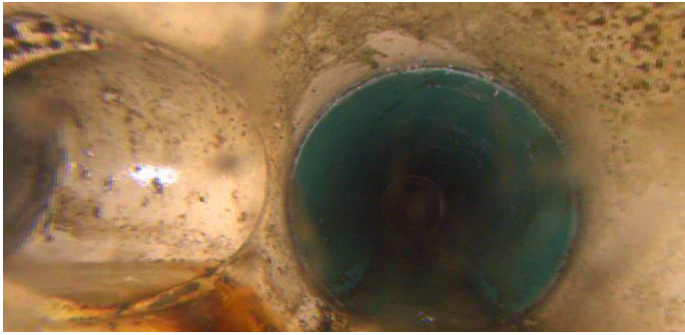
Code: **TF**
Description: **Tap Factory**

Distance (ft): **162.2**
Structural Grade: **0**
O&M Grade: **0**
Clock Start/From: **9**
Clock To:
1st Value: **4.000**
2nd Value:
Value Percent:
Continuous Index:
Within 8" of Joint: **YES**
Remarks:

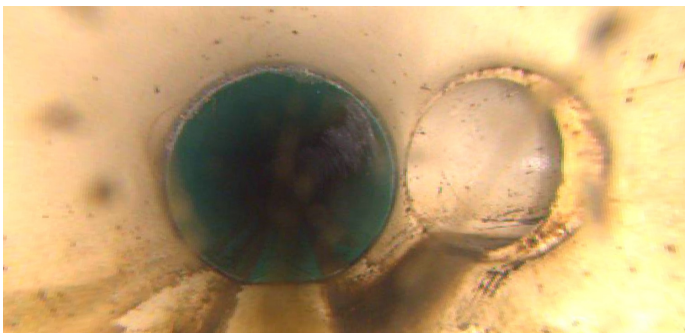
Code: **TF**
Description: **Tap Factory**

Distance (ft): **166.5**
Structural Grade: **0**
O&M Grade: **0**
Clock Start/From: **3**
Clock To:
1st Value: **4.000**
2nd Value:
Value Percent:
Continuous Index:
Within 8" of Joint: **YES**
Remarks:

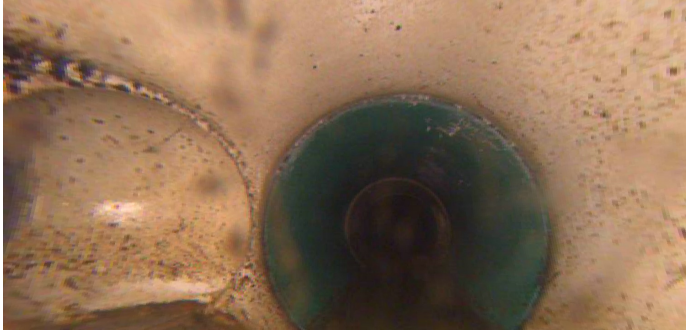
Code: **TF**
Description: **Tap Factory**

Distance (ft): **208.4**
Structural Grade: **0**
O&M Grade: **0**
Clock Start/From: **9**
Clock To:
1st Value: **4.000**
2nd Value:
Value Percent:
Continuous Index:
Within 8" of Joint: **YES**
Remarks:

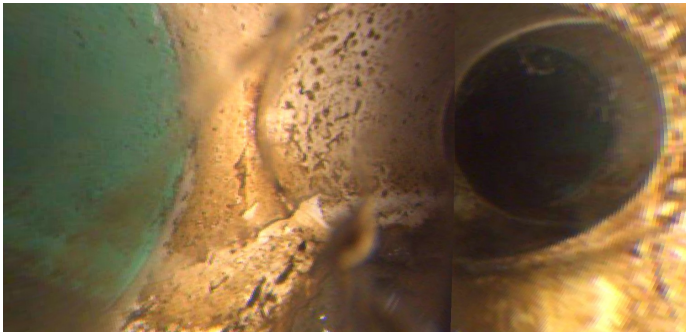
Code: **TF**
Description: **Tap Factory**

Distance (ft): **211.7**
Structural Grade: **0**
O&M Grade: **0**
Clock Start/From: **3**
Clock To:
1st Value: **4.000**
2nd Value:
Value Percent:
Continuous Index:
Within 8" of Joint: **YES**
Remarks:

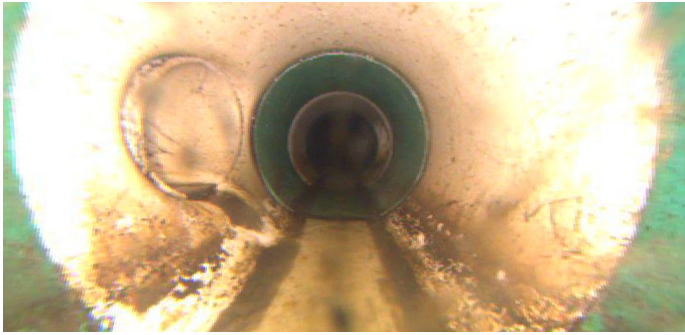
Code: **TF**
Description: **Tap Factory**

Distance (ft): **256.0**
Structural Grade: **0**
O&M Grade: **0**
Clock Start/From: **9**
Clock To:
1st Value: **4.000**
2nd Value:
Value Percent:
Continuous Index:
Within 8" of Joint: **YES**
Remarks:

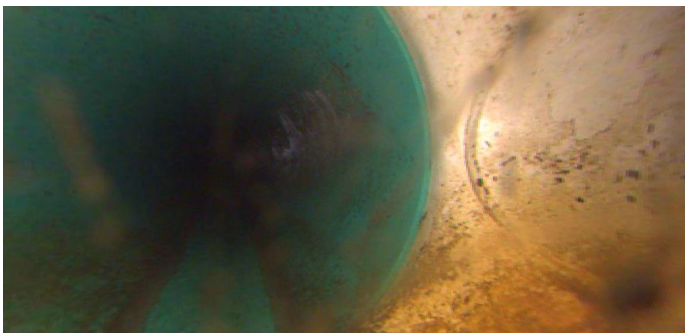
Code: **TF**
Description: **Tap Factory**

Distance (ft): **259.3**
Structural Grade: **0**
O&M Grade: **0**
Clock Start/From: **3**
Clock To:
1st Value: **4.000**
2nd Value:
Value Percent:
Continuous Index:
Within 8" of Joint: **YES**
Remarks:
