Profile/Photo Observation Report

Street:	S DELAWARE ST	Flow Control:	Not Controlled
City:	Hobart, IN	Year Renewed:	
Location:	Light Highway	Tape/Media #:	
Purpose:	Routine Assessment	Dia/Height:	12"
Use:	Sanitary	Material:	PVC
Drain Area:	NA	Lining:	
Category:	NA		
Comment:	Flow direction wrong

Location Details:		Direction of Survey:	Downstream
US MH:	M-505-050	DS MH:	M-505-051
		Total Length Surveyed (ft):	286.0

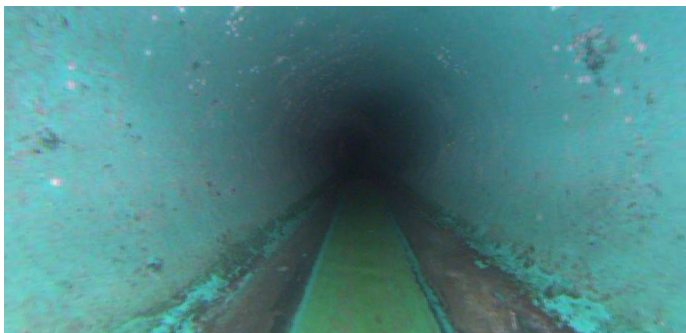
Code: **AMH**
Description: **Manhole**

Distance (ft): **.0**
Structural Grade: **0**
O&M Grade: **0**
Clock Start/From:
Clock To:
1st Value:
2nd Value:
Value Percent:
Continuous Index:
Within 8" of Joint: **NO**
Remarks: **M-505-050**

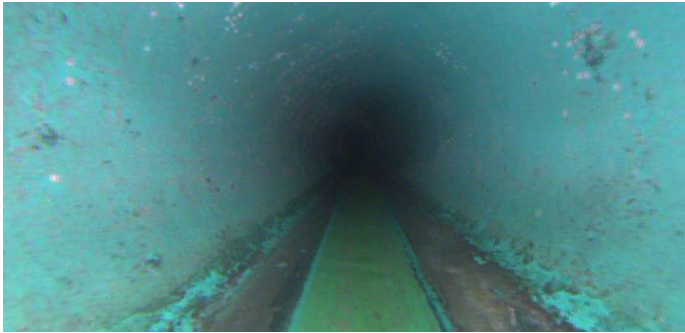
Code:	MWL
Description:	Water Level

Distance (ft):	.0
Structural Grade:	0
O&M Grade:	0
Clock Start/From:	
Clock To:	
1st Value:	
2nd Value:	
Value Percent:	5.000
Continuous Index:	
Within 8" of Joint:	NO
Remarks:

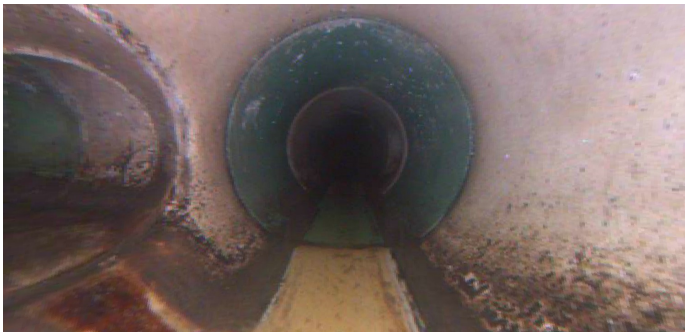
Code:	TF
Description:	Tap Factory

Distance (ft):	7.5
Structural Grade:	0
O&M Grade:	0
Clock Start/From:	9
Clock To:	
1st Value:	4.000
2nd Value:	
Value Percent:	
Continuous Index:	
Within 8" of Joint:	YES
Remarks:

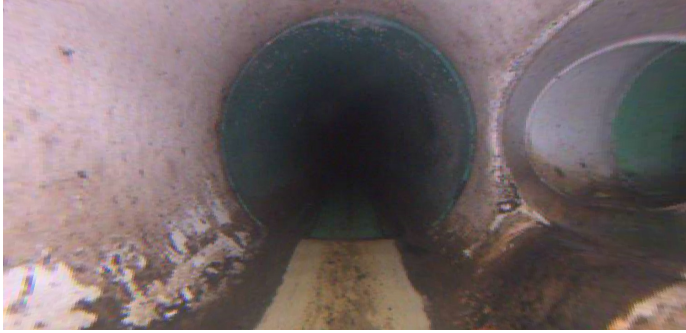
Code: **TF**
Description: **Tap Factory**

Distance (ft): **9.8**
Structural Grade: **0**
O&M Grade: **0**
Clock Start/From: **3**
Clock To:
1st Value: **4.000**
2nd Value:
Value Percent:
Continuous Index:
Within 8" of Joint: **YES**
Remarks:

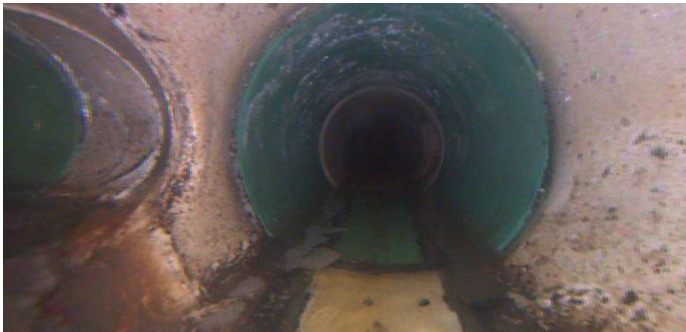
Code: **TF**
Description: **Tap Factory**

Distance (ft): **50.3**
Structural Grade: **0**
O&M Grade: **0**
Clock Start/From: **9**
Clock To:
1st Value: **4.000**
2nd Value:
Value Percent:
Continuous Index:
Within 8" of Joint: **YES**
Remarks:

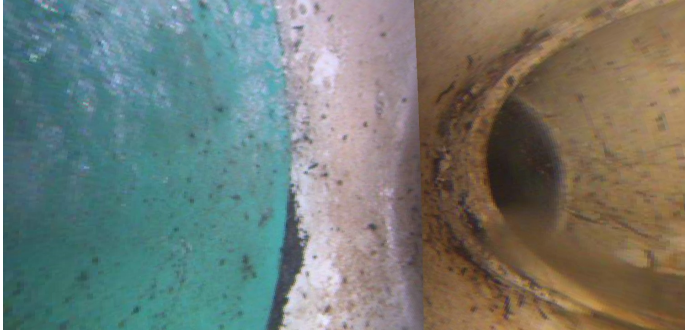
Code: **TF**
Description: **Tap Factory**

Distance (ft): **53.6**
Structural Grade: **0**
O&M Grade: **0**
Clock Start/From: **3**
Clock To:
1st Value: **4.000**
2nd Value:
Value Percent:
Continuous Index:
Within 8" of Joint: **YES**
Remarks:

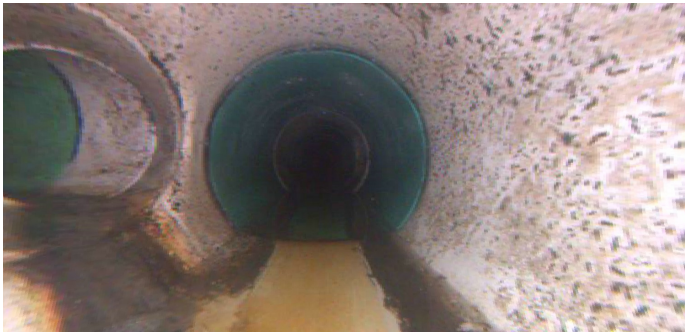
Code: **TF**
Description: **Tap Factory**

Distance (ft): **96.4**
Structural Grade: **0**
O&M Grade: **0**
Clock Start/From: **9**
Clock To:
1st Value: **4.000**
2nd Value:
Value Percent:
Continuous Index:
Within 8" of Joint: **YES**
Remarks:

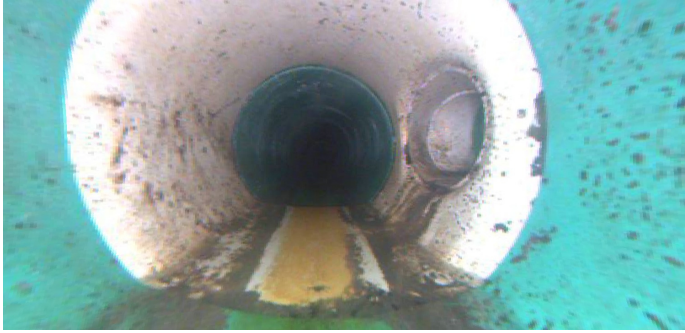
Code: **TF**
Description: **Tap Factory**

Distance (ft): **98.8**
Structural Grade: **0**
O&M Grade: **0**
Clock Start/From: **3**
Clock To:
1st Value: **4.000**
2nd Value:
Value Percent:
Continuous Index:
Within 8" of Joint: **YES**
Remarks:

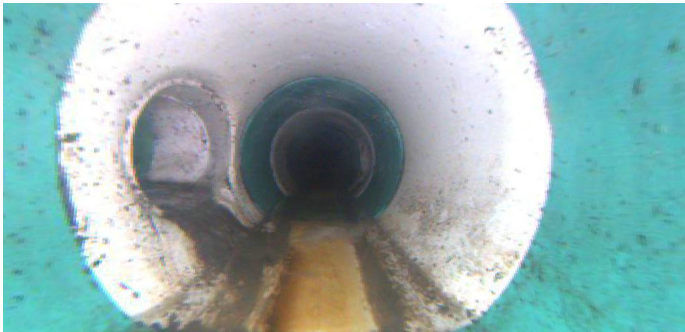
Code: **TF**
Description: **Tap Factory**

Distance (ft): **137.6**
Structural Grade: **0**
O&M Grade: **0**
Clock Start/From: **9**
Clock To:
1st Value: **4.000**
2nd Value:
Value Percent:
Continuous Index:
Within 8" of Joint: **YES**
Remarks:

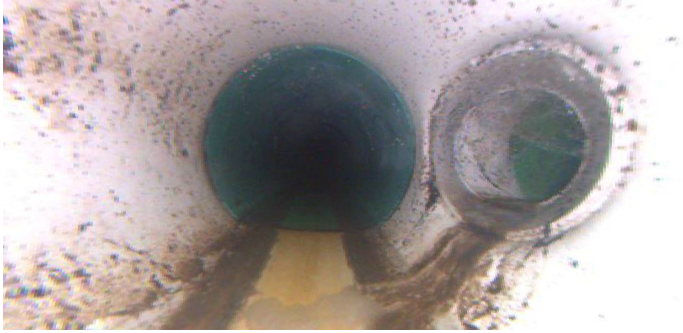
Code: **TF**
Description: **Tap Factory**

Distance (ft): **140.1**
Structural Grade: **0**
O&M Grade: **0**
Clock Start/From: **3**
Clock To:
1st Value: **4.000**
2nd Value:
Value Percent:
Continuous Index:
Within 8" of Joint: **YES**
Remarks:

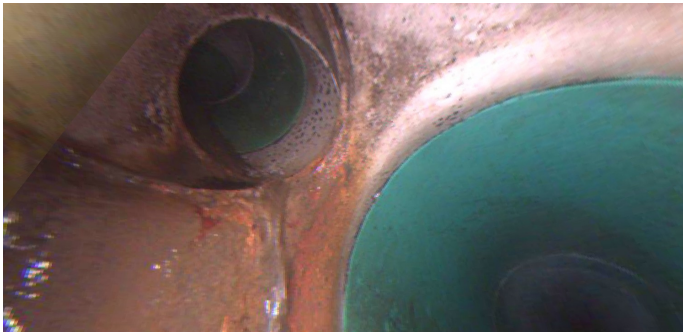
Code: **TFA**
Description: **Tap Factory Active**

Distance (ft): **173.8**
Structural Grade: **0**
O&M Grade: **0**
Clock Start/From: **11**
Clock To:
1st Value: **4.000**
2nd Value:
Value Percent:
Continuous Index:
Within 8" of Joint: **YES**
Remarks:

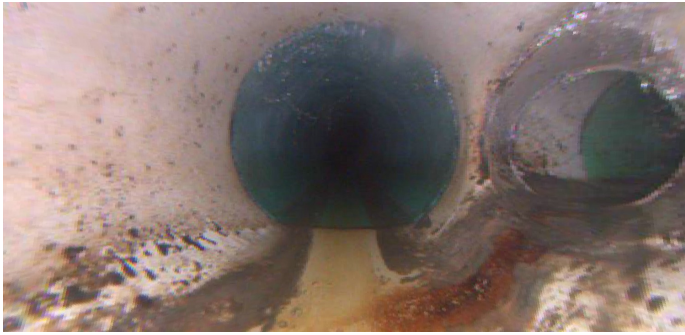
Code: **TF**
Description: **Tap Factory**

Distance (ft): **189.4**
Structural Grade: **0**
O&M Grade: **0**
Clock Start/From: **3**
Clock To:
1st Value: **4.000**
2nd Value:
Value Percent:
Continuous Index:
Within 8" of Joint: **YES**
Remarks:

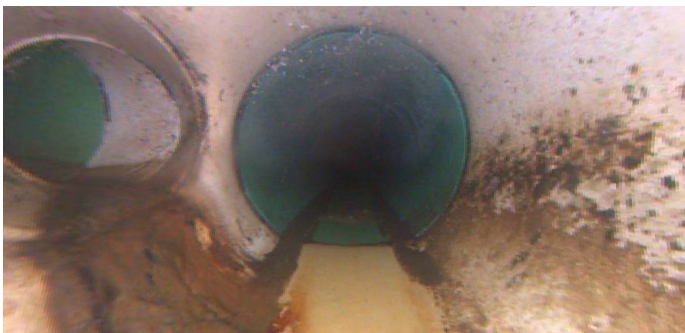
Code: **TF**
Description: **Tap Factory**

Distance (ft): **229.7**
Structural Grade: **0**
O&M Grade: **0**
Clock Start/From: **9**
Clock To:
1st Value: **4.000**
2nd Value:
Value Percent:
Continuous Index:
Within 8" of Joint: **YES**
Remarks:

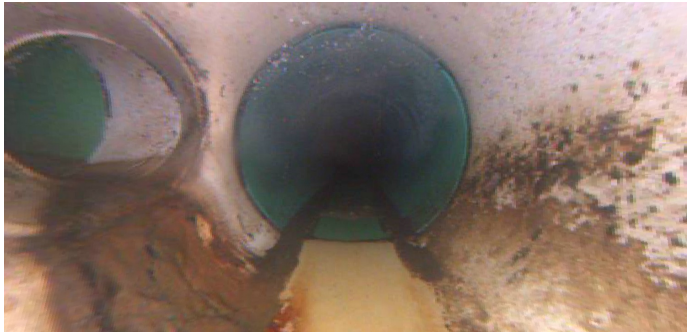
Code: **DAGS**
Description: **Deposits Attached Grease**

Distance (ft): **229.7**
Structural Grade: **0**
O&M Grade: **2**
Clock Start/From: **7**
Clock To: **9**
1st Value:
2nd Value:
Value Percent: **5.000**
Continuous Index:
Within 8" of Joint: **NO**
Remarks:

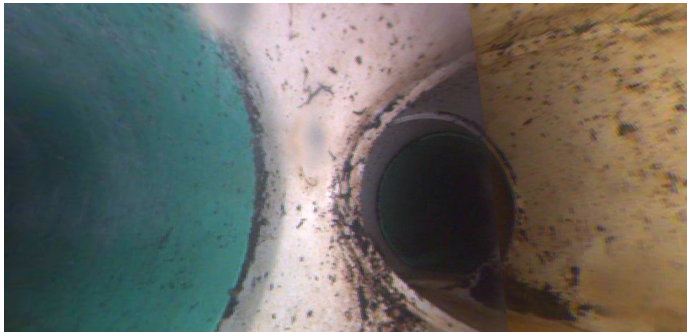
Code: **TF**
Description: **Tap Factory**

Distance (ft): **237.1**
Structural Grade: **0**
O&M Grade: **0**
Clock Start/From: **3**
Clock To:
1st Value: **4.000**
2nd Value:
Value Percent:
Continuous Index:
Within 8" of Joint: **YES**
Remarks:

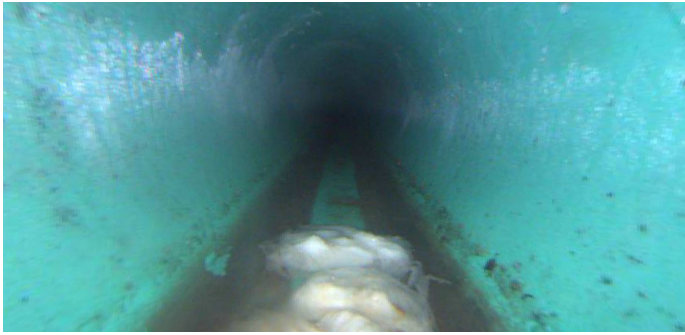
Code: **DSZ**
Description: **Deposits Settled Other**

Distance (ft): **257.0**
Structural Grade: **0**
O&M Grade: **2**
Clock Start/From: **6**
Clock To:
1st Value:
2nd Value:
Value Percent: **5.000**
Continuous Index:
Within 8" of Joint: **NO**
Remarks: **tissue**

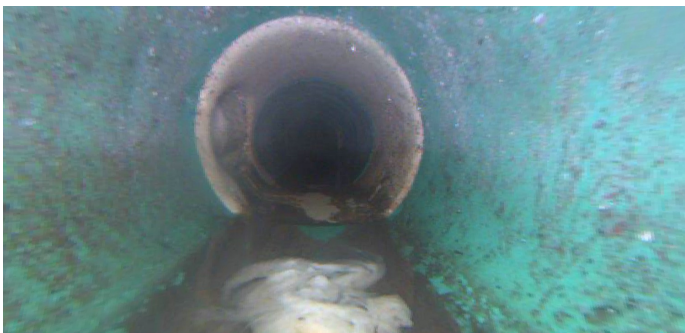
Code: **DSZ**
Description: **Deposits Settled Other**

Distance (ft): **273.5**
Structural Grade: **0**
O&M Grade: **2**
Clock Start/From: **6**
Clock To:
1st Value:
2nd Value:
Value Percent: **5.000**
Continuous Index:
Within 8" of Joint: **NO**
Remarks: **tissue**

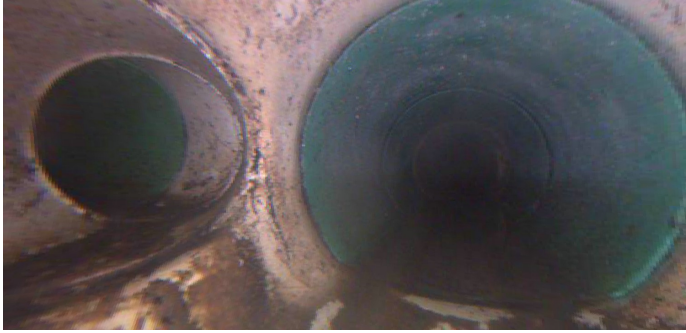
Code: **TF**
Description: **Tap Factory**

Distance (ft): **275.1**
Structural Grade: **0**
O&M Grade: **0**
Clock Start/From: **9**
Clock To:
1st Value: **5.000**
2nd Value:
Value Percent:
Continuous Index:
Within 8" of Joint: **YES**
Remarks:

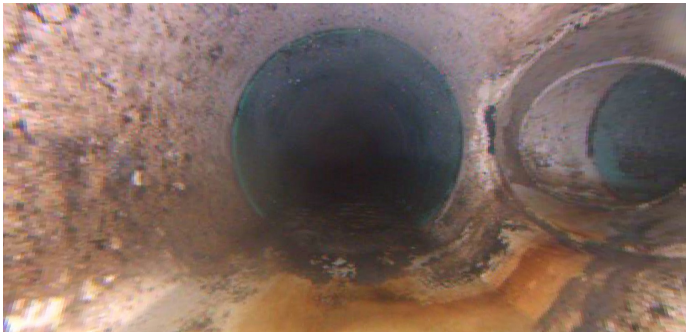
Code: **TF**
Description: **Tap Factory**

Distance (ft): **278.3**
Structural Grade: **0**
O&M Grade: **0**
Clock Start/From: **3**
Clock To:
1st Value: **4.000**
2nd Value:
Value Percent:
Continuous Index:
Within 8" of Joint: **YES**
Remarks:

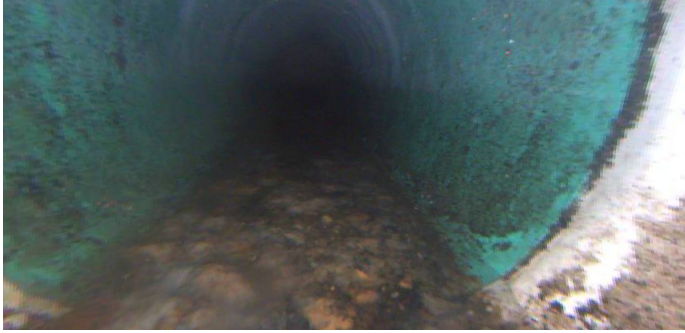
Code: **DSZ**
Description: **Deposits Settled Other**

Distance (ft): **279.2**
Structural Grade: **0**
O&M Grade: **2**
Clock Start/From: **6**
Clock To:
1st Value:
2nd Value:
Value Percent: **5.000**
Continuous Index: **S01**
Within 8" of Joint: **NO**
Remarks: **debris**

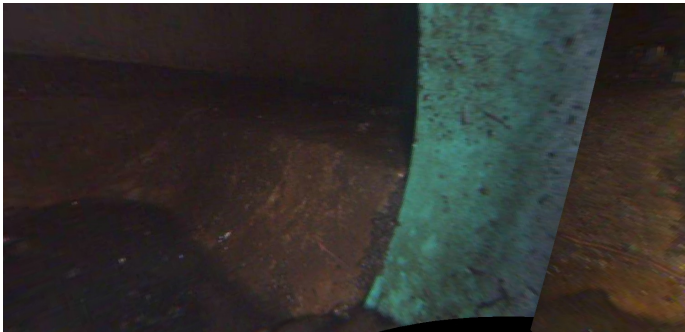
Code: **DSZ**
Description: **Deposits Settled Other**

Distance (ft): **283.9**
Structural Grade: **0**
O&M Grade: **2**
Clock Start/From: **6**
Clock To:
1st Value:
2nd Value:
Value Percent: **5.000**
Continuous Index: **F01**
Within 8" of Joint: **NO**
Remarks: **debris**

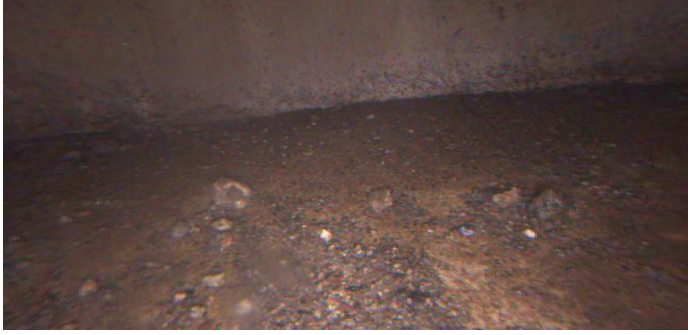
Code:	AMH
Description:	Manhole
Distance (ft):	286.0
Structural Grade:	0
O&M Grade:	0
Clock Start/From:	
Clock To:	
1st Value:	
2nd Value:	
Value Percent:	
Continuous Index:	
Within 8" of Joint:	NO
Remarks:	M-505-051
