Profile/Photo Observation Report

Street:	Colorado Street	Flow Control:	Not Controlled
City:	Hobart, IN	Year Renewed:	
Location:	Light Highway	Tape/Media #:	DEP 54
Purpose:	Routine Assessment	Dia/Height:	18"
Use:	Sanitary	Material:	VCP
Drain Area:		Lining:

US MH: **M-505-052** DS MH: **M-505-049** Total Length Surveyed (ft): **161.9**

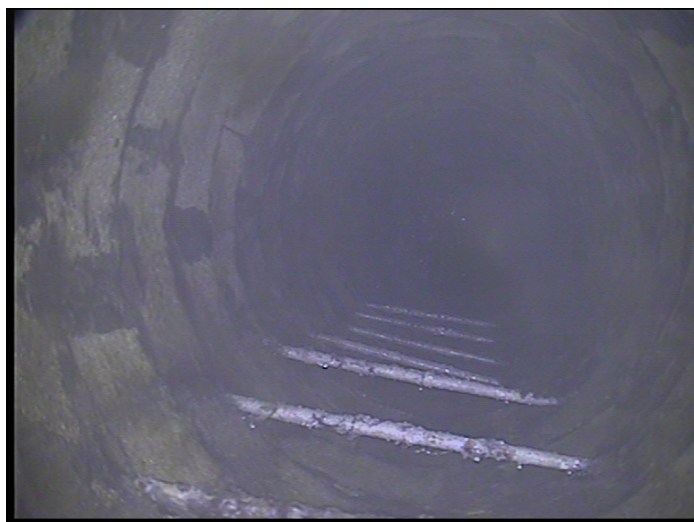
Code: **AMH**
 Description: **Manhole**

Distance (ft): **.0**
 Structural Grade: **0**
 O&M Grade: **0**
 Clock Start/From:
 Clock To:
 1st Value:
 2nd Value:
 Value Percent:
 Continuous Index:
 Within 8" of Joint: **NO**
 Remarks: **M-505-052**

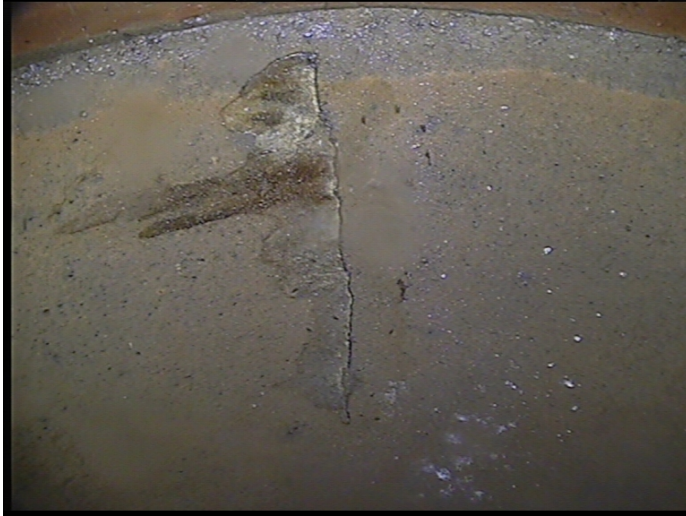
Code: **CL**
Description: **Crack Longitudinal**

Distance (ft): **89.2**
Structural Grade: **2**
O&M Grade: **0**
Clock Start/From: **10**
Clock To:
1st Value:
2nd Value:
Value Percent:
Continuous Index:
Within 8" of Joint: **YES**
Remarks:

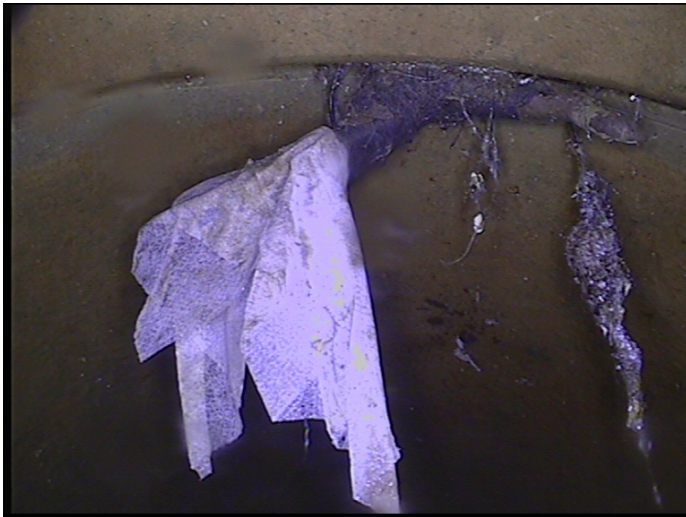
Code: **RTJ**
Description: **Roots Tap Joint**

Distance (ft): **91.6**
Structural Grade: **0**
O&M Grade: **2**
Clock Start/From: **12**
Clock To:
1st Value:
2nd Value:
Value Percent: **10.000**
Continuous Index:
Within 8" of Joint: **YES**
Remarks:

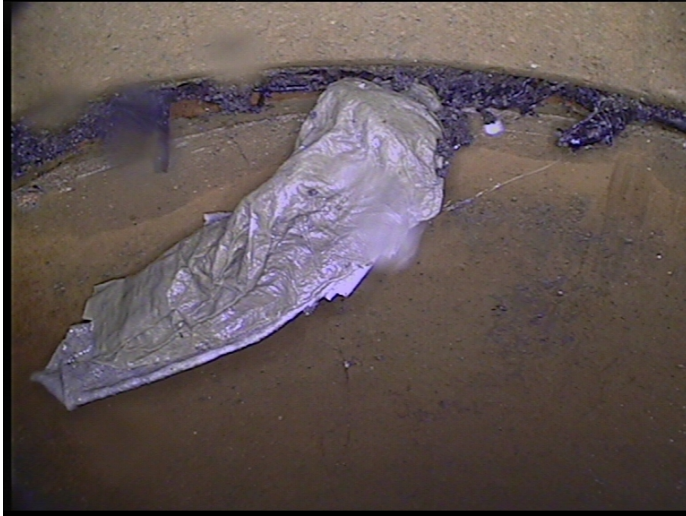
Code:	DAR
Description:	Deposits Attached Ragging
Distance (ft):	109.5
Structural Grade:	0
O&M Grade:	2
Clock Start/From:	9
Clock To:	
1st Value:	
2nd Value:	
Value Percent:	5.000
Continuous Index:	
Within 8" of Joint:	YES
Remarks:

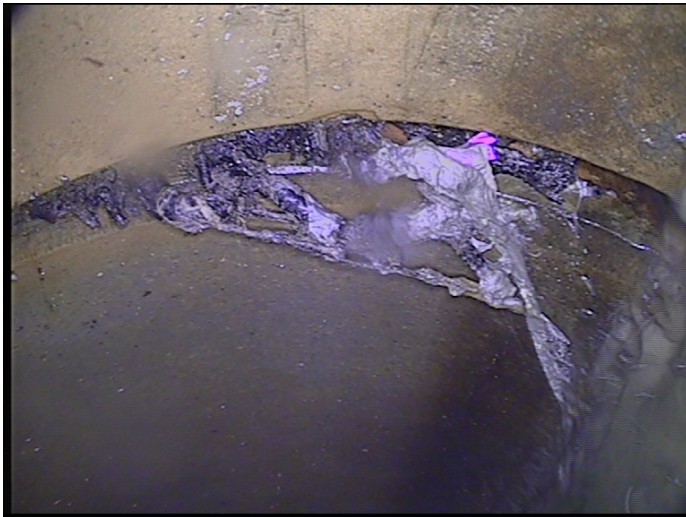
Code:	RFJ
Description:	Roots Fine Joint
Distance (ft):	111.7
Structural Grade:	0
O&M Grade:	1
Clock Start/From:	1
Clock To:	5
1st Value:	
2nd Value:	
Value Percent:	
Continuous Index:	
Within 8" of Joint:	YES
Remarks:

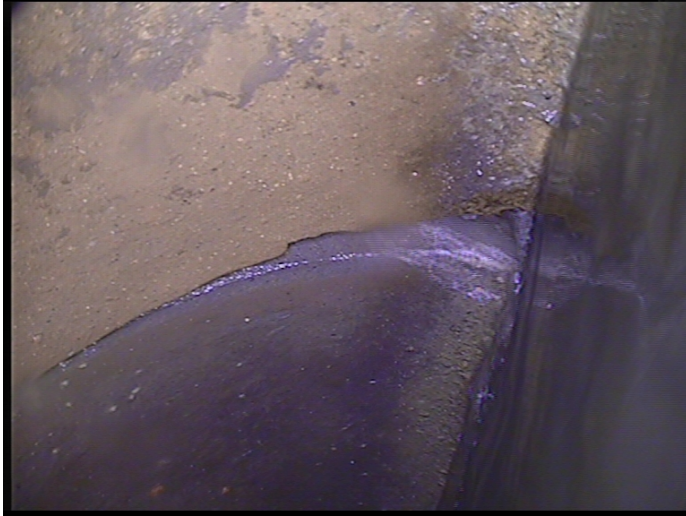
Code: **IR**
Description: **Infil Runner**

Distance (ft): **155.4**
Structural Grade: **0**
O&M Grade: **4**
Clock Start/From: **3**
Clock To:
1st Value:
2nd Value:
Value Percent:
Continuous Index:
Within 8" of Joint: **YES**
Remarks:

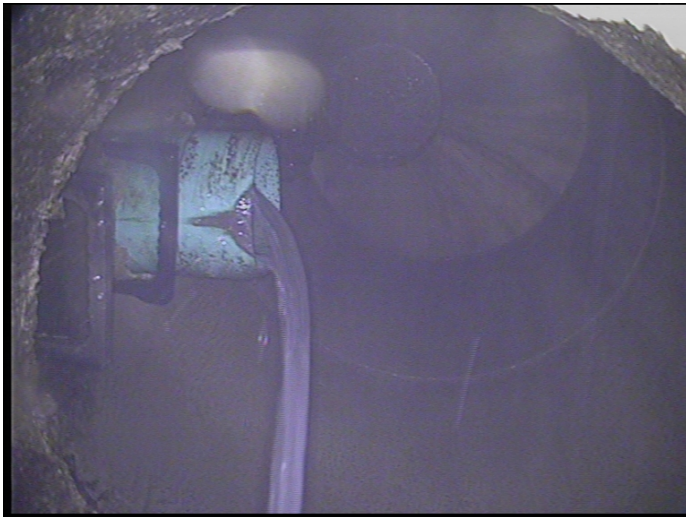
Code: **AMH**
Description: **Manhole**

Distance (ft): **161.9**
Structural Grade: **0**
O&M Grade: **0**
Clock Start/From:
Clock To:
1st Value:
2nd Value:
Value Percent:
Continuous Index:
Within 8" of Joint: **NO**
Remarks: **M-505-049**
