Profile/Photo Observation Report

Street:	Colorado Street	Flow Control:	Not Controlled
City:	Hobart, IN	Year Renewed:	
Location:	Light Highway	Tape/Media #:	DEP 52
Purpose:	Routine Assessment	Dia/Height:	18"
Use:	Sanitary	Material:	VCP
Drain Area:		Lining:

US MH: **M-505-055** DS MH: **M-505-054** Total Length Surveyed (ft): **4.2**

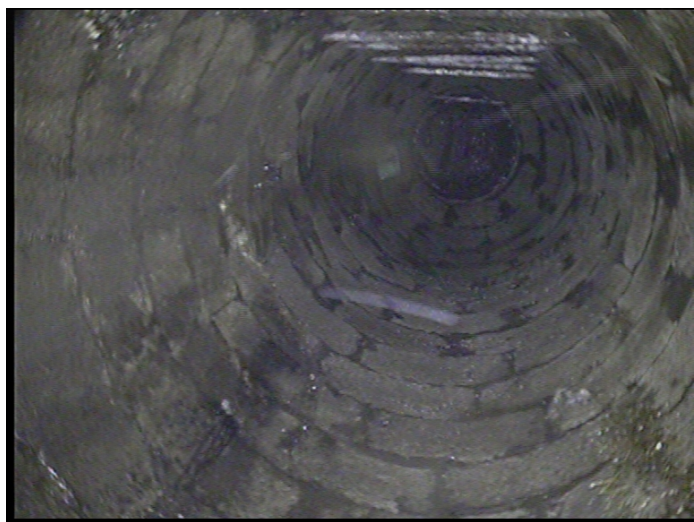
Code: **AMH**
 Description: **Manhole**

Distance (ft): **.0**
 Structural Grade: **0**
 O&M Grade: **0**
 Clock Start/From:
 Clock To:
 1st Value:
 2nd Value:
 Value Percent:
 Continuous Index:
 Within 8" of Joint: **NO**
 Remarks: **M-505-055**

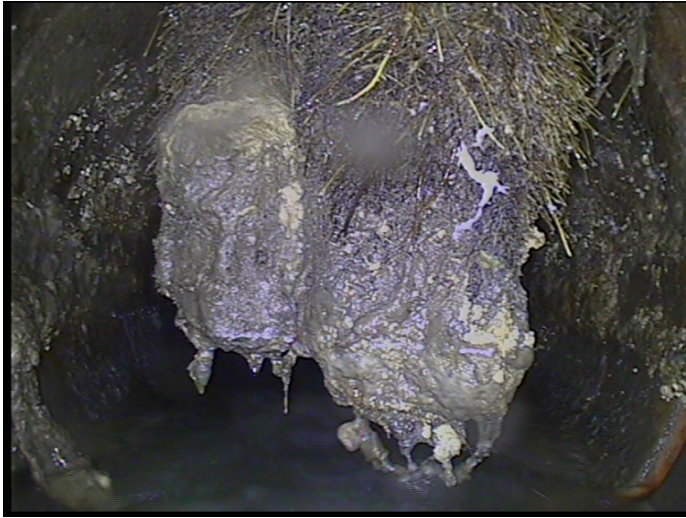
Code: **MWL**
Description: **Water Level**

Distance (ft): **.0**
Structural Grade: **0**
O&M Grade: **0**
Clock Start/From:
Clock To:
1st Value:
2nd Value:
Value Percent: **10.000**
Continuous Index:
Within 8" of Joint: **NO**
Remarks:

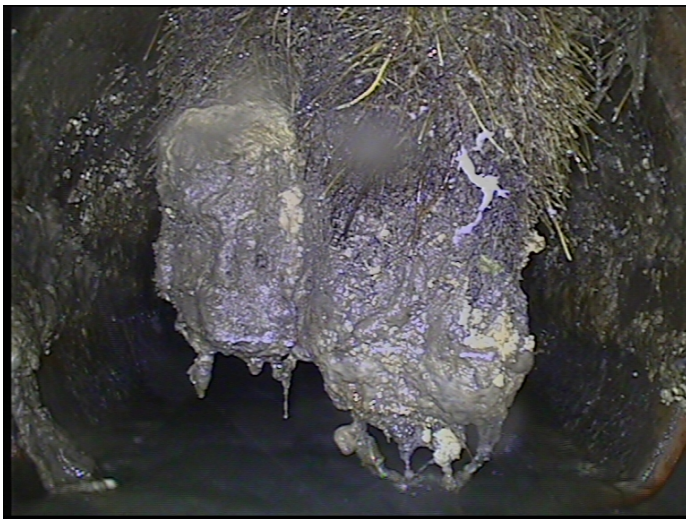
Code: **RMJ**
Description: **Roots Medium Joint**

Distance (ft): **.0**
Structural Grade: **0**
O&M Grade: **3**
Clock Start/From: **10**
Clock To: **2**
1st Value:
2nd Value:
Value Percent: **30.000**
Continuous Index:
Within 8" of Joint: **YES**
Remarks:

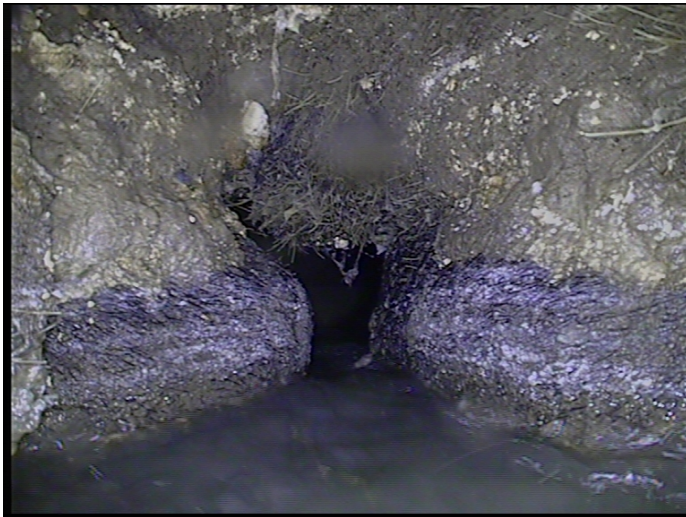
Code: **RBJ**
 Description: **Roots Ball Joint**

Distance (ft): **2.6**
 Structural Grade: **0**
 O&M Grade: **4**
 Clock Start/From: **8**
 Clock To: **4**
 1st Value:
 2nd Value:
 Value Percent: **60.000**
 Continuous Index:
 Within 8" of Joint: **YES**
 Remarks:

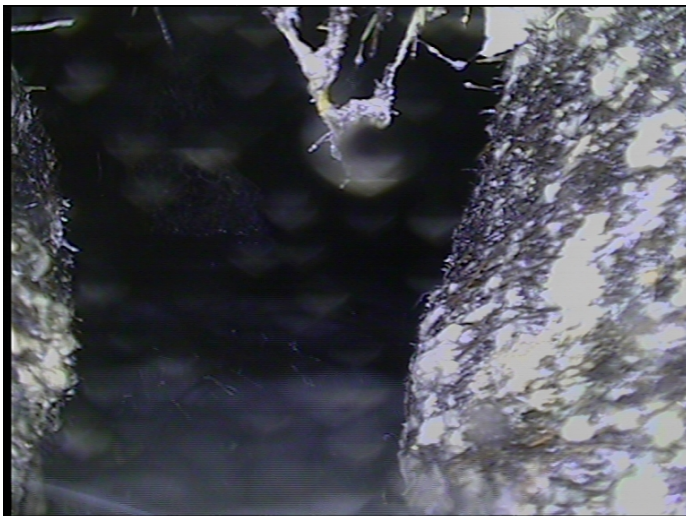
Code: **MSA**
 Description: **Abandoned Survey**

Distance (ft): **4.2**
 Structural Grade: **0**
 O&M Grade: **0**
 Clock Start/From:
 Clock To:
 1st Value:
 2nd Value:
 Value Percent:
 Continuous Index:
 Within 8" of Joint: **NO**
 Remarks: **root ball**
