Profile/Photo Observation Report

Profile/Photo Observation Report								
Date: Pipe Length (fi P.O.#: Customer:	04/14/2018 t): 52-1 City of Hobart	Weather: Owner: Surveyor: Clean Date:	City of Hoba M. Pielacha	rt	Coding: Pre Clean: PSR: Shape:	PACP 6.0 No Pre-Cleaning M-505-056-M-505-055		
Street:	Colorado Street Hobart, IN	Clean Date.	Flow Control: Year Renewed	:	Not Controlled			
Location: Purpose:	Light Highway Routine Assessment		Tape/Media #		DEP 52 18"			
Use: Drain Area:	Sanitary		Material: Lining:		VCP			
Category: Comment:	NA							
Location Detain US MH:	ils: M-505-056	DS MH:	Direction of Su M-505-055	•	Downstream Total Length Surveyed (ft):	161.6		
O&M Index:	0.00	O&M Quick:		000	O&M Rating:	0.00		
Structural Index	0.00	 Structural Qu	uick: 00	000	Structural Rating:	0.00		
Overall Index:	0.00	Overall Quicl	c:0	000	Overall Rating:	0.00

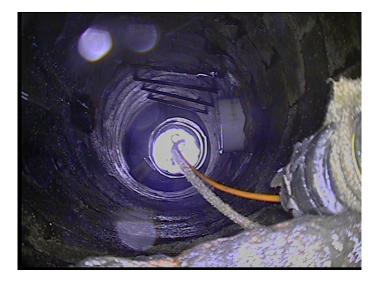
Code: Description:	AMH Manhole
Distance (ft):	.0
Structural Grade:	0
O&M Grade:	0
Clock Start/From:	
Clock To:	
1st Value:	
2nd Value:	
Value Percent:	
Continuous Index:	
Within 8" of Joint:	NO
Remarks:	M-505-056

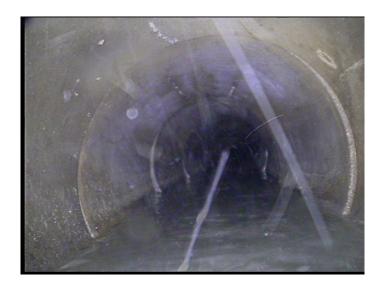
Code: MWL
Description: Water Level

Distance (ft): .0
Structural Grade: 0
O&M Grade: 0
Clock Start/From:

Value Percent: 15.000

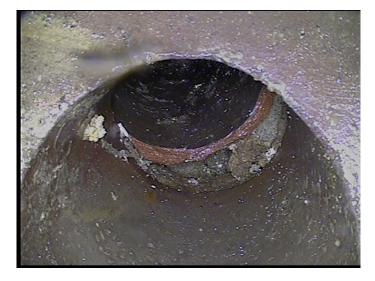
Code: TF

Description: Tap Factory

Distance (ft): 35.1
Structural Grade: 0
O&M Grade: 0
Clock Start/From: 10

1st Value: **4.000**

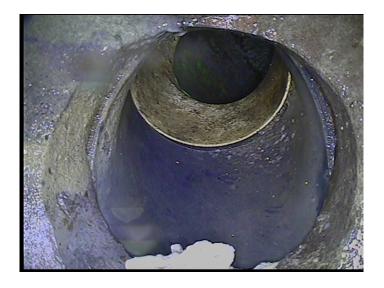
Code: TFA

Description: Tap Factory Active

Distance (ft): 76.4
Structural Grade: 0

Clock Start/From: 10

1st Value: **4.000**

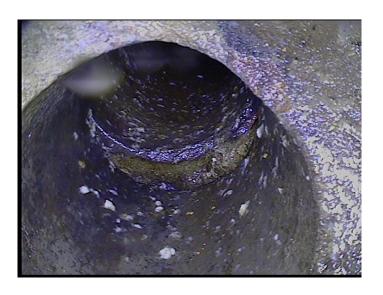
Code: **TF**

Description: Tap Factory

Distance (ft): 122.5
Structural Grade: 0
O&M Grade: 0
Clock Start/From: 10

1st Value: **4.000**

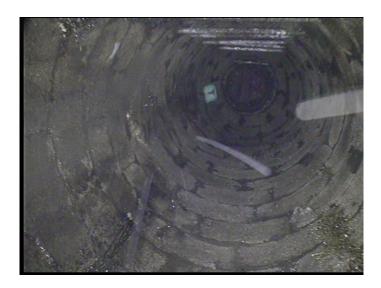
Code: AMH
Description: Manhole

Distance (ft): 161.6
Structural Grade: 0
O&M Grade: 0

Remarks: M-505-055
