## Profile/Photo Observation Report

Date:	<b>04/14/2018</b>	Weather:		Coding:	<b>PACP 6.0</b>
Pipe Length (ft):		Owner:	<b>City of Hobart</b>	Pre Clean:	<b>No Pre-Cleaning</b>
P.O.#:	<b>52-1</b>	Surveyor:	<b>M. Pielacha</b>	PSR:	<b>M-505-056-M-505-055</b>
Customer:	<b>City of Hobart</b>	Clean Date:		Shape:	<b>C</b>

Street:	<b>Colorado Street</b>	Flow Control:	<b>Not Controlled</b>
City:	<b>Hobart, IN</b>	Year Renewed:	
Location:	<b>Light Highway</b>	Tape/Media #:	<b>DEP 52</b>
Purpose:	<b>Routine Assessment</b>	Dia/Height:	<b>18"</b>
Use:	<b>Sanitary</b>	Material:	<b>VCP</b>
Drain Area:		Lining:

US MH: **M-505-056** DS MH: **M-505-055** Total Length Surveyed (ft): **161.6**

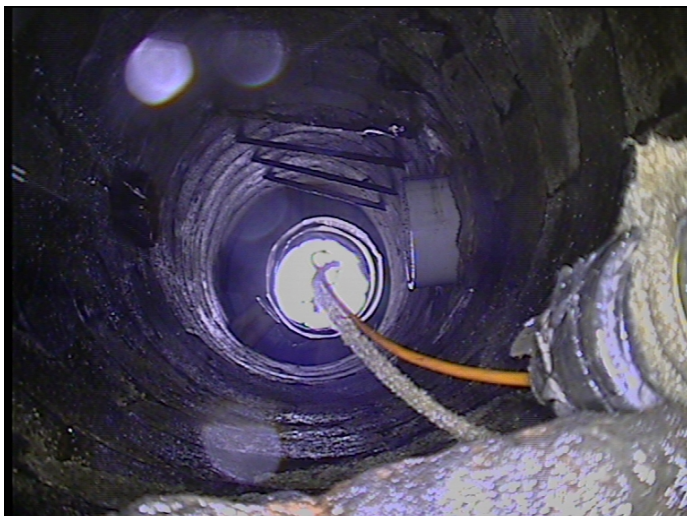
Code: **AMH**  
 Description: **Manhole**

Distance (ft): **.0**  
 Structural Grade: **0**  
 O&M Grade: **0**  
 Clock Start/From:  
 Clock To:  
 1st Value:  
 2nd Value:  
 Value Percent:  
 Continuous Index:  
 Within 8" of Joint: **NO**  
 Remarks: **M-505-056**

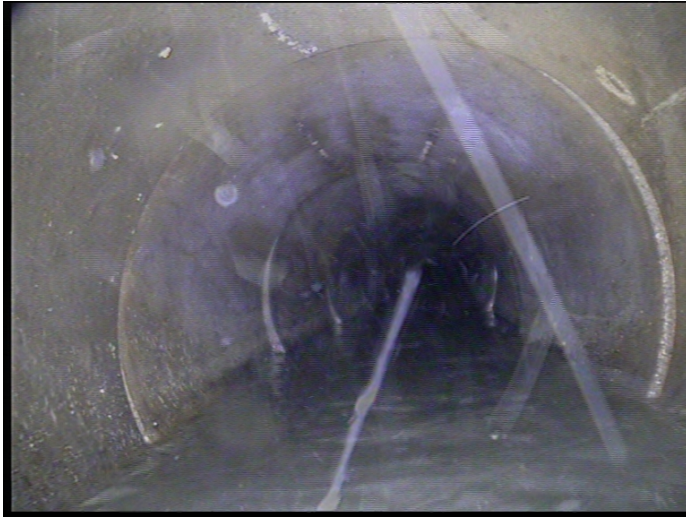
Code:	<b>MWL</b>
Description:	<b>Water Level</b>
Distance (ft):	<b>.0</b>
Structural Grade:	<b>0</b>
O&M Grade:	<b>0</b>
Clock Start/From:	
Clock To:	
1st Value:	
2nd Value:	
Value Percent:	<b>15.000</b>
Continuous Index:	
Within 8" of Joint:	<b>NO</b>
Remarks:

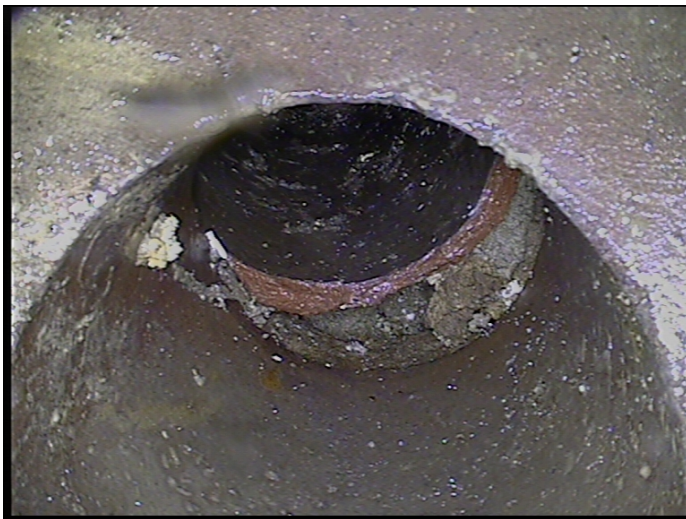
Code:	<b>TF</b>
Description:	<b>Tap Factory</b>
Distance (ft):	<b>35.1</b>
Structural Grade:	<b>0</b>
O&M Grade:	<b>0</b>
Clock Start/From:	<b>10</b>
Clock To:	
1st Value:	<b>4.000</b>
2nd Value:	
Value Percent:	
Continuous Index:	
Within 8" of Joint:	<b>NO</b>
Remarks:

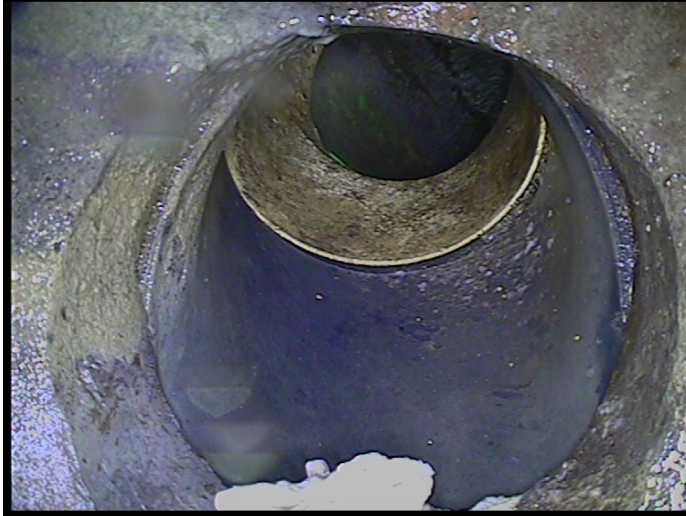
Code: **TFA**  
Description: **Tap Factory Active**

Distance (ft): **76.4**  
Structural Grade: **0**  
O&M Grade: **0**  
Clock Start/From: **10**  
Clock To:  
1st Value: **4.000**  
2nd Value:  
Value Percent:  
Continuous Index:  
Within 8" of Joint: **NO**  
Remarks:

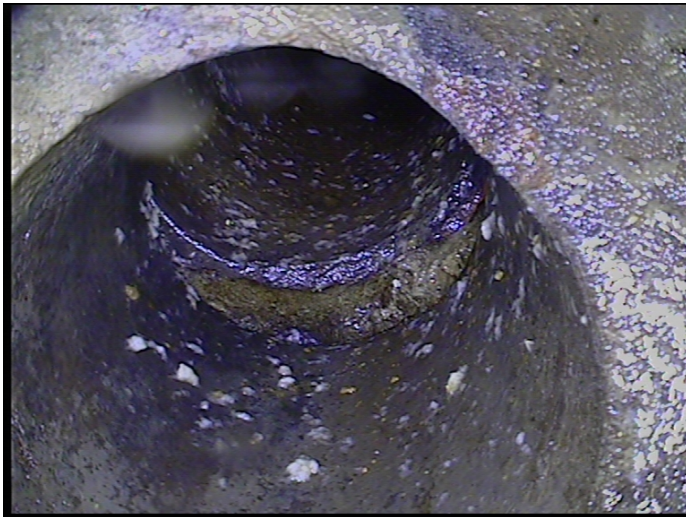
Code: **TF**  
Description: **Tap Factory**

Distance (ft): **122.5**  
Structural Grade: **0**  
O&M Grade: **0**  
Clock Start/From: **10**  
Clock To:  
1st Value: **4.000**  
2nd Value:  
Value Percent:  
Continuous Index:  
Within 8" of Joint: **NO**  
Remarks:

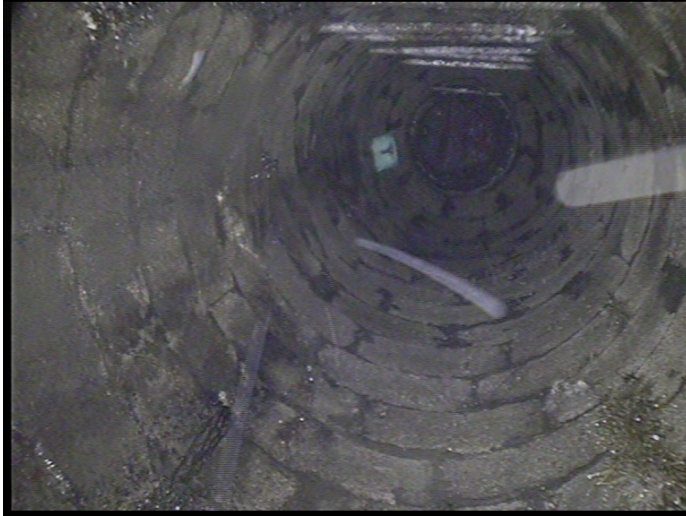
Code:	<b>AMH</b>
Description:	<b>Manhole</b>
Distance (ft):	<b>161.6</b>
Structural Grade:	<b>0</b>
O&M Grade:	<b>0</b>
Clock Start/From:	
Clock To:	
1st Value:	
2nd Value:	
Value Percent:	
Continuous Index:	
Within 8" of Joint:	<b>NO</b>
Remarks:	<b>M-505-055</b>
