Profile/Photo Observation Report

Date:	04/14/2018	Weather:		Coding:	PACP 6.0
Pipe Length (ft):		Owner:	City of Hobart	Pre Clean:	No Pre-Cleaning
P.O.#:	51-1	Surveyor:	M. Pielacha	PSR:	M-505-057-M-505-056
Customer:	City of Hobart	Clean Date:		Shape:	C

Street:	Colorado Street	Flow Control:	Not Controlled
City:	Hobart, IN	Year Renewed:	
Location:	Light Highway	Tape/Media #:	DEP 51
Purpose:	Routine Assessment	Dia/Height:	18"
Use:	Sanitary	Material:	VCP
Drain Area:		Lining:	
Category:	NA		
Comment:			
Location Details:		Direction of Survey:	Upstream
US MH:	M-505-057	DS MH:	M-505-056
		Total Length Surveyed (ft):	115.5

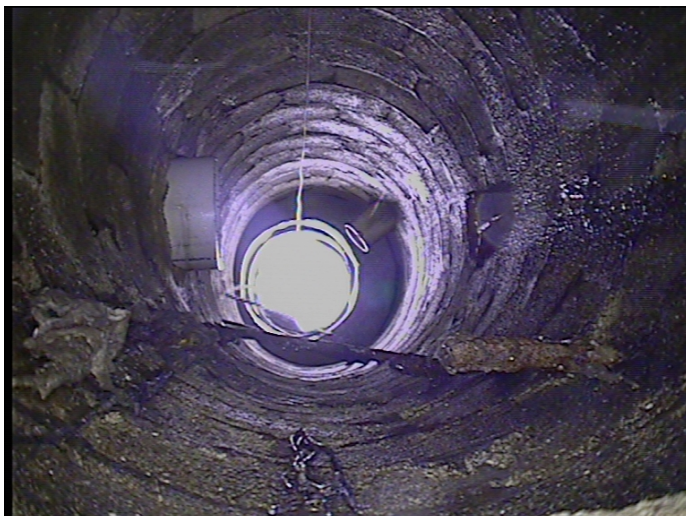
Code: **AMH**
 Description: **Manhole**

Distance (ft): **.0**
 Structural Grade: **0**
 O&M Grade: **0**
 Clock Start/From:
 Clock To:
 1st Value:
 2nd Value:
 Value Percent:
 Continuous Index:
 Within 8" of Joint: **NO**
 Remarks: **M-505-056**

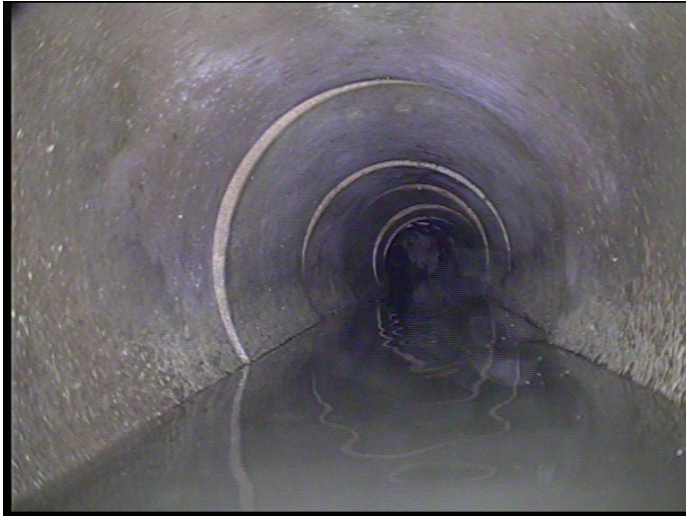
Code: **MWL**
Description: **Water Level**

Distance (ft): **.0**
Structural Grade: **0**
O&M Grade: **0**
Clock Start/From:
Clock To:
1st Value:
2nd Value:
Value Percent: **15.000**
Continuous Index:
Within 8" of Joint: **NO**
Remarks:

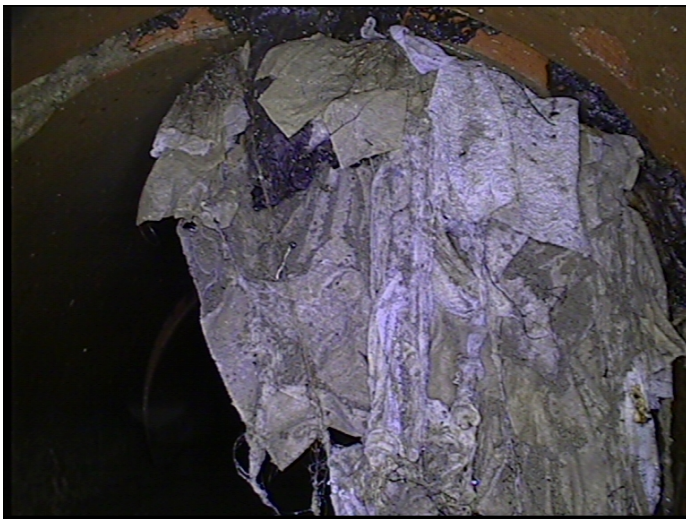
Code: **DAR**
Description: **Deposits Attached Ragging**

Distance (ft): **18.6**
Structural Grade: **0**
O&M Grade: **5**
Clock Start/From: **12**
Clock To: **4**
1st Value:
2nd Value:
Value Percent: **35.000**
Continuous Index:
Within 8" of Joint: **NO**
Remarks:

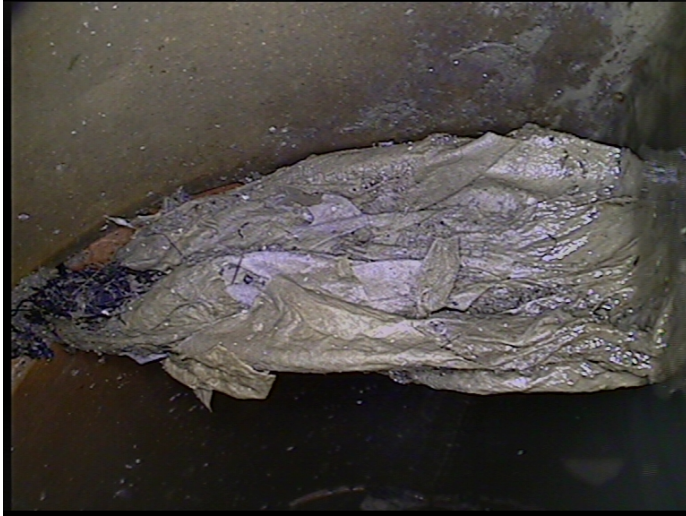
Code:	DAR
Description:	Deposits Attached Ragging
Distance (ft):	29.1
Structural Grade:	0
O&M Grade:	3
Clock Start/From:	1
Clock To:	5
1st Value:	
2nd Value:	
Value Percent:	15.000
Continuous Index:	
Within 8" of Joint:	YES
Remarks:

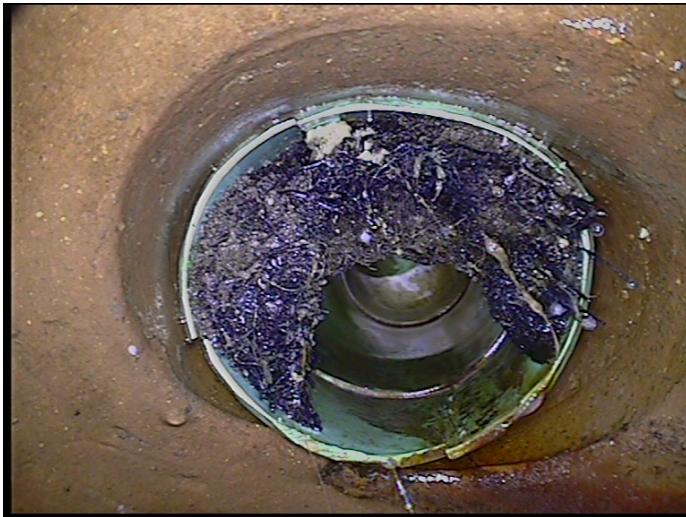
Code: **TB**
 Description: **Tap Break-in**

Distance (ft): **39.2**
 Structural Grade: **0**
 O&M Grade: **0**
 Clock Start/From: **2**
 Clock To:
 1st Value: **4.000**
 2nd Value:
 Value Percent:
 Continuous Index:
 Within 8" of Joint: **NO**
 Remarks:

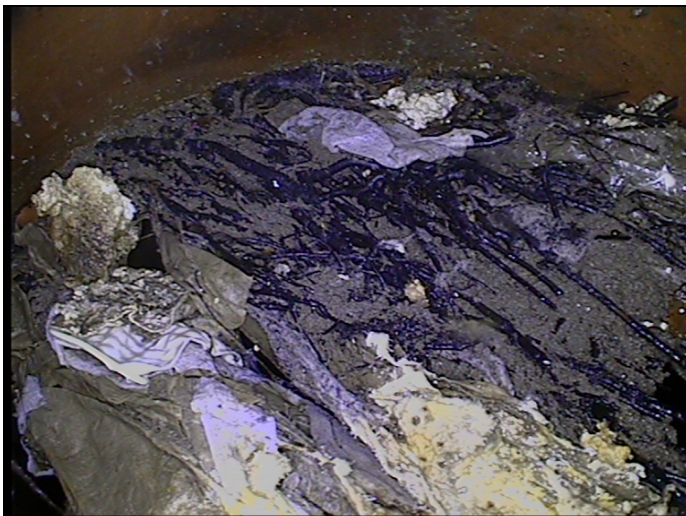
Code: **RMJ**
 Description: **Roots Medium Joint**

Distance (ft): **39.4**
 Structural Grade: **0**
 O&M Grade: **3**
 Clock Start/From: **8**
 Clock To: **4**
 1st Value:
 2nd Value:
 Value Percent: **30.000**
 Continuous Index:
 Within 8" of Joint: **YES**
 Remarks:

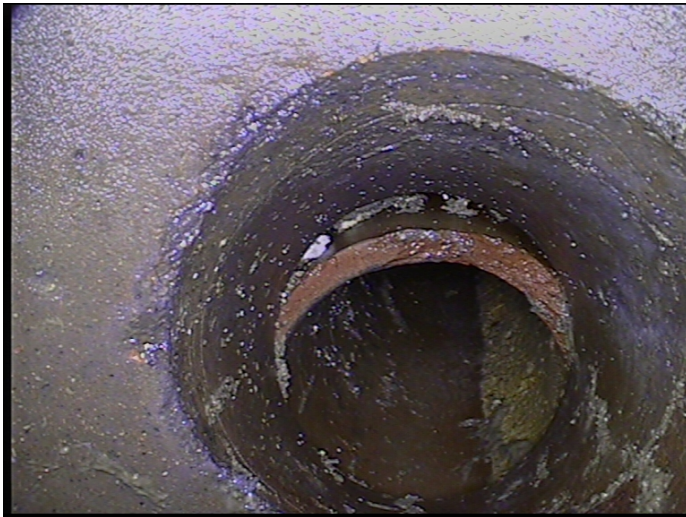
Code: **TF**
 Description: **Tap Factory**

Distance (ft): **74.9**
 Structural Grade: **0**
 O&M Grade: **0**
 Clock Start/From: **1**
 Clock To:
 1st Value: **4.000**
 2nd Value:
 Value Percent:
 Continuous Index:
 Within 8" of Joint: **NO**
 Remarks:

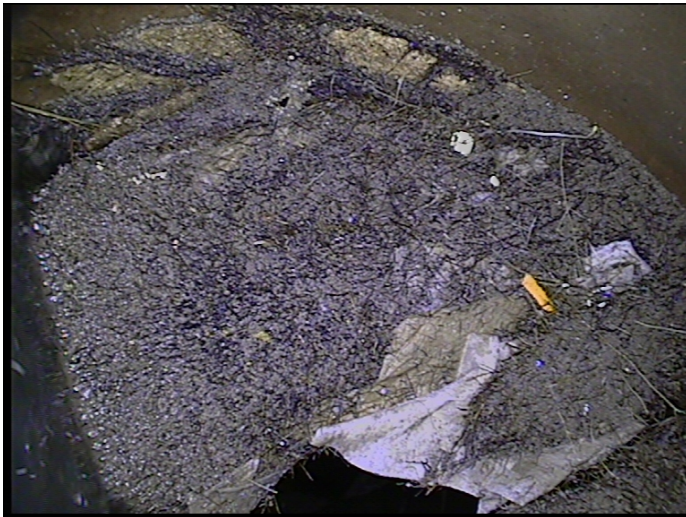
Code: **RMJ**
 Description: **Roots Medium Joint**

Distance (ft): **103.1**
 Structural Grade: **0**
 O&M Grade: **3**
 Clock Start/From: **8**
 Clock To: **4**
 1st Value:
 2nd Value:
 Value Percent: **35.000**
 Continuous Index:
 Within 8" of Joint: **YES**
 Remarks:

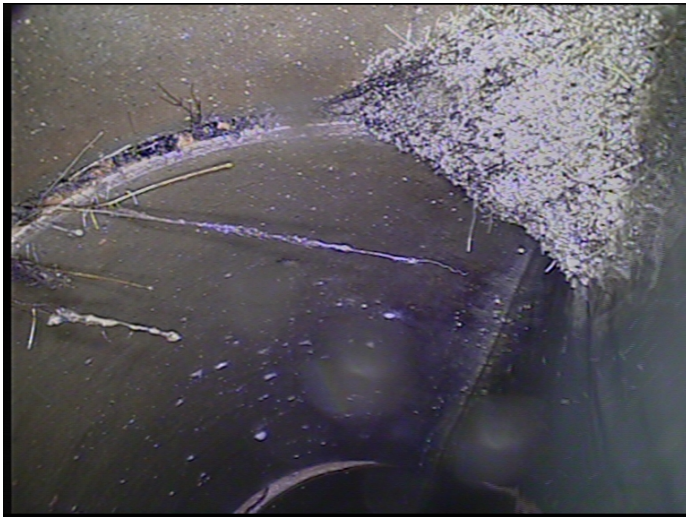
Code: **RMJ**
Description: **Roots Medium Joint**

Distance (ft): **111.2**
Structural Grade: **0**
O&M Grade: **3**
Clock Start/From: **8**
Clock To: **4**
1st Value:
2nd Value:
Value Percent: **20.000**
Continuous Index:
Within 8" of Joint: **YES**
Remarks:

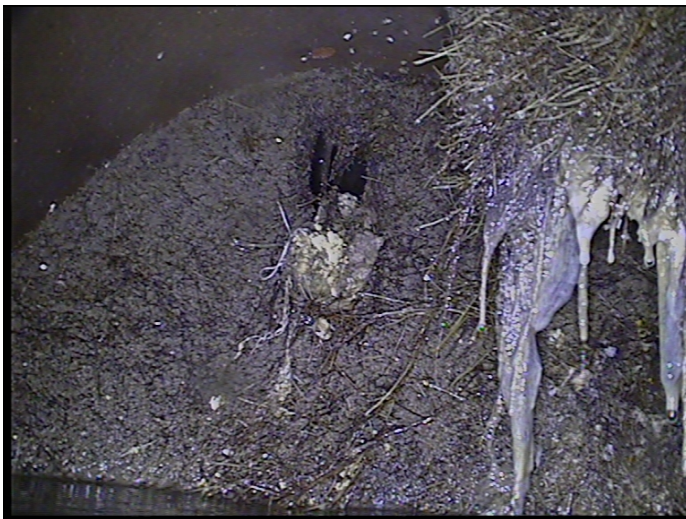
Code: **RBJ**
Description: **Roots Ball Joint**

Distance (ft): **115.5**
Structural Grade: **0**
O&M Grade: **4**
Clock Start/From: **8**
Clock To: **4**
1st Value:
2nd Value:
Value Percent: **55.000**
Continuous Index:
Within 8" of Joint: **YES**
Remarks:

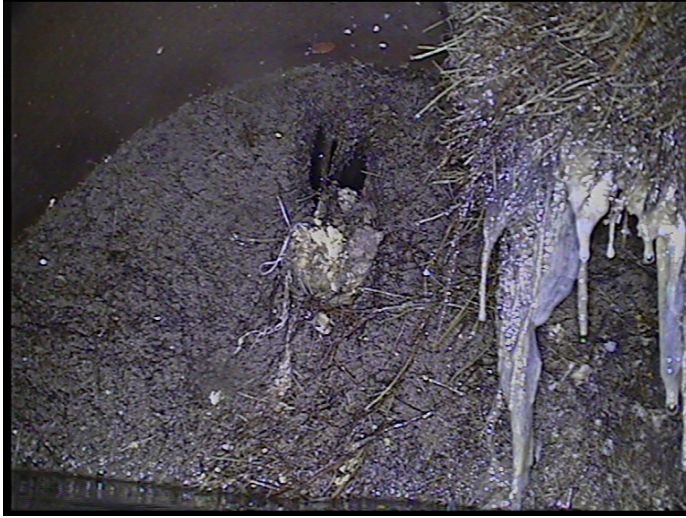
Code:	MSA
Description:	Abandoned Survey
Distance (ft):	115.5
Structural Grade:	0
O&M Grade:	0
Clock Start/From:	
Clock To:	
1st Value:	
2nd Value:	
Value Percent:	
Continuous Index:	
Within 8" of Joint:	NO
Remarks:	roots
