Profile/Photo Observation Report

Street:	FOXCROFT STREET	Flow Control:	Not Controlled
City:	Hobart, IN	Year Renewed:	
Location:	Light Highway	Tape/Media #:	
Purpose:	Routine Assessment	Dia/Height:	12"
Use:	Sanitary	Material:	VCP
Drain Area:	NA	Lining:	
Category:	NA		
Comment:	Flow direction wrong		
Location Details:		Direction of Survey:	Downstream
US MH:	M-505-063	DS MH:	M-505-064
		Total Length Surveyed (ft):	288.7

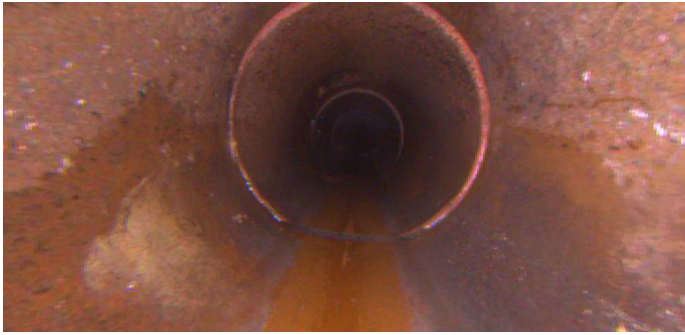
Code: **AMH**
Description: **Manhole**

Distance (ft): **.0**
Structural Grade: **0**
O&M Grade: **0**
Clock Start/From:
Clock To:
1st Value:
2nd Value:
Value Percent:
Continuous Index:
Within 8" of Joint: **NO**
Remarks: **M-505-063**

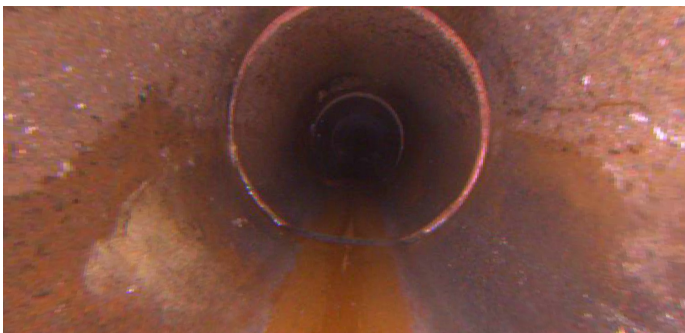
Code: **MWL**
Description: **Water Level**

Distance (ft): **.0**
Structural Grade: **0**
O&M Grade: **0**
Clock Start/From:
Clock To:
1st Value:
2nd Value:
Value Percent: **5.000**
Continuous Index:
Within 8" of Joint: **NO**
Remarks:

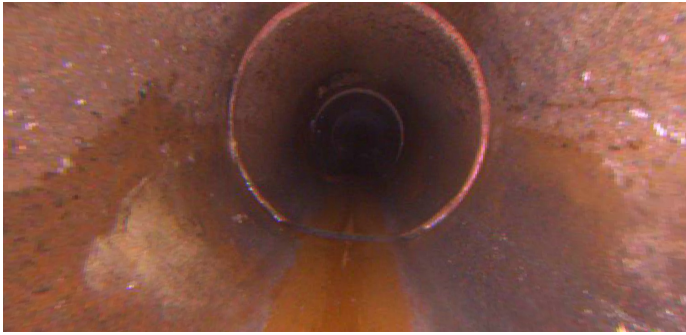
Code: **CM**
Description: **Crack Multiple**

Distance (ft): **.0**
Structural Grade: **3**
O&M Grade: **0**
Clock Start/From: **9**
Clock To: **3**
1st Value:
2nd Value:
Value Percent:
Continuous Index: **S01**
Within 8" of Joint: **YES**
Remarks: **wandering**

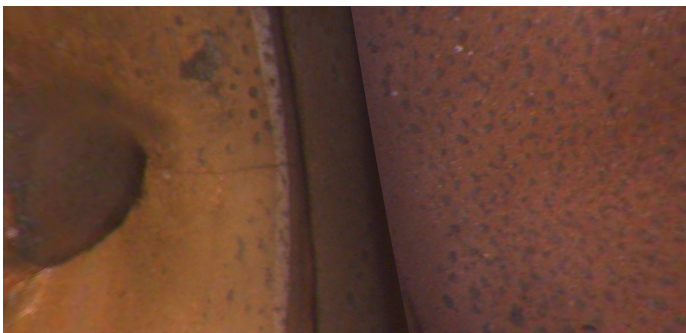
Code: **TF**
Description: **Tap Factory**

Distance (ft): **4.1**
Structural Grade: **0**
O&M Grade: **0**
Clock Start/From: **10**
Clock To:
1st Value: **4.000**
2nd Value:
Value Percent:
Continuous Index:
Within 8" of Joint: **YES**
Remarks:

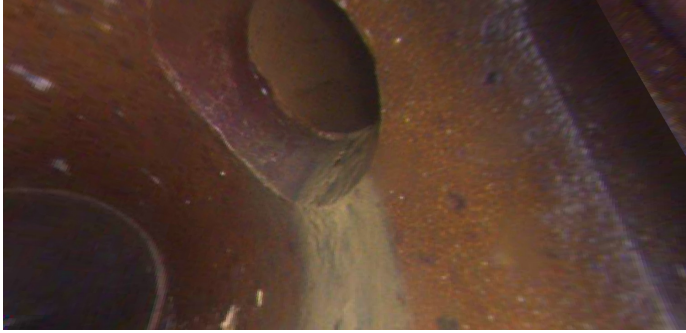
Code: **TF**
Description: **Tap Factory**

Distance (ft): **32.1**
Structural Grade: **0**
O&M Grade: **0**
Clock Start/From: **10**
Clock To:
1st Value: **4.000**
2nd Value:
Value Percent:
Continuous Index:
Within 8" of Joint: **YES**
Remarks:

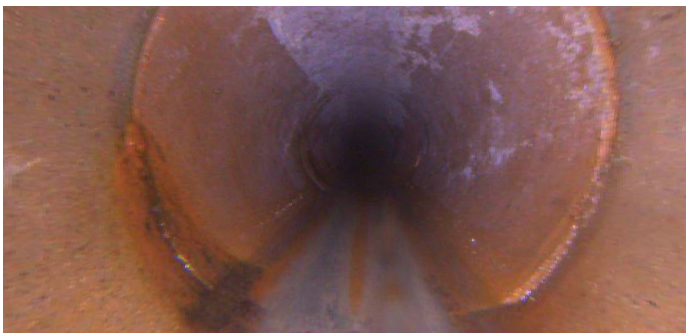
Code: **IS**
Description: **Infil Stain**

Distance (ft): **39.6**
Structural Grade: **0**
O&M Grade: **0**
Clock Start/From: **9**
Clock To:
1st Value:
2nd Value:
Value Percent:
Continuous Index:
Within 8" of Joint: **YES**
Remarks:

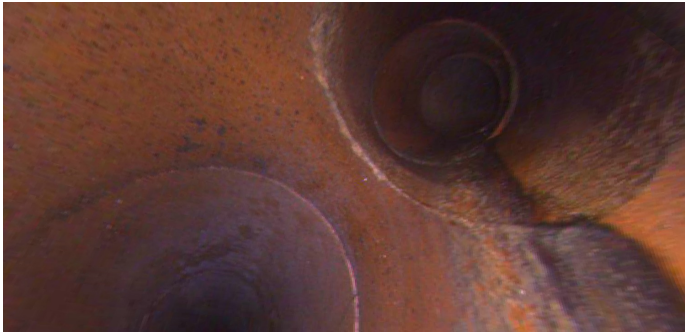
Code: **TF**
Description: **Tap Factory**

Distance (ft): **57.4**
Structural Grade: **0**
O&M Grade: **0**
Clock Start/From: **1**
Clock To:
1st Value: **4.000**
2nd Value:
Value Percent:
Continuous Index:
Within 8" of Joint: **YES**
Remarks:

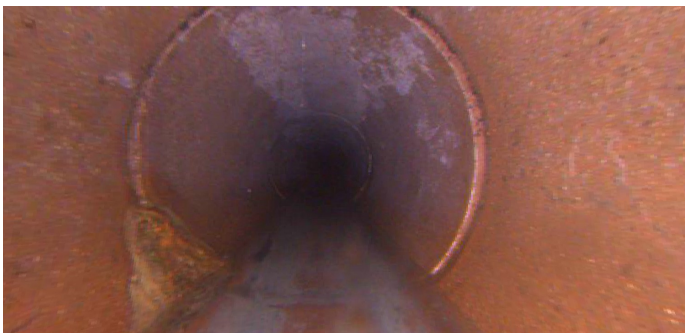
Code: **DAE**
Description: **Deposits Attached Encrustation**

Distance (ft): **61.7**
Structural Grade: **0**
O&M Grade: **2**
Clock Start/From: **8**
Clock To:
1st Value:
2nd Value:
Value Percent: **5.000**
Continuous Index:
Within 8" of Joint: **YES**
Remarks:

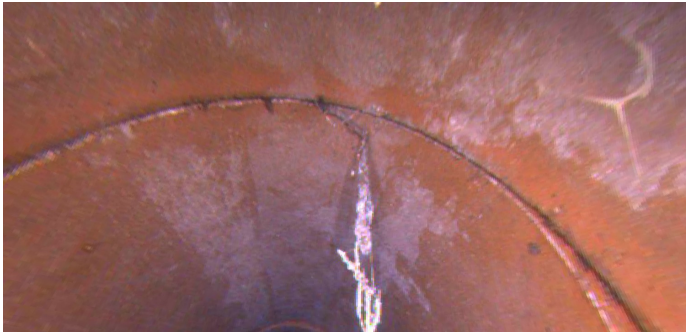
Code: **RFJ**
Description: **Roots Fine Joint**

Distance (ft): **72.1**
Structural Grade: **0**
O&M Grade: **1**
Clock Start/From: **12**
Clock To:
1st Value:
2nd Value:
Value Percent:
Continuous Index:
Within 8" of Joint: **YES**
Remarks:

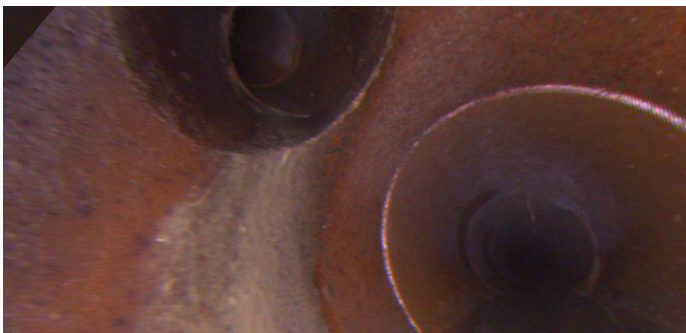
Code: **TF**
Description: **Tap Factory**

Distance (ft): **87.5**
Structural Grade: **0**
O&M Grade: **0**
Clock Start/From: **11**
Clock To:
1st Value: **4.000**
2nd Value:
Value Percent:
Continuous Index:
Within 8" of Joint: **YES**
Remarks:

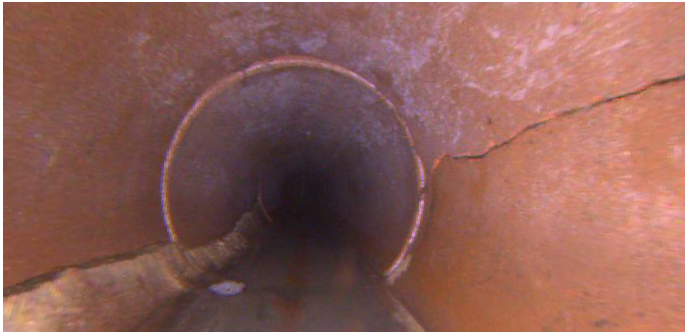
Code: **FM**
Description: **Fracture Multiple**

Distance (ft): **93.5**
Structural Grade: **4**
O&M Grade: **0**
Clock Start/From: **8**
Clock To: **2**
1st Value:
2nd Value:
Value Percent:
Continuous Index:
Within 8" of Joint: **YES**
Remarks:

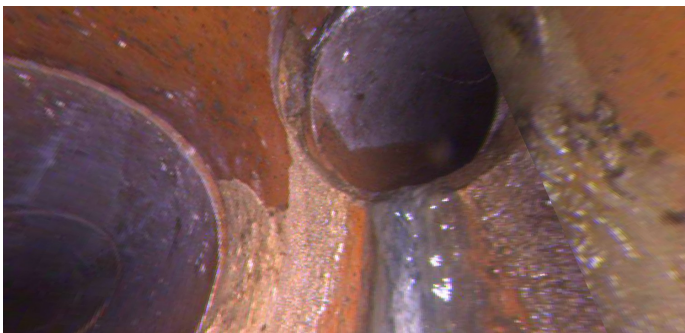
Code: **TF**
Description: **Tap Factory**

Distance (ft): **101.7**
Structural Grade: **0**
O&M Grade: **0**
Clock Start/From: **1**
Clock To:
1st Value: **4.000**
2nd Value:
Value Percent:
Continuous Index:
Within 8" of Joint: **YES**
Remarks:

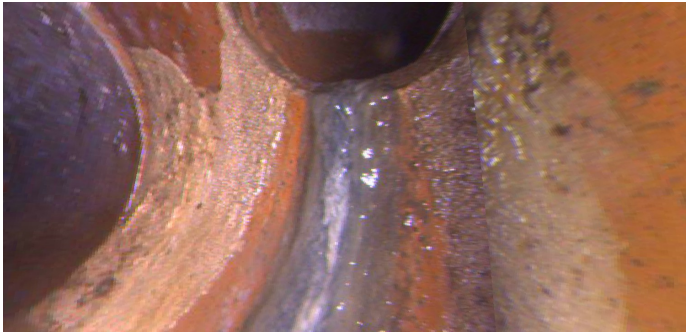
Code: **DAGS**
Description: **Deposits Attached Grease**

Distance (ft): **101.7**
Structural Grade: **0**
O&M Grade: **2**
Clock Start/From: **3**
Clock To: **5**
1st Value:
2nd Value:
Value Percent: **5.000**
Continuous Index:
Within 8" of Joint: **NO**
Remarks:

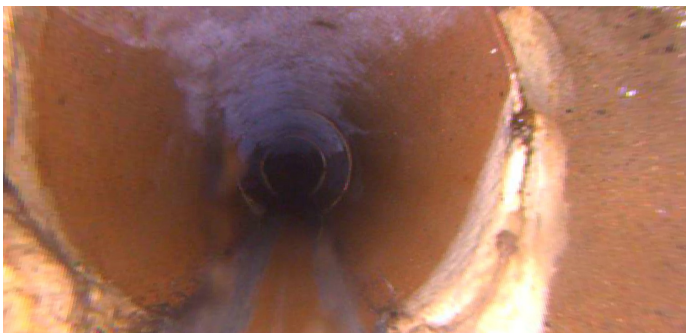
Code: **DAZ**
Description: **Deposits Attached Other**

Distance (ft): **112.3**
Structural Grade: **0**
O&M Grade: **2**
Clock Start/From: **7**
Clock To: **5**
1st Value:
2nd Value:
Value Percent: **5.000**
Continuous Index: **S02**
Within 8" of Joint: **YES**
Remarks:

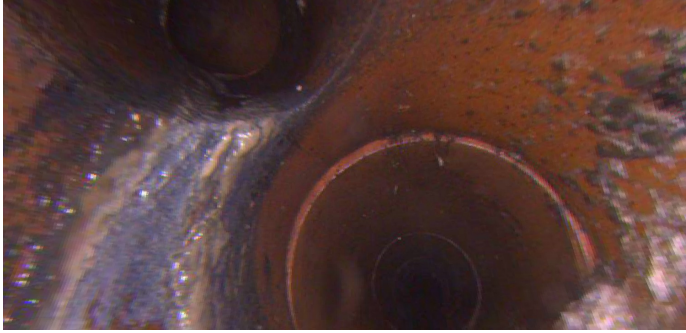
Code: **TF**
Description: **Tap Factory**

Distance (ft): **131.9**
Structural Grade: **0**
O&M Grade: **0**
Clock Start/From: **11**
Clock To:
1st Value: **4.000**
2nd Value:
Value Percent:
Continuous Index:
Within 8" of Joint: **YES**
Remarks:

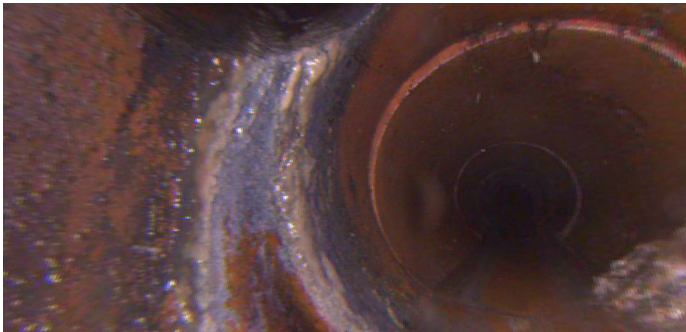
Code: **DAGS**
Description: **Deposits Attached Grease**

Distance (ft): **131.9**
Structural Grade: **0**
O&M Grade: **2**
Clock Start/From: **7**
Clock To: **10**
1st Value:
2nd Value:
Value Percent: **5.000**
Continuous Index:
Within 8" of Joint: **YES**
Remarks:

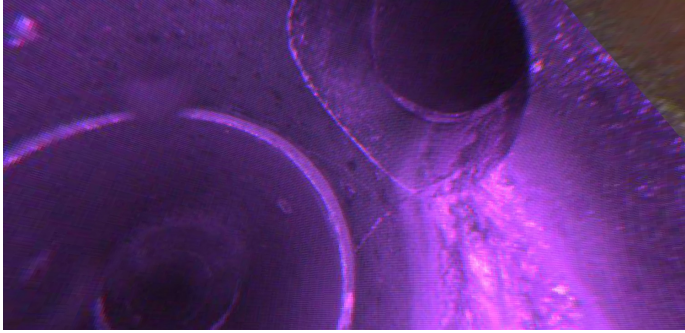
Code: **TF**
Description: **Tap Factory**

Distance (ft): **144.2**
Structural Grade: **0**
O&M Grade: **0**
Clock Start/From: **1**
Clock To:
1st Value: **4.000**
2nd Value:
Value Percent:
Continuous Index:
Within 8" of Joint: **YES**
Remarks:

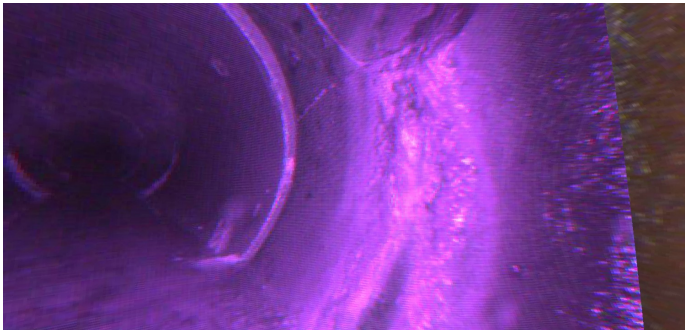
Code: **DAGS**
Description: **Deposits Attached Grease**

Distance (ft): **144.2**
Structural Grade: **0**
O&M Grade: **2**
Clock Start/From: **2**
Clock To: **5**
1st Value:
2nd Value:
Value Percent: **5.000**
Continuous Index:
Within 8" of Joint: **NO**
Remarks:

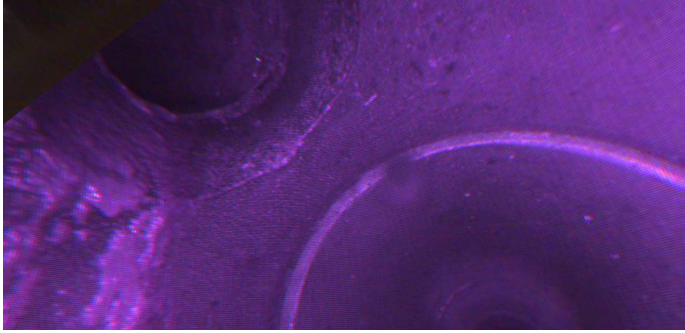
Code: **TF**
Description: **Tap Factory**

Distance (ft): **176.9**
Structural Grade: **0**
O&M Grade: **0**
Clock Start/From: **11**
Clock To:
1st Value: **4.000**
2nd Value:
Value Percent:
Continuous Index:
Within 8" of Joint: **YES**
Remarks:

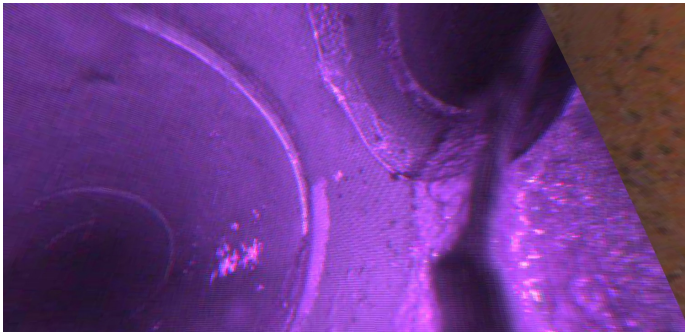
Code: **TF**
Description: **Tap Factory**

Distance (ft): **186.8**
Structural Grade: **0**
O&M Grade: **0**
Clock Start/From: **2**
Clock To:
1st Value: **4.000**
2nd Value:
Value Percent:
Continuous Index:
Within 8" of Joint: **YES**
Remarks:

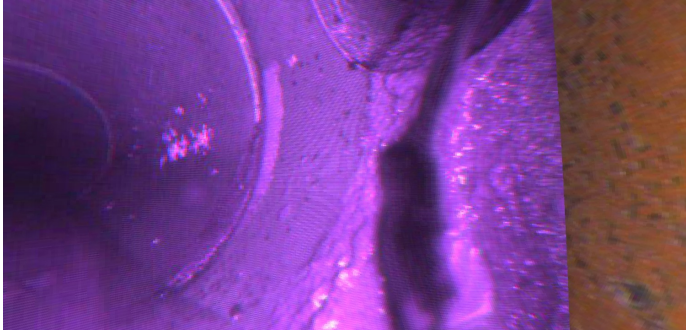
Code: **DAGS**
Description: **Deposits Attached Grease**

Distance (ft): **186.8**
Structural Grade: **0**
O&M Grade: **2**
Clock Start/From: **2**
Clock To: **5**
1st Value:
2nd Value:
Value Percent: **5.000**
Continuous Index:
Within 8" of Joint: **YES**
Remarks:

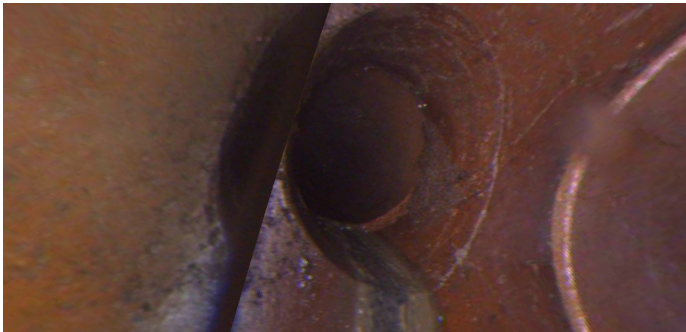
Code: **TF**
Description: **Tap Factory**

Distance (ft): **220.8**
Structural Grade: **0**
O&M Grade: **0**
Clock Start/From: **10**
Clock To:
1st Value: **4.000**
2nd Value:
Value Percent:
Continuous Index:
Within 8" of Joint: **YES**
Remarks:

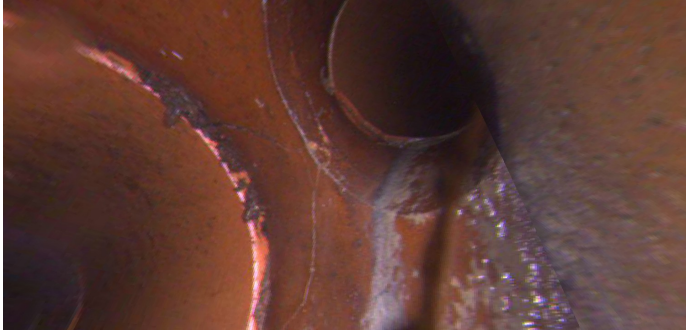
Code: **TF**
Description: **Tap Factory**

Distance (ft): **235.0**
Structural Grade: **0**
O&M Grade: **0**
Clock Start/From: **2**
Clock To:
1st Value: **4.000**
2nd Value:
Value Percent:
Continuous Index:
Within 8" of Joint: **YES**
Remarks:

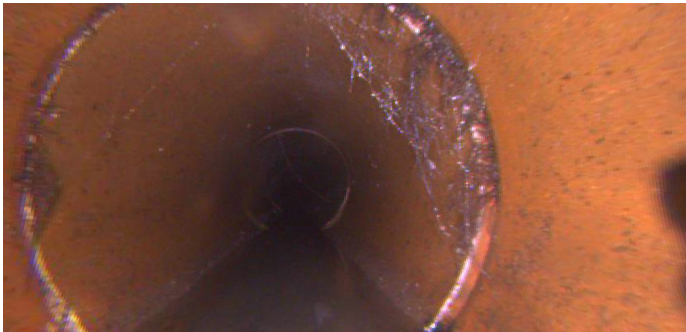
Code: **RFJ**
Description: **Roots Fine Joint**

Distance (ft): **243.1**
Structural Grade: **0**
O&M Grade: **1**
Clock Start/From: **9**
Clock To: **3**
1st Value:
2nd Value:
Value Percent:
Continuous Index: **S03**
Within 8" of Joint: **YES**
Remarks: **wandering**

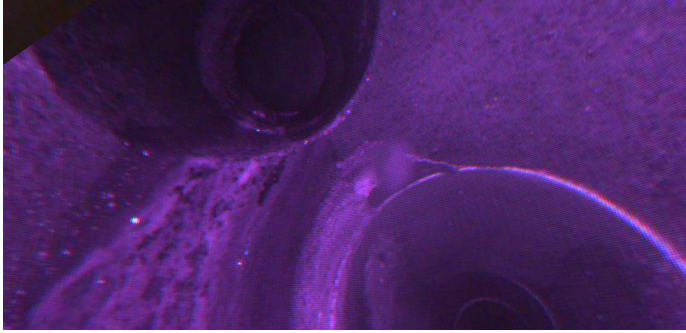
Code: **TF**
Description: **Tap Factory**

Distance (ft): **261.9**
Structural Grade: **0**
O&M Grade: **0**
Clock Start/From: **11**
Clock To:
1st Value: **4.000**
2nd Value:
Value Percent:
Continuous Index:
Within 8" of Joint: **YES**
Remarks:

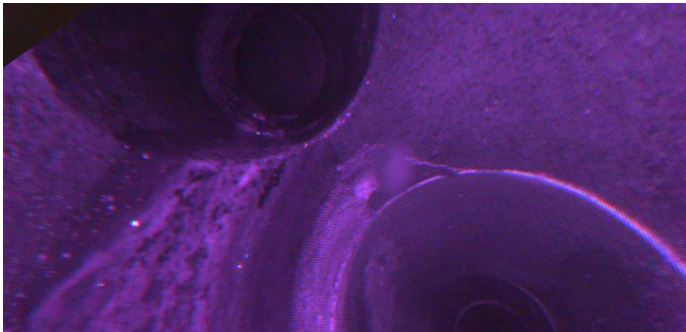
Code: **DAGS**
Description: **Deposits Attached Grease**

Distance (ft): **261.9**
Structural Grade: **0**
O&M Grade: **2**
Clock Start/From: **7**
Clock To: **10**
1st Value:
2nd Value:
Value Percent: **5.000**
Continuous Index:
Within 8" of Joint: **NO**
Remarks:

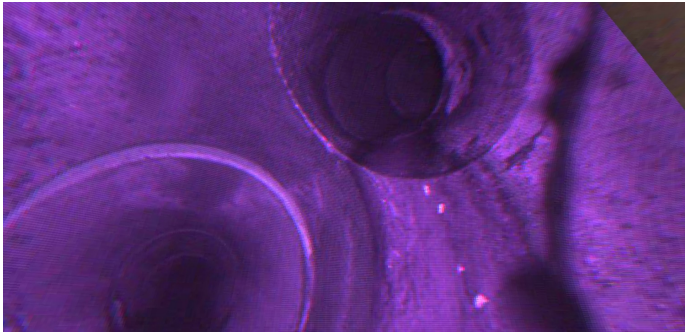
Code: **TF**
Description: **Tap Factory**

Distance (ft): **276.9**
Structural Grade: **0**
O&M Grade: **0**
Clock Start/From: **1**
Clock To:
1st Value: **4.000**
2nd Value:
Value Percent:
Continuous Index:
Within 8" of Joint: **YES**
Remarks:

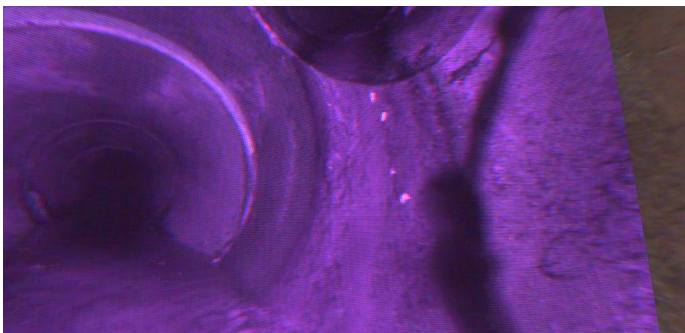
Code: **DAGS**
Description: **Deposits Attached Grease**

Distance (ft): **276.9**
Structural Grade: **0**
O&M Grade: **2**
Clock Start/From: **2**
Clock To: **5**
1st Value:
2nd Value:
Value Percent: **5.000**
Continuous Index:
Within 8" of Joint: **NO**
Remarks:

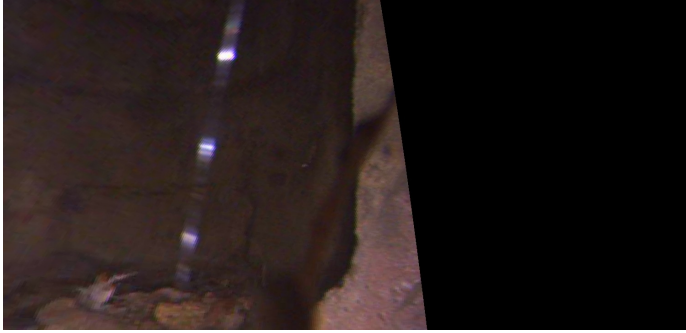
Code: **DAZ**
Description: **Deposits Attached Other**

Distance (ft): **287.8**
Structural Grade: **0**
O&M Grade: **2**
Clock Start/From: **7**
Clock To: **5**
1st Value:
2nd Value:
Value Percent: **5.000**
Continuous Index: **F02**
Within 8" of Joint: **YES**
Remarks:

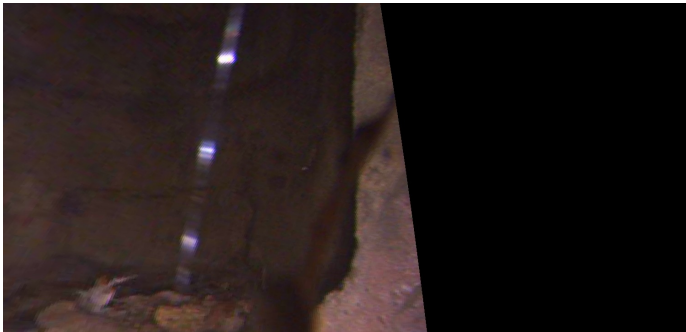
Code: **RFJ**
Description: **Roots Fine Joint**

Distance (ft): **287.8**
Structural Grade: **0**
O&M Grade: **1**
Clock Start/From: **9**
Clock To: **3**
1st Value:
2nd Value:
Value Percent:
Continuous Index: **F03**
Within 8" of Joint: **YES**
Remarks: **wandering**

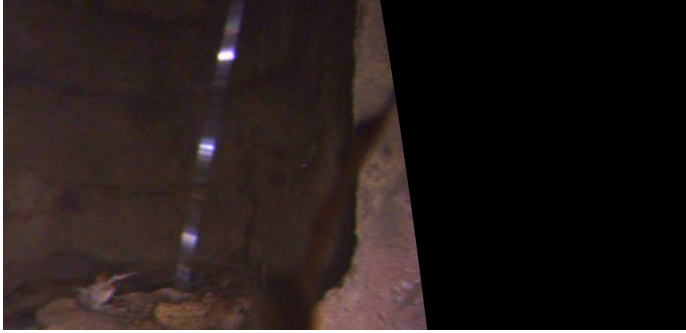
Code: **CM**
Description: **Crack Multiple**

Distance (ft): **287.8**
Structural Grade: **3**
O&M Grade: **0**
Clock Start/From: **9**
Clock To: **3**
1st Value:
2nd Value:
Value Percent:
Continuous Index: **F01**
Within 8" of Joint: **YES**
Remarks: **wandering**

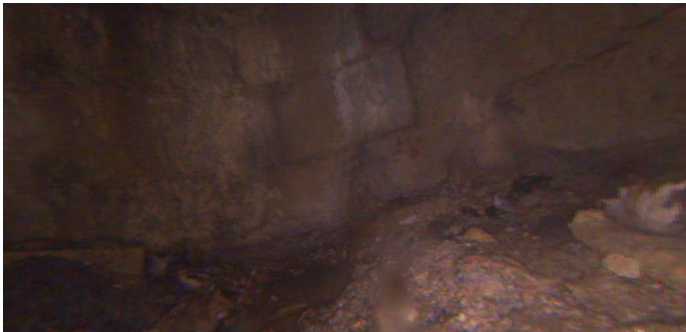
Code: **AMH**
Description: **Manhole**

Distance (ft): **288.7**
Structural Grade: **0**
O&M Grade: **0**
Clock Start/From:
Clock To:
1st Value:
2nd Value:
Value Percent:
Continuous Index:
Within 8" of Joint: **NO**
Remarks: **M-505-064**
