Profile/Photo Observation Report

Street:	S WILSON ST	Flow Control:	Not Controlled
City:	Hobart, IN	Year Renewed:	
Location:	Light Highway	Tape/Media #:	
Purpose:	Routine Assessment	Dia/Height:	10"
Use:	Sanitary	Material:	VCP
Drain Area:	NA	Lining:	
Category:	NA		
Comment:	P_C At 13 ft roots . Flow direction wrong		
Location Details:		Direction of Survey:	Downstream
US MH:	M-505-070	DS MH:	M-505-069
		Total Length Surveyed (ft):	14.2

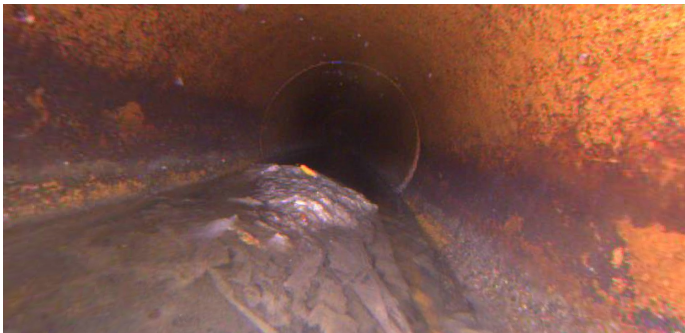
Code:	MWL
Description:	Water Level

Distance (ft):	.0
Structural Grade:	0
O&M Grade:	0
Clock Start/From:	
Clock To:	
1st Value:	
2nd Value:	
Value Percent:	20.000
Continuous Index:	
Within 8" of Joint:	NO
Remarks:

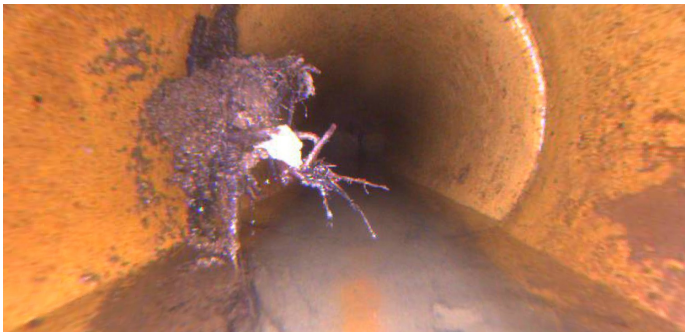
Code:	RMJ
Description:	Roots Medium Joint

Distance (ft):	9.7
Structural Grade:	0
O&M Grade:	3
Clock Start/From:	7
Clock To:	10
1st Value:	
2nd Value:	
Value Percent:	10.000
Continuous Index:	
Within 8" of Joint:	YES
Remarks:

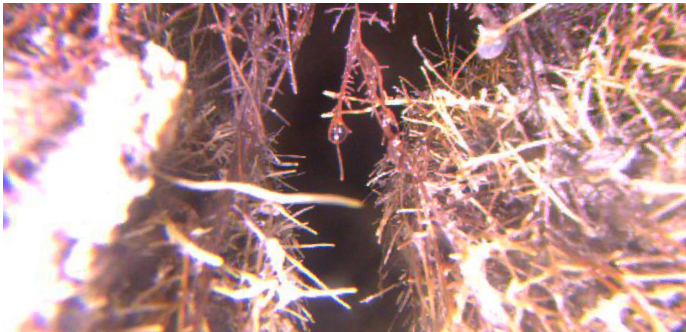
Code: **MSA**
Description: **Abandoned Survey**

Distance (ft): **14.2**
Structural Grade: **0**
O&M Grade: **0**
Clock Start/From:
Clock To:
1st Value:
2nd Value:
Value Percent:
Continuous Index:
Within 8" of Joint: **NO**
Remarks: **rbb**
