Profile/Photo Observation Report

Street:	W 4TH PL	Flow Control:	Not Controlled
City:	Hobart, IN	Year Renewed:	
Location:	Yard	Tape/Media #:	
Purpose:	Routine Assessment	Dia/Height:	10"
Use:	Sanitary	Material:	VCP
Drain Area:	NA	Lining:	
Category:	NA		
Comment:

Location Details:		Direction of Survey:	Upstream
US MH:	M-505-080	DS MH:	M-505-097
		Total Length Surveyed (ft):	130.0

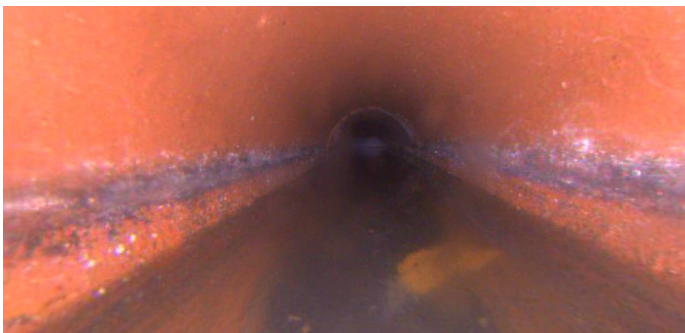
Code: **MWL**
Description: **Water Level**

Distance (ft): **.0**
Structural Grade: **0**
O&M Grade: **0**
Clock Start/From:
Clock To:
1st Value:
2nd Value:
Value Percent: **30.000**
Continuous Index:
Within 8" of Joint: **NO**
Remarks:

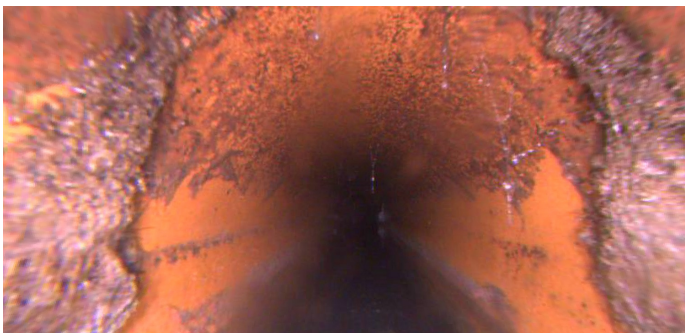
Code: **RMJ**
Description: **Roots Medium Joint**

Distance (ft): **82.5**
Structural Grade: **0**
O&M Grade: **3**
Clock Start/From: **8**
Clock To: **4**
1st Value:
2nd Value:
Value Percent: **10.000**
Continuous Index:
Within 8" of Joint: **YES**
Remarks:

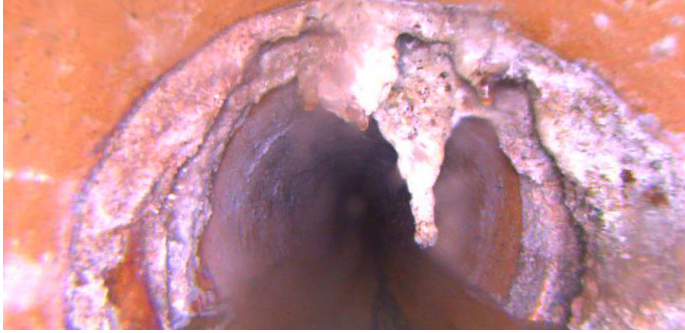
Code: **DAE**
Description: **Deposits Attached Encrustation**

Distance (ft): **107.6**
Structural Grade: **0**
O&M Grade: **3**
Clock Start/From: **8**
Clock To: **4**
1st Value:
2nd Value:
Value Percent: **20.000**
Continuous Index:
Within 8" of Joint: **YES**
Remarks:

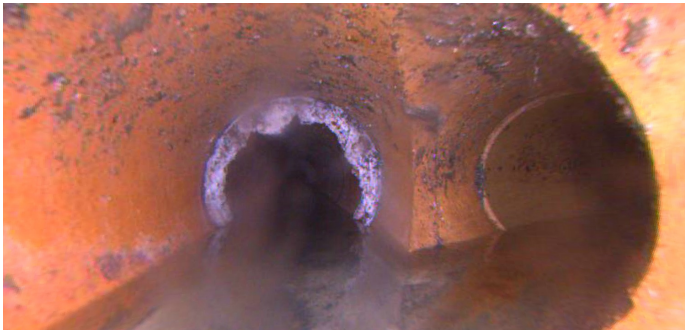
Code: **TFA**
Description: **Tap Factory Active**

Distance (ft): **118.9**
Structural Grade: **0**
O&M Grade: **0**
Clock Start/From: **3**
Clock To:
1st Value: **4.000**
2nd Value:
Value Percent:
Continuous Index:
Within 8" of Joint:
Remarks:

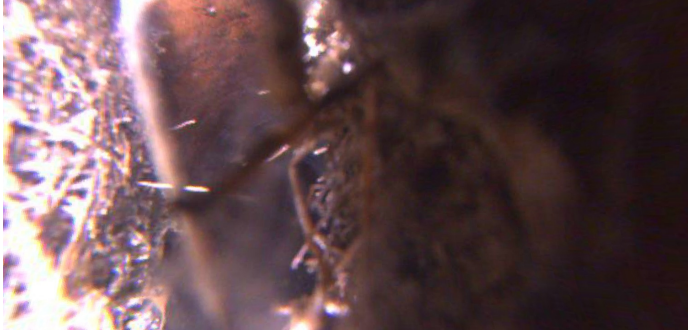
Code:	MSA
Description:	Abandoned Survey
Distance (ft):	130.0
Structural Grade:	0
O&M Grade:	0
Clock Start/From:	
Clock To:	
1st Value:	
2nd Value:	
Value Percent:	
Continuous Index:	
Within 8" of Joint:	NO
Remarks:	ROOTS
