## Profile/Photo Observation Report

| Street: | <b>FOXCROFT STREET</b> | Flow Control: | <b>Not Controlled</b> |
| City: | <b>Hobart, IN</b> | Year Renewed: | |

| US MH: | <b>M-505-080</b> | DS MH: | <b>M-505-097</b> |

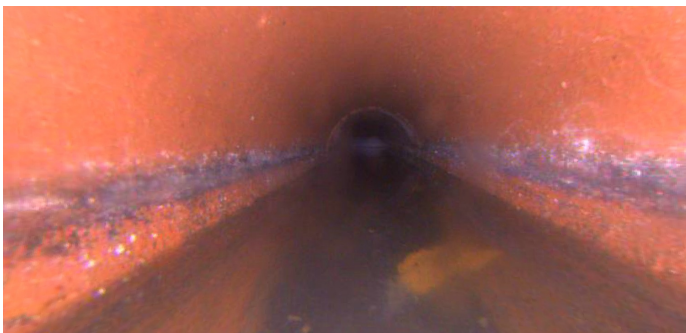
Code: **MWL**  
Description: **Water Level**

Distance (ft): **.0**  
Structural Grade: **0**  
O&M Grade: **0**  
Clock Start/From:  
Clock To:  
1st Value:  
2nd Value:  
Value Percent: **30.000**  
Continuous Index:  
Within 8" of Joint: **NO**  
Remarks:

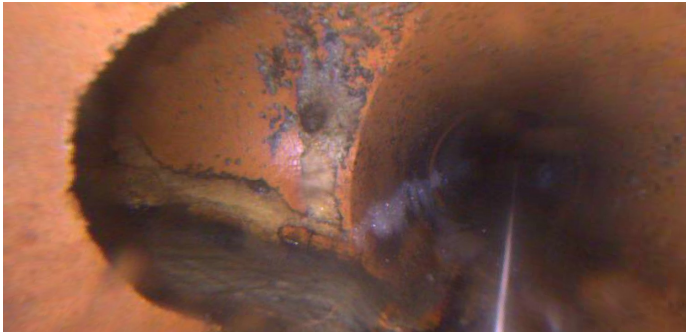
Code: **TFA**  
Description: **Tap Factory Active**

Distance (ft): **10.1**  
Structural Grade: **0**  
O&M Grade: **0**  
Clock Start/From: **3**  
Clock To:  
1st Value: **4.000**  
2nd Value:  
Value Percent:  
Continuous Index:  
Within 8" of Joint:  
Remarks:

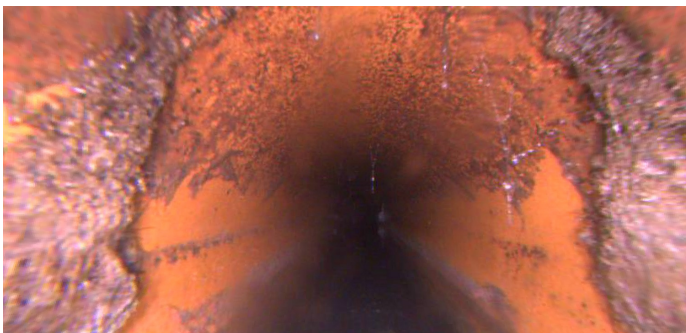
Code: **RMJ**  
Description: **Roots Medium Joint**

Distance (ft): **82.5**  
Structural Grade: **0**  
O&M Grade: **3**  
Clock Start/From: **8**  
Clock To: **4**  
1st Value:  
2nd Value:  
Value Percent: **10.000**  
Continuous Index:  
Within 8" of Joint: **YES**  
Remarks:

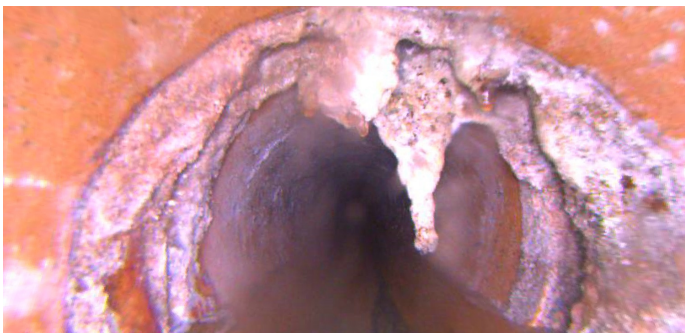
Code: **ID**  
Description: **Infil Dripper**

Distance (ft): **107.6**  
Structural Grade: **0**  
O&M Grade: **3**  
Clock Start/From: **11**  
Clock To: **1**  
1st Value:  
2nd Value:  
Value Percent:  
Continuous Index:  
Within 8" of Joint: **YES**  
Remarks:

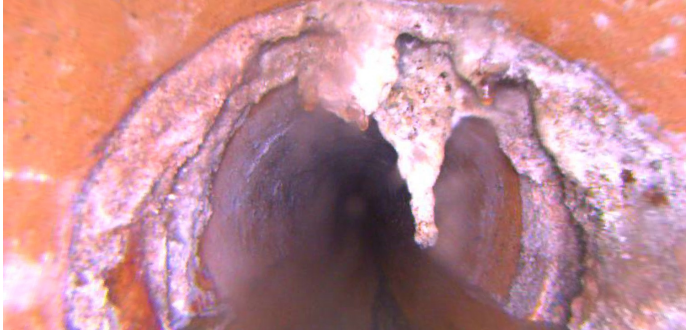
Code: **DAE**  
Description: **Deposits Attached Encrustation**

Distance (ft): **107.6**  
Structural Grade: **0**  
O&M Grade: **3**  
Clock Start/From: **8**  
Clock To: **4**  
1st Value:  
2nd Value:  
Value Percent: **20.000**  
Continuous Index:  
Within 8" of Joint: **YES**  
Remarks:

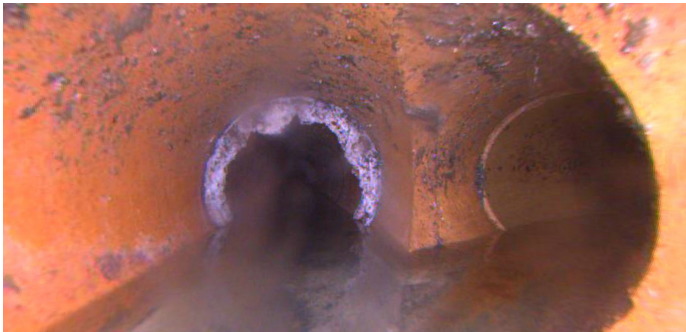
Code: **TFA**  
Description: **Tap Factory Active**

Distance (ft): **118.9**  
Structural Grade: **0**  
O&M Grade: **0**  
Clock Start/From: **3**  
Clock To:  
1st Value: **4.000**  
2nd Value:  
Value Percent:  
Continuous Index:  
Within 8" of Joint:  
Remarks:

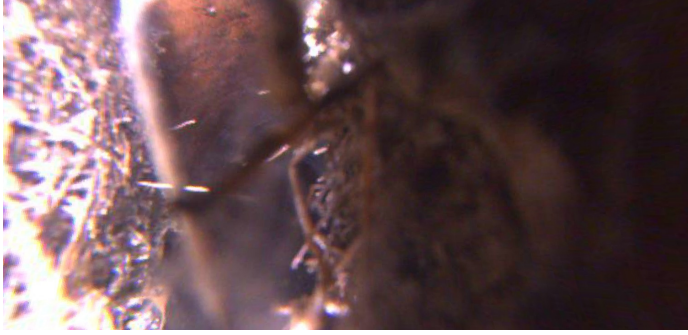
| Code: | <b>MSA</b> |
| Description: | <b>Abandoned Survey</b> |
| Distance (ft): | <b>130.0</b> |
| Remarks: | <b>ROOTS</b> |
