Profile/Photo Observation Report

Date:	01/14/2022	Weather:		Coding:	PACP 7.0
Pipe Length (ft):	299.1	Owner:	City of Hobart	Pre Clean:	Heavy Cleaning
P.O.#:	YES502259	Surveyor:	S. Bucklin	PSR:	P-505-084-085
Customer:	City of Hobart	Clean Date:	01/12/2021	Shape:	C

Street:	West 4th Place	Flow Control:	Not Controlled
City:	Hobart, IN	Year Renewed:	
Location:	Local rural streets with light traffic, t	Tape/Media #:	
Purpose:	Routine Assessment	Dia/Height:	10"
Use:	Sanitary Sewage Pipe	Material:	VCP
Drain Area:		Lining:	None
Category:	NA		
Comment:			
Location Details:		Direction of Survey:	Upstream
US MH:	M-505-084	DS MH:	M-505-085
		Total Length Surveyed (ft):	299.1

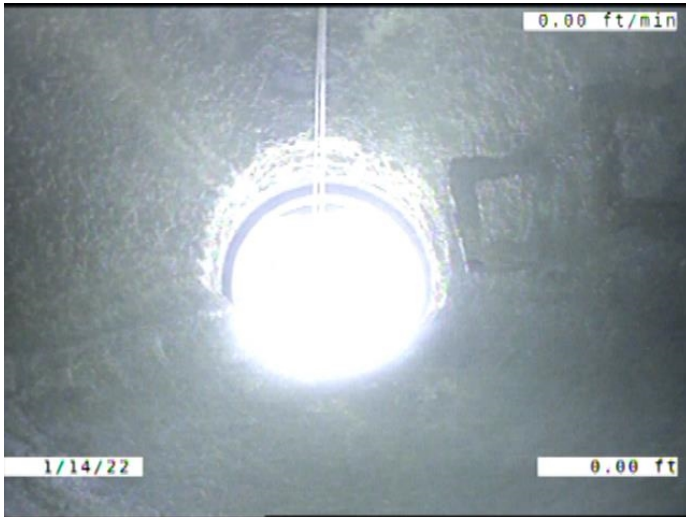
Code: **AMH**
 Description: **Manhole**

Distance (ft): **.0**
 Structural Grade: **0**
 O&M Grade: **0**
 Clock Start/From:
 Clock To:
 1st Value:
 2nd Value:
 Value Percent:
 Continuous Index:
 Within 8" of Joint: **NO**
 Remarks: **M-505-085**

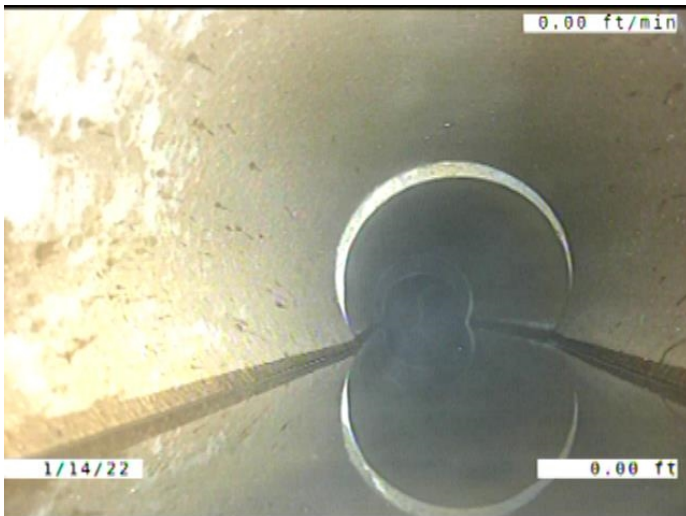
Code: **MWL**
 Description: **Miscellaneous Water Level**

Distance (ft): **.0**
 Structural Grade: **0**
 O&M Grade: **0**
 Clock Start/From:
 Clock To:
 1st Value:
 2nd Value:
 Value Percent: **10.000**
 Continuous Index:
 Within 8" of Joint: **NO**
 Remarks:

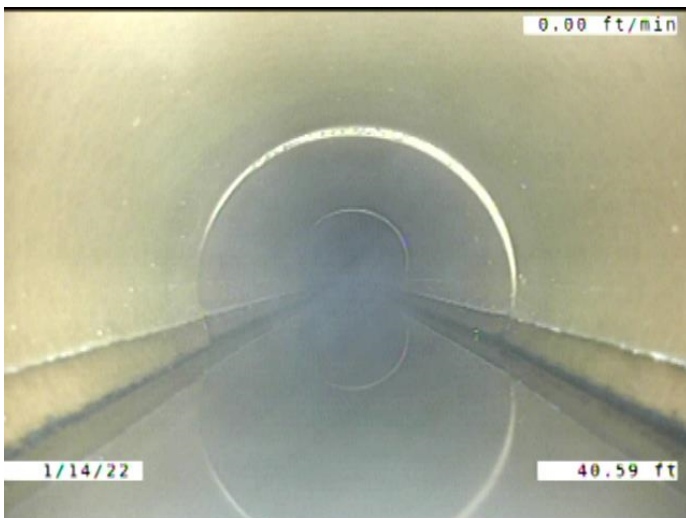
Code: **MWLS**
Description: **Miscellaneous Water Level Sag**

Distance (ft): **40.6**
Structural Grade: **2**
O&M Grade: **0**
Clock Start/From:
Clock To:
1st Value:
2nd Value:
Value Percent: **10.000**
Continuous Index: **S03**
Within 8" of Joint: **NO**
Remarks:

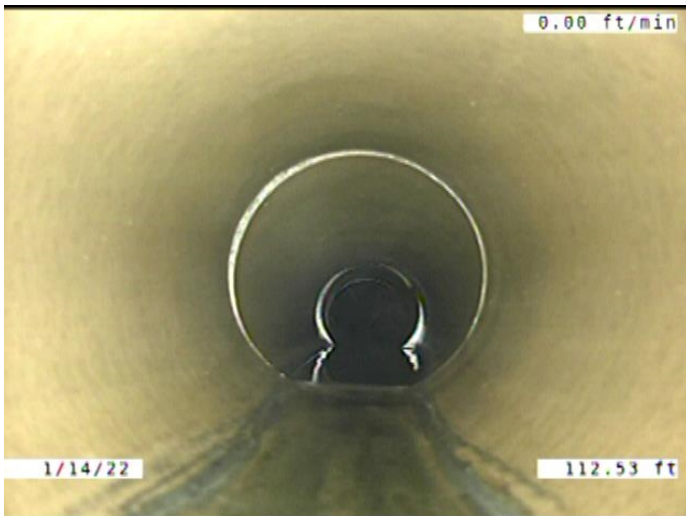
Code: **MWLS**
 Description: **Miscellaneous Water Level Sag**

Distance (ft): **112.5**
 Structural Grade: **2**
 O&M Grade: **0**
 Clock Start/From:
 Clock To:
 1st Value:
 2nd Value:
 Value Percent: **10.000**
 Continuous Index: **F03**
 Within 8" of Joint: **NO**
 Remarks:

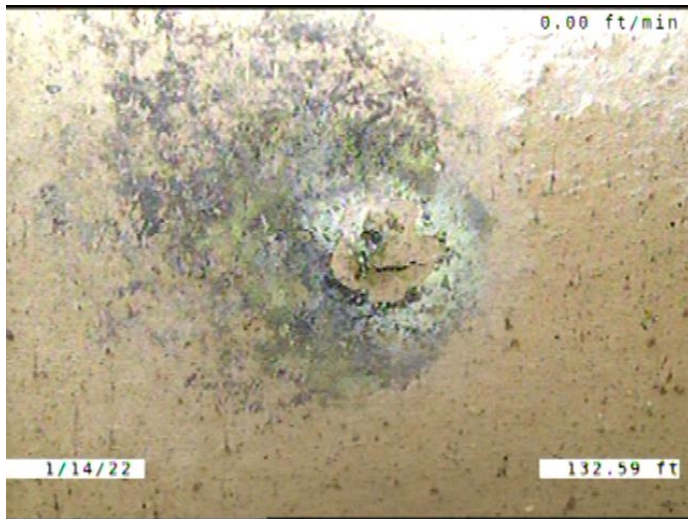
Code: **DAE**
Description: **Deposits Attached Encrustation**

Distance (ft): **132.6**
Structural Grade: **0**
O&M Grade: **2**
Clock Start/From: **9**
Clock To:
1st Value:
2nd Value:
Value Percent: **5.000**
Continuous Index:
Within 8" of Joint: **NO**
Remarks:

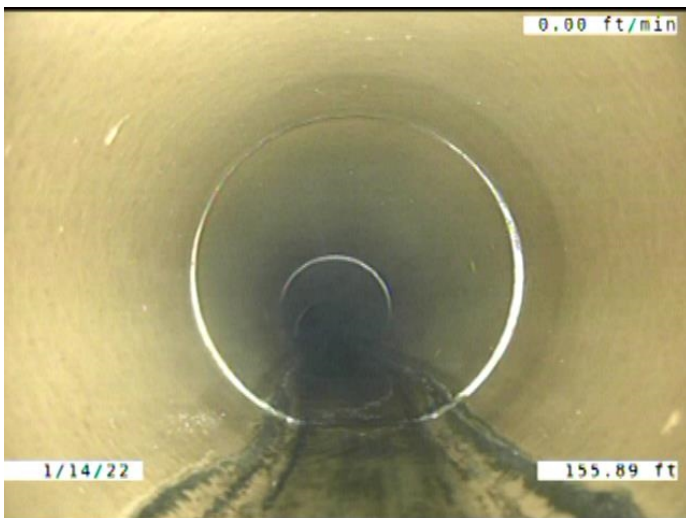
Code: **MWLS**
 Description: **Miscellaneous Water Level Sag**

Distance (ft): **155.9**
 Structural Grade: **2**
 O&M Grade: **0**
 Clock Start/From:
 Clock To:
 1st Value:
 2nd Value:
 Value Percent: **15.000**
 Continuous Index: **F05**
 Within 8" of Joint: **NO**
 Remarks:

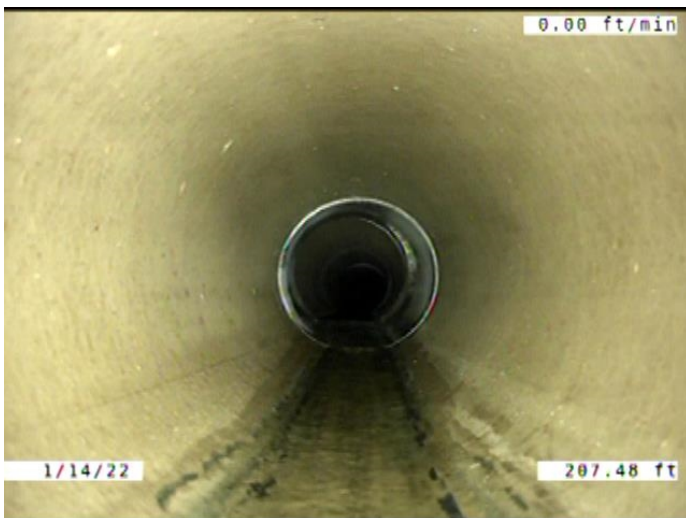
Code: **MWLS**
Description: **Miscellaneous Water Level Sag**

Distance (ft): **207.5**
Structural Grade: **2**
O&M Grade: **0**
Clock Start/From:
Clock To:
1st Value:
2nd Value:
Value Percent: **15.000**
Continuous Index: **F06**
Within 8" of Joint: **NO**
Remarks:

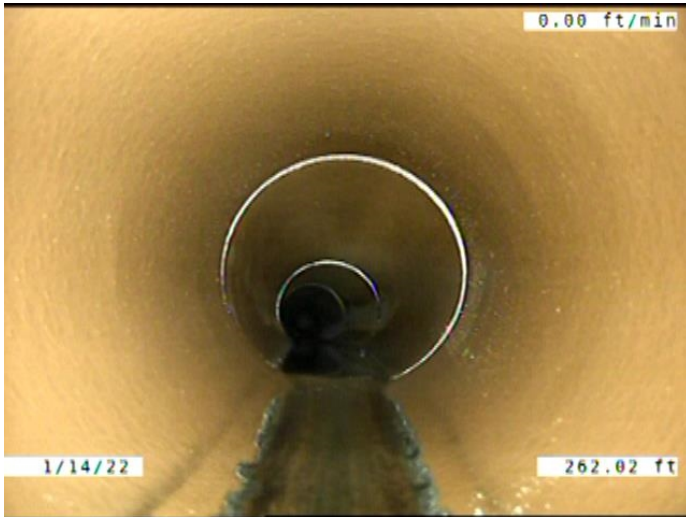
Code: **MWLS**
 Description: **Miscellaneous Water Level Sag**

Distance (ft): **262.0**
 Structural Grade: **2**
 O&M Grade: **0**
 Clock Start/From:
 Clock To:
 1st Value:
 2nd Value:
 Value Percent: **10.000**
 Continuous Index: **F07**
 Within 8" of Joint: **NO**
 Remarks:

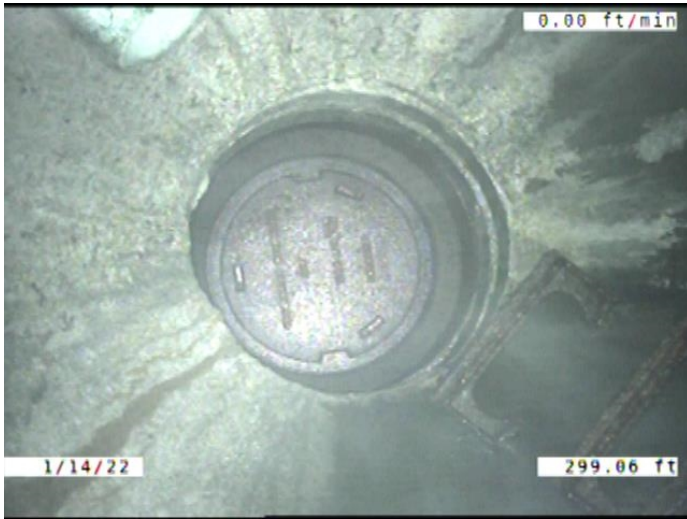
Code:	AMH
Description:	Manhole
Distance (ft):	299.1
Structural Grade:	0
O&M Grade:	0
Clock Start/From:	
Clock To:	
1st Value:	
2nd Value:	
Value Percent:	
Continuous Index:	
Within 8" of Joint:	NO
Remarks:	M-505-084
